Reposition Forward Junction Box HV Cables

Classification	Campaign Bulletin	Section/Group	44 - High Voltage System	Country/Region	Europe, APAC
Year	2016	Model	Model S	Version	RHD RWD

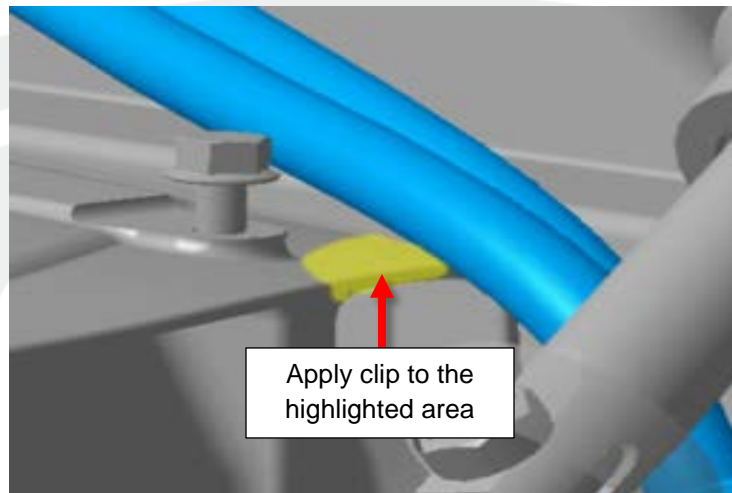
Figure 1

On some right hand drive rear wheel drive vehicles, the HV Cables on the RH side of the forward junction box might contact the steering shaft. Over time, repeated contact between the HV cables and the steering shaft might lead to an error message on the touchscreen and prevent the vehicle from starting.

1. Remove the underhood storage unit (refer to Service Manual procedure 15242301).
2. Inspect the fabric harness tape on the forward junction box HV cables:
 - If any part of the tape is penetrated or worn through, replace the HV cables and continue this procedure.
 - If no damage is present, continue this procedure.
3. Secure the edge clip to the top of the front rail extension (Figure 1).
