Adjust 2nd Row LH Fold-Flat Seat Recliner Cable

Classification	Recall Bulletin	Section/Group	13 - Seats	Country/Region	All
Year	2017	Model	Model X	Version	Fold-flat Seats

Correction Description	Correction	Time
SB-17-13-004 Not Applicable	S011713004	0.00
Adjust 2 nd Row LH Fold-Flat Seat Recliner Cable, 1 st Generation Seats	S021713004	0.15
Adjust 2 nd Row LH Fold-Flat Seat Recliner Cable, 2 nd Generation Seats	S031713004	0.10

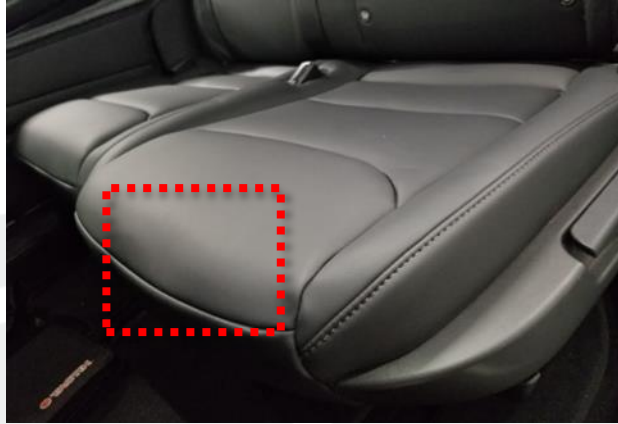
Figure 1

1. Inspect the recliner adjuster hardware underneath the 2nd row LH fold-flat seat to identify the seat generation that is being serviced (Figure 1).

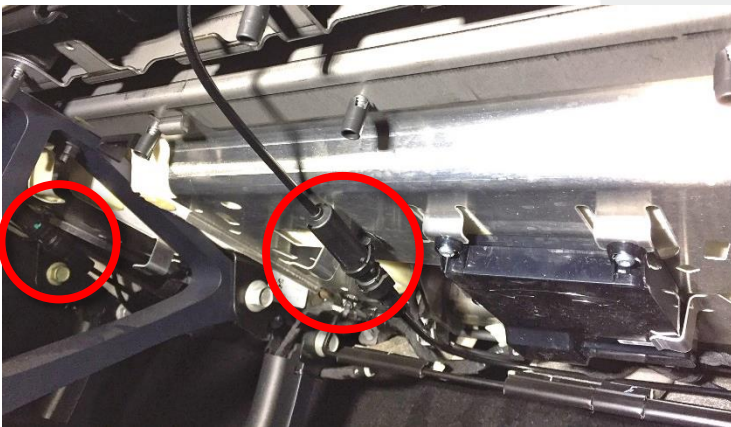
Figure 2 (2nd generation seat)

- If both a LH and RH recliner adjuster is present (Figure 2), the vehicle has 2nd generation seats. Continue to step 5.
- If no LH recliner adjuster is present (Figure 3), the vehicle has 1st generation seats. Continue to step 2.

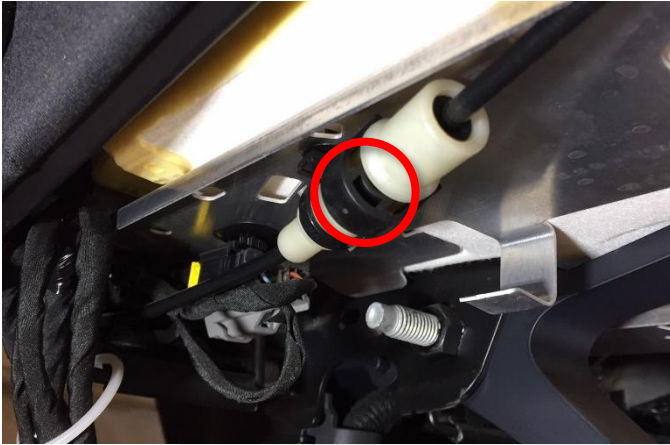
Figure 12 (1st generation seat)

NOTE: The recliner adjuster is open when there is a visible gap between the locking clip and the adjuster cylinder (Figures 12 and 13).

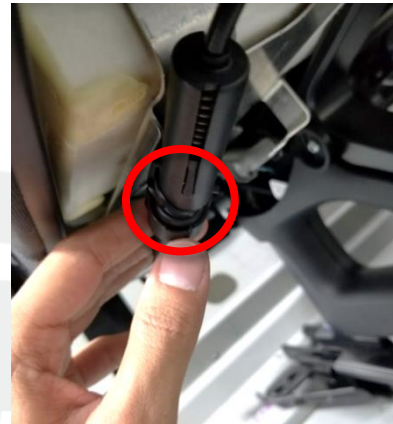
Figure 20 (2nd generation seat, 1st generation similar)

NOTE: The recliner adjuster is locked when there is no gap between the locking clip and the adjuster cylinder (Figure 20).
