Replace Huck BOM Fastener on Front Seats

Classification Repair Bulletin **Section/Group** 13 - Seats **Country/Region** All

Year 2015-2018 **Model** Model S, Model X **Version** All

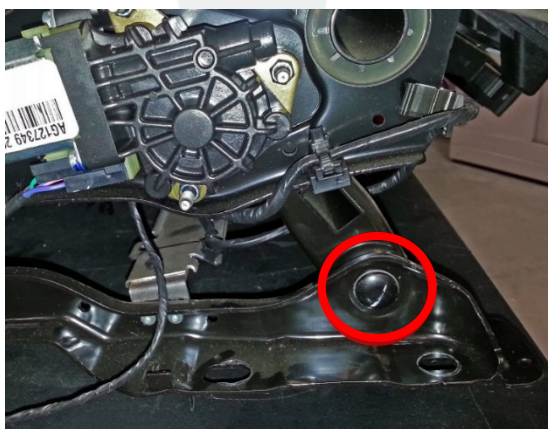
Figure 1

On some Model S and Model X front seats, the forward inboard Huck BOM fastener and pivot bushing (nearest to the center console) used on the front lift links may develop an interactive clearance condition, which might result in a rocking motion in the seat. This does not affect performance, but may result in customer dissatisfaction.

1. Remove the affected front seat (refer to Service Manual procedure 13040101).
2. Move the seat to a clean, flat work area.
3. Remove the front seat memory module (refer to Service Manual procedure 13010602).
4. Remove the seat track (refer to Service Manual procedure 13010102).
5. Remove the Huck BOM fastener:
 - a. Locate the Huck BOM rivet on the inboard side (closest to the center console) of the seat frame (Figure 1).

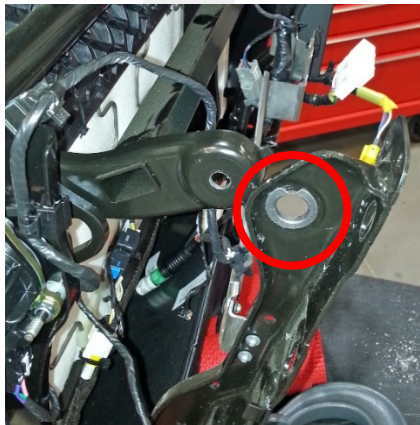
Figure 13

NOTE: The newly formed flange might or might not be split, as shown in Figure 13.

- h. Apply the C-clamp and tighten to flatten the flared part of the bushing body to form a flange on the outboard side of the seat track (Figure 13).
