# Popping Noise From Rear Door Upper Trim Brackets

<b>Classification</b>	Repair Bulletin	<b>Section/Group</b>	15 - Interior Trim	<b>Country/Region</b>	All
<b>Year</b>	2016	<b>Model</b>	Model X	<b>Version</b>	All

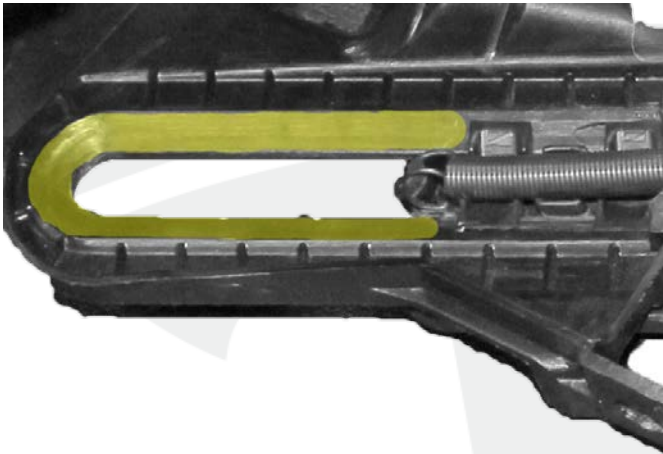
**Figure 1**

On some Model X vehicles, a popping noise might be audible from the rear door upper trim brackets when opening or closing the rear doors.

1. Remove the LH front and rear door upper trim brackets (refer to Service Manual procedures 15134402 and 15134802).
2. Perform the following steps on the front and rear door upper trim brackets:
  - a. Apply a thin layer of Kluber MR3 lubricant to both sides of the sliding mechanism (Figures 1 and 2).
