Reposition Intrusion Sensors

Classification	Campaign Bulletin	Section/Group	15 - Interior Trim	Country/Region	Europe
Year	2016	Model	Model X	Version	All

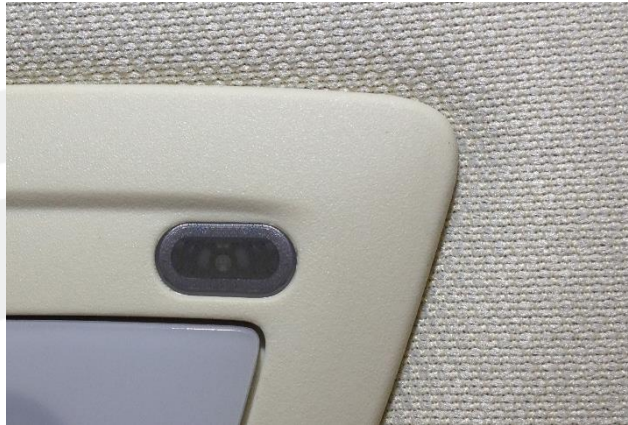
✓ **Figure 1 (Sensor flush with the map lamp assembly)**

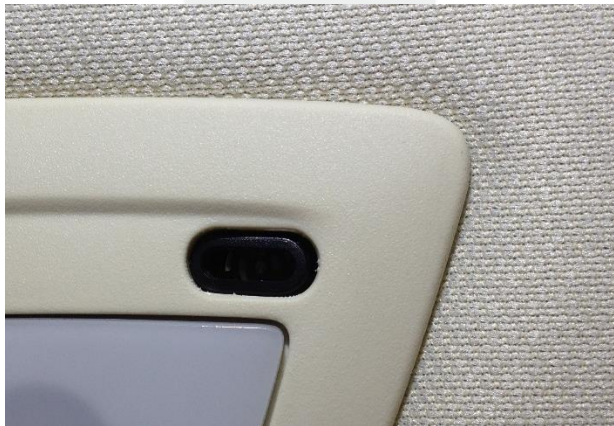
On some Model X vehicles, one or both intrusion sensors may have been incorrectly installed and may not function properly.

✗ **Figure 2 (Sensor not flush with the map lamp assembly)**

Check the intrusion sensors for flushness. If either sensor is not flush to the map lamp assembly, reposition the sensor.
