Reroute The Intrusion Sensor Wires

Classification	Repair Bulletin	Section/Group	17 - Electrical	Country/Region	Europe
Year	2016	Model	Model X	Version	All

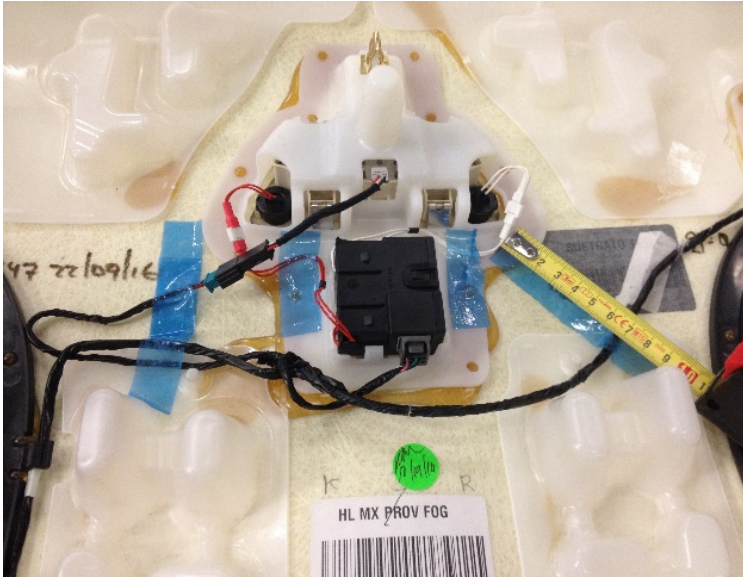
1. Remove the headliner (Refer to Service Manual procedure 15201002).
2. Inspect the wiring of the intrusion sensor, located inside of the map lamp assembly (Figures 1 and 2): If the black headliner harness is at least 6 cm away from the white intrusion sensor wire and the black headliner harness crosses the red intrusion sensor wire at a 90° angle, the wiring is correct. Discontinue this procedure and escalate a Toolbox session as appropriate.

✓ **Figure 1 (correct wiring)**

3. Remove all tape from the map lamp assembly.
4. Move the black headliner harness so that it is at least 6 cm away from the white wire (Figure 1).
5. Tape the red and white wires into position so that there is slack on the wire, the connectors, and the sensors.

⚠ CAUTION: Make sure that the white wire is at least 6 cm away from the black headliner harness. If the wires are too close together, electrical interference might occur.

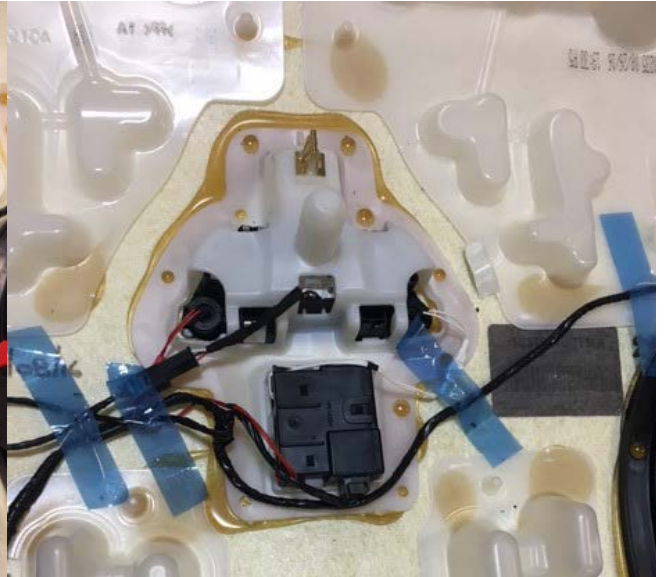
On some Model X vehicles, incorrect routing of the intrusion sensor wires might result in electrical interference between the intrusion sensor and the intrusion sensor electrical control unit (ECU). The electrical interference causes the car alarm to activate, even if the vehicle is not being intruded.

✗ **Figure 2 (incorrect wiring)**
