Replace Instrument Panel Carrier Due To Premature Scratches/Stains

| Classification | Repair Bulletin | Section/Group | 14 - Instrument Panel & Pedals | Country/Region | United States, Canada |
| Year | 2017-2018 | Model | Model 3 | Version | LHD |

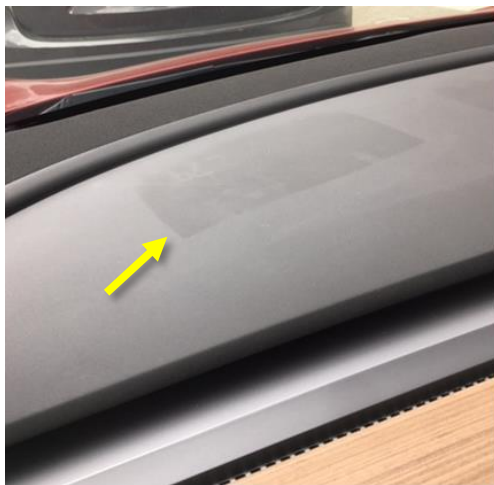
Figure 1

On some Model 3 vehicles, the top surface of the Instrument Panel (IP) carrier is prone to premature outlines or stains (Figure 1), such as an object left on the IP carrier in the sunlight. These outlines or stains can be temporarily removed, but can return, making it difficult to remove permanently. In addition, the surface of the IP carrier might be overly susceptible to scratches when attempting to clean it (Figure 2).

Inspect the vehicle for symptoms related to the condition. If symptoms are present, replace the IP carrier with an updated component.

Inspect the IP carrier; if stains or scratches are found, replace the IP carrier (refer to Service Manual procedure 14052102).
