Install 2nd Row Floor Panel Reinforcements

Classification	Repair Bulletin	Section/Group	45 - Noise, Vibration & Harshness	Country/Region	United States
Year	2017	Model	Model 3	Version	All

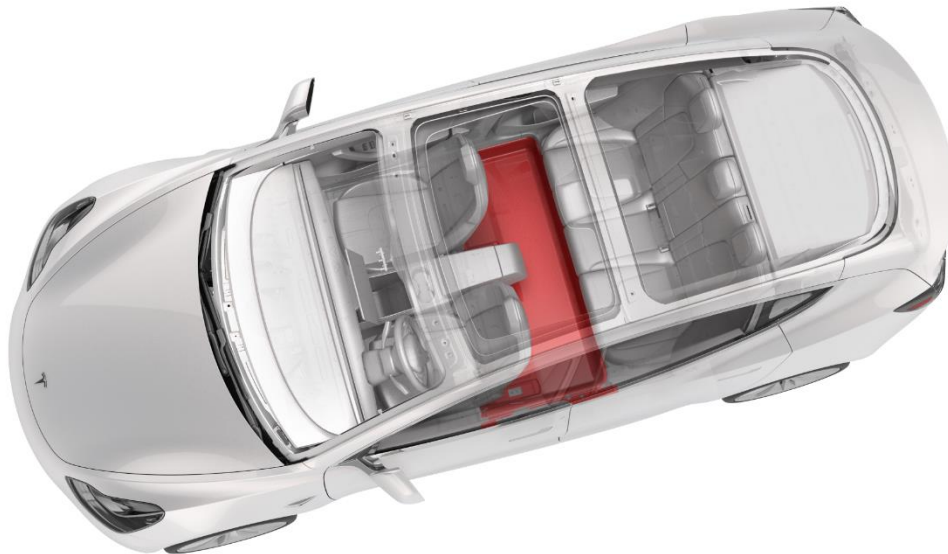
Figure 1

On some Model 3 vehicles, the 2nd row floor footwell might make a muffled thud or pop noise when a passenger steps on the affected areas highlighted in red (Figure 1).

Inspect the vehicle for symptoms related to the condition. If symptoms are present, install reinforcements in the 2nd row floor footwell.
