Tesla, Inc.
Service Bulletin

Replace Front and Mid Aero Shield Panels

SB-19-12-001
September 25, 2019 **R1**

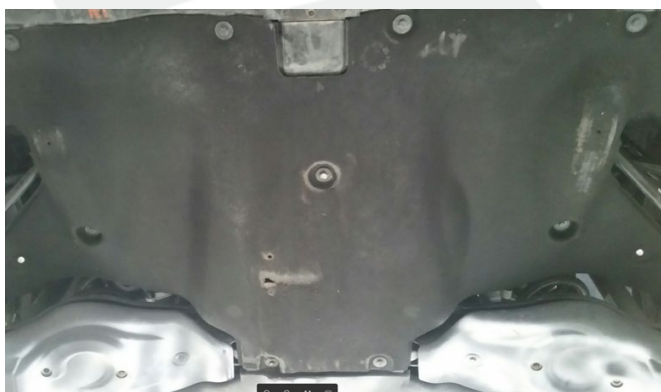
1. Verify that the vehicle VIN is on the affected vehicle list and is subject to this bulletin.
 - If the vehicle VIN is not on the affected vehicle list, the vehicle does not qualify for this bulletin. Discontinue the procedure.
 - If the vehicle VIN is on the affected vehicle list, continue to the next step.
2. Raise the vehicle (if not already on a lift) and inspect the front and mid aero shield panels for the type of damage, if any.
 - If either the front or mid aero shield panel is missing, replace both panels.
 - Object-contact damage is evident from panel abrasion (Figure 1), sheared fasteners (Figure 2), or wear through (Figure 3).

Figure 1 – Panel Abrasion; Not Covered

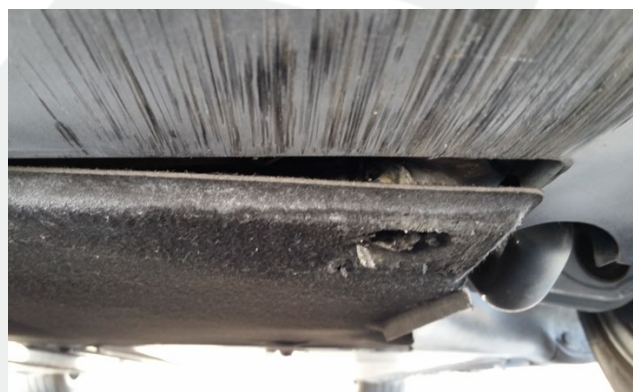
Figure 2 – Sheared Fasteners; Not Covered

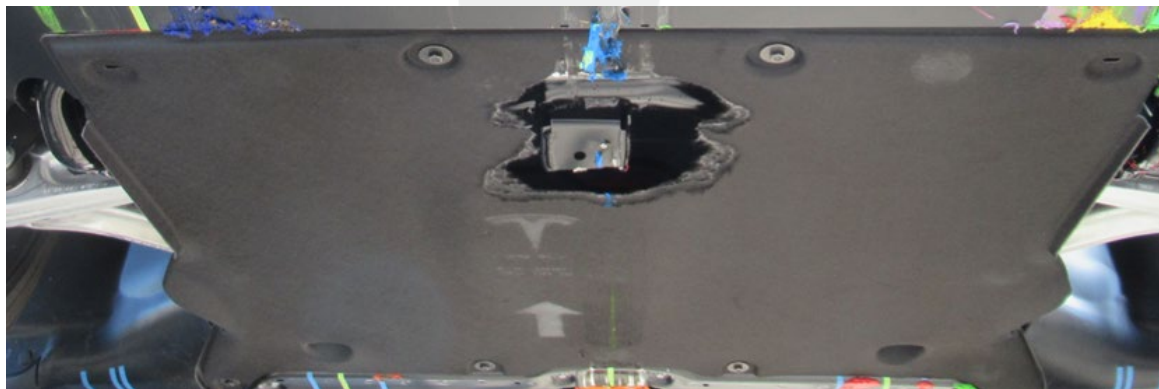
Figure 3 – Wear Through; Not Covered

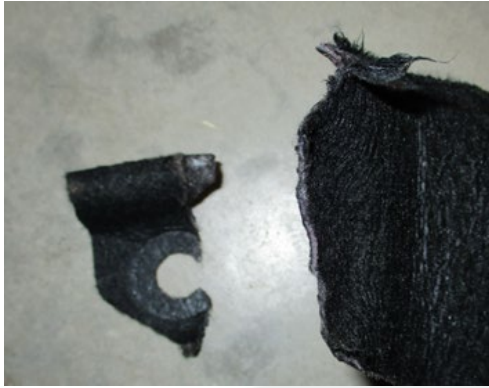
- Water-induced damage is evident from panel tearing at fastener locations (Figure 4), panel folding at leading edges (Figure 5), or panel separation at leading edges (Figure 6), all without evidence of object-contact.

Figure 4 – Panel Tearing at Fasteners; Replace Panels

- Both panels are present and not damaged, lower the vehicle and discontinue this procedure.
- Either panel has object-contact damage (which is not covered by this bulletin), discontinue this procedure and inform the customer of the following:
 - The extent of damage, and advise or recommend replacement
 - That such damage is not covered by warranty, and that replacement is customer pay
- One or both panels have water-induced damage or are missing, replace both panels (refer to Service Manual procedures 12030102 and 12030502).

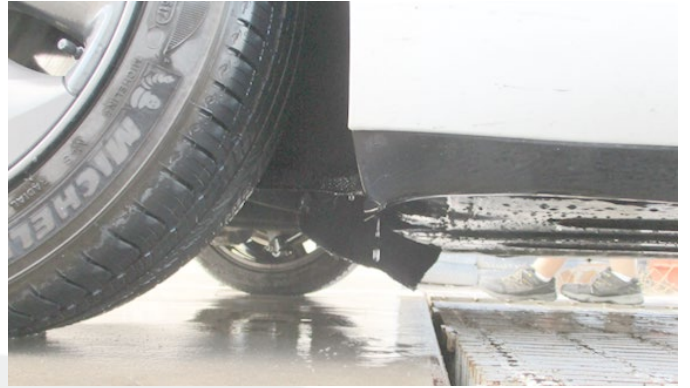
Figure 5 – Panel Folding at Leading Edge; Replace Panels

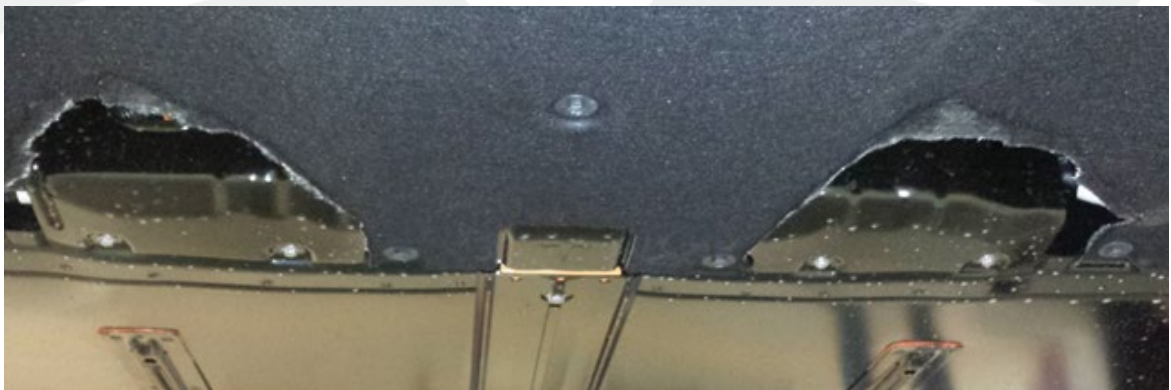
Figure 6 – Panel Separation At Leading Edge; Replace Panels

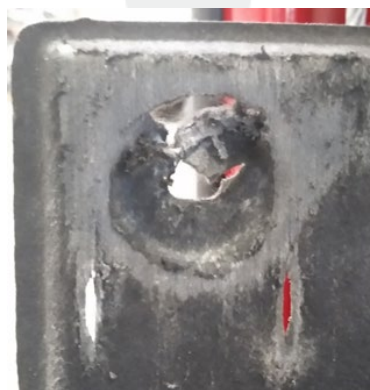
NOTE: If object-contact damage is adjacent or integral to what *might* be water-induced damage, for example, severe abrasion next to a torn panel at a fastener (Figure 7), consider the damage is from object-contact, and is not covered by this bulletin.

Figure 7 – Object-contact; Not Covered
