Replace 2nd Row Seat Back Board

Classification	Repair Bulletin	Section/Group	13 - Seats	Country/Region	All
Year	2016 - 2018	Model	Model X	Version	All

This Service Document supersedes SB-19-13-001, March 22, 2019. Each content change is marked by a vertical line in the left margin. Discard the previous version and replace it with this one.

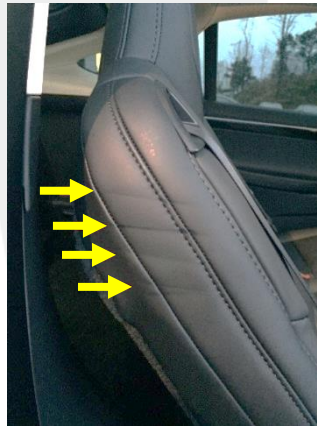
Figure 1 (RH shown, LH similar)

On some Model X vehicles equipped with 2nd row fold-flat bench seats, the RH and/or LH seat backs might interfere with the rear door panel when the door is closed and cause NVH issues.

1. Open both rear doors and inspect the outward facing surfaces of the 2nd row seats for witness marks indicating interference with the doors (Figure 1).

NOTE: Interference with the rear doors might cause a squeaking sound when the doors are closed in addition to or instead of visible witness marks. Witness marks are relieved when the condition is resolved; there is no permanent damage to the seat upholstery.

2. Install a 2nd row bench seat back panel to the seat where there is interference:
 - 5-Passenger Vehicle: 2nd Row LH Seat - Refer to Service Manual procedure 13082122
 - 5-Passenger Vehicle: 2nd Row RH Seat - Refer to Service Manual procedure 13082202
 - 7-Passenger Vehicle: 2nd Row LH Seat - Refer to Service Manual procedure 13082112
 - 7-Passenger Vehicle: 2nd Row RH Seat - Refer to Service Manual procedure 13082212
