Tesla, Inc. Service Bulletin		<i>Replace Instrument Panel Carrier Due To Bumps Or Bubbling</i>	
SB-19-14-001 September 25, 2019			
Classification Repair Bulletin		Section/Group 14 - Instrument Panel & Pedals	Mobile Service Cannot Perform
Model Year 2017 - 2019	Model Model 3	Country/Region All	Version All
<small>The model(s) and model year(s) listed are a general approximation of the affected VIN list. Refer to the VIN/Bulletin Tracker or Customer/Vehicle profile to determine applicability of this bulletin for a particular vehicle.</small>

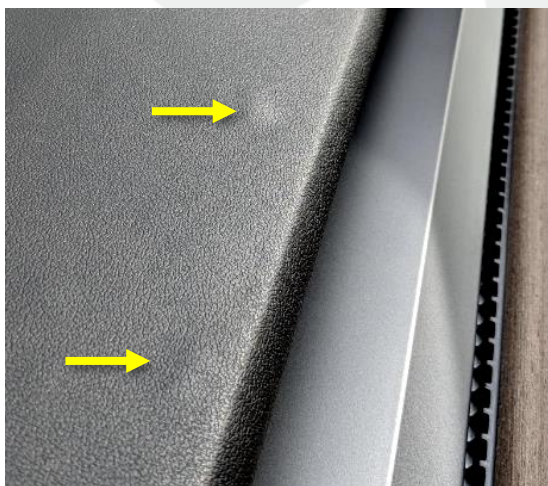
Figure 1

On some Model 3 vehicles, the top or front surfaces of the Instrument Panel (IP) carrier might form bubbles or bumps (Figures 1 and 2) in warm ambient temperatures.

Inspect the vehicle for symptoms related to the condition. If symptoms are present, replace the IP carrier with an updated component.

Inspect the IP carrier; if bumps or bubbling are found, replace the IP carrier (refer to Service Manual procedure 14052102).
