# Modify Steering Shaft Sleeve

<b>Classification</b>	Repair Bulletin	<b>Section/Group</b>	32 - Steering	<b>Country/Region</b>	United States, Canada
<b>Year</b>	2017	<b>Model</b>	Model 3	<b>Version</b>	All

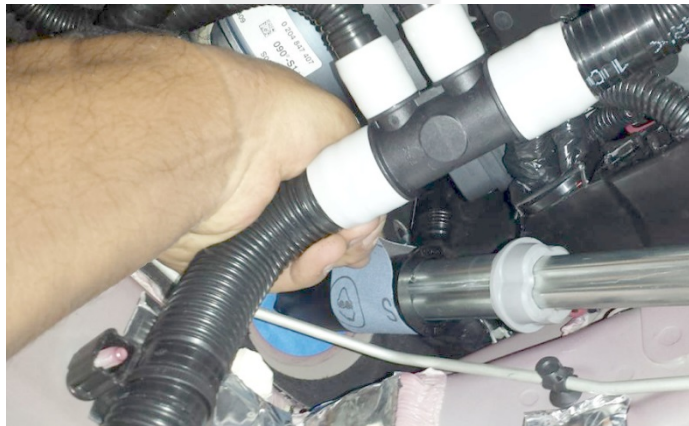
**Figure 4**

On a certain few Model 3 vehicles, the steering shaft sleeve diameter is too large, and might preload the steering shaft boot bearing so as to cause a squeaking noise to come from the steering shaft boot when the steering wheel is turned. The squeaking noise is most prevalent at lower ambient temperatures, and might diminish as the temperature rises. This is exclusively an NVH issue and does not affect steering functionality.

5. Cut a piece of 150 grit sandpaper to approximate width of 1.75 inches for a length of 8 inches or more.
6. Raise the vehicle on the lift, and then remove the front aero shield panel (refer to Service Manual procedure 12030102).
7. Wrap the sandpaper around the lower end of the steering shaft sleeve, against the lip of the sleeve (Figure 4).

8. Have an assistant turn a front road wheel from full left to full right 40 times, while the sandpaper is held against the steering shaft sleeve.

**! CAUTION:** Do not allow the sandpaper to touch the metal of the steering shaft, as it will damage the shaft. The sandpaper must only sand the steering shaft sleeve.
