Replace Charge Port Door Assembly Sensor Target

Classification	Repair Bulletin	Section/Group	44 - High Voltage System	Country/Region	United States, Canada
Year	2018	Model	Model 3	Version	All

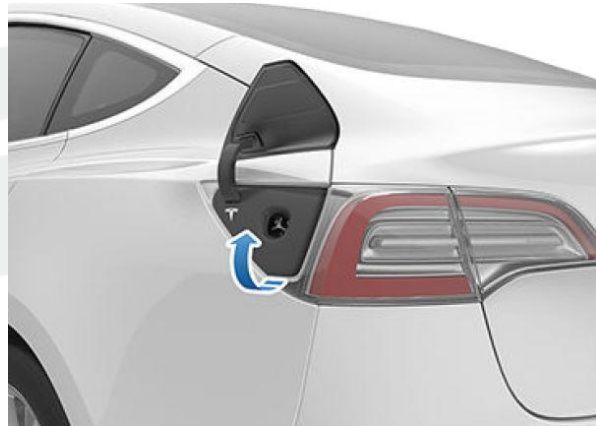
Figure 1

On some Model 3 vehicles, the sensor target on the charge port door assembly might have fallen off, causing the push-to-open feature on the charge port door to become inoperative. The charge port door can still be operated through the touchscreen, the mobile application, or the charge port handle button.

1. Unlock all doors.
2. Check the charge port door assembly push-to-open operation by pressing the bottom of the charge port door (Figure 1):
 - If the charge port door opens, discontinue this procedure.
 - If the charge port does not open, continue to the next step.

Inspect the vehicle for an inoperative push-to-open feature of the charge port door. If the symptom is present, install a new charge port door sensor target.
