Tesla, Inc.
Service Bulletin

Inspect Front Stabilizer Bar For Squeak Noise

SB-20-31-001
July 24, 2020

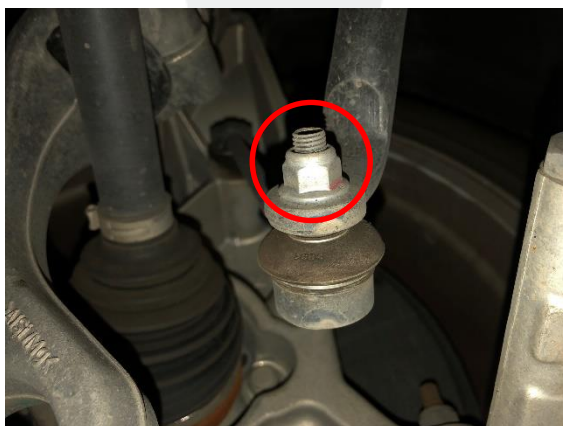
Figure 1 – Model X (LH side shown for clarity, Model S similar)

1. Perform a short test drive where the vehicle travels slowly over large speed bumps, curbs cuts, or road imperfections that will substantially compress or extend the front suspension.
2. While moving over the speed bump, curb cut, or road imperfection, listen for a squeak noise from the front suspension.
 - If there is no squeak noise, then this bulletin does not apply. Discontinue this procedure.
 - If there is a squeak noise, continue to the next step.
3. Remove both front wheels (refer to Service Manual procedure 34012401).
4. Raise the vehicle to a working height.
5. Remove and discard the nuts that attach both stabilizer bar links to the front stabilizer bar and remove the links from the stabilizer bar (Figure 1).

9. Use the pry bar to move the end of the replacement front stabilizer bar up and down on each side of the vehicle (Figure 2):
 - If there is still a squeak noise from either side when moving the stabilizer bar end up and down, escalate a Toolbox session and wait for further instruction.
 - If there is no squeak noise from either side when moving the stabilizer bar end up and down, continue to the next step.
10. Install the stabilizer links onto the front stabilizer bar, and then install new nuts to attach the links to the stabilizer bar (torque 70 Nm) (Figure 1).

! CAUTION: Use a wrench to hold the stabilizer link ball joint stud while installing the nut to prevent stabilizer link ball joint damage.

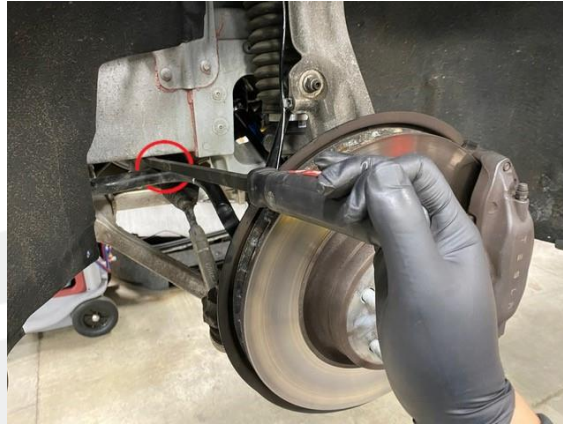
Figure 2 – Model X (LH side shown for clarity, Model S similar)

6. Use a pry bar to move the end of the front stabilizer bar up and down on each side of the vehicle (Figure 2):
 - If there is no squeak noise from either side when moving the stabilizer bar end up and down, this bulletin does not address the source of the squeak noise. Skip to step 10.
 - If there is a squeak noise from either side when moving the stabilizer bar end up and down, the stabilizer bar is to be replaced. Continue to the next step.

7. Inspect the replacement stabilizer bar for a green paint mark on a rubber bushing and a yellow paint mark on the bushing mount verifying proper vulcanization of the bushings.

8. Replace the front stabilizer bar (refer to Service Manual procedure 31012202), however, do not attach the stabilizer links to the stabilizer bar or install the wheels as of yet.
