Tesla, Inc. Service Bulletin		<h2 style="margin: 0;">Inspect Front Spring and Damper Assembly Insulators</h2>	
SB-20-31-003 June 25, 2020			
Classification		Section/Group	Mobile Service
Campaign Bulletin		31 - Suspension	Cannot Perform
Model Year	Model	Country/Region	Version
2020	Model 3	China	All
<small>The model(s) and model year(s) listed are a general approximation of the affected VIN list. Refer to the VIN/Bulletin Tracker or Customer/Vehicle profile to determine applicability of this bulletin for a particular vehicle.</small>

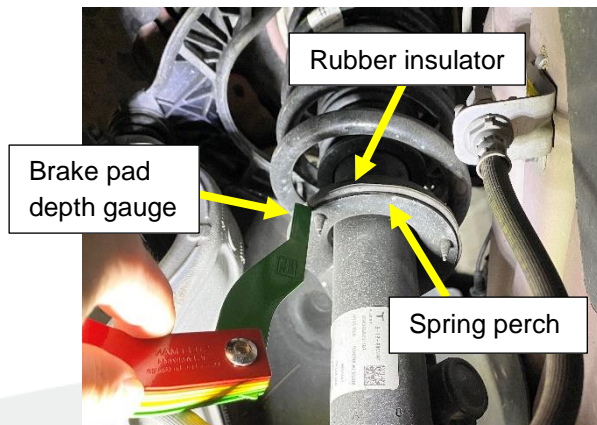
Figure 1

2. Use the brake pad depth gauge to inspect the protrusion of the rubber insulator at the spring perch of both the LH and RH front spring and damper assemblies (Figure 1):

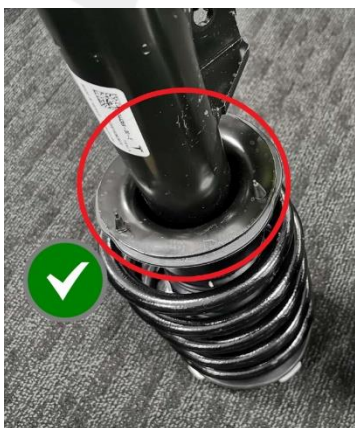
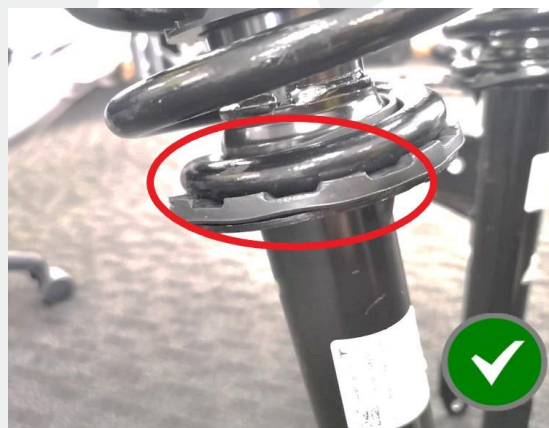
- **✓** If the insulator is uniformly spaced on the spring perch and at no point protrudes more than 10 mm from the perch (Figures 2 and 3), that spring and damper assembly is within specification and does not need to be replaced. If both spring and damper assemblies are within specification, lower the vehicle and discontinue this procedure.

Figure 2 – Assembly removed from vehicle for clarity

Figure 3 – Assembly removed from vehicle for clarity

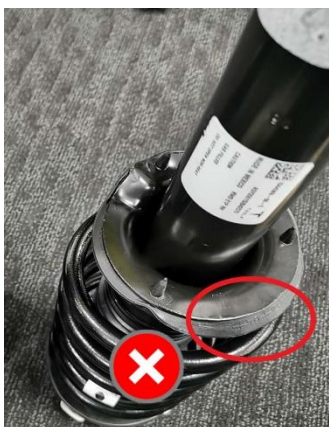
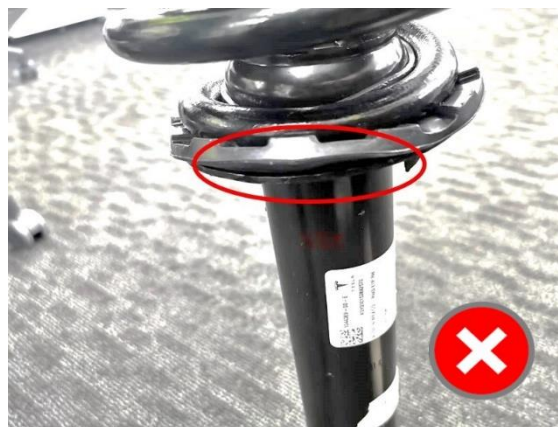
- **✗** If the insulator is unevenly spaced on the spring perch and protrudes more than 10 mm from the perch (Figures 4 and 5), that spring and damper assembly is outside of specification and must be replaced (refer to Service Manual procedure [31151002](#)).

Figure 4 – Assembly removed from vehicle for clarity

Figure 5 – Assembly removed from vehicle for clarity

Inspect the vehicle for symptoms related to the condition. If symptoms are present, replace that front spring and damper assembly.
