Tesla, Inc. Service Bulletin		<h2 style="margin: 0;">Inspect Upper Steering Column Bolt</h2>	
SB-20-32-008 May 7, 2020			
Classification		Section/Group	Mobile Service
Recall Bulletin		32 - Steering	Can Perform (where permitted)
Model Year	Model	Country/Region	Version
2020	Model 3	United Kingdom	RHD
<small>The model(s) and model year(s) listed are a general approximation of the affected VIN list. Refer to the VIN/Bulletin Tracker or Customer/Vehicle profile to determine applicability of this bulletin for a particular vehicle.</small>

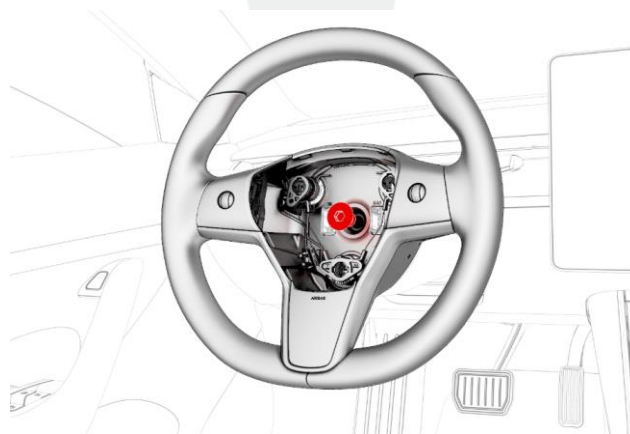
Figure 1 – LHD shown, RHD similar

On some Model 3 vehicles in the United Kingdom, the upper steering column bolt may not be installed according to internal specifications, which could cause excessive play between the steering wheel and steering column.

📄 NOTE: Before installing the driver airbag, install a new bolt that attaches the steering wheel to the steering column (Figure 1) (torque 80 Nm).
