<b>Tesla, Inc.</b> Service Bulletin		<h2 style="margin: 0;">Inspect Upper B-Pillar Trim For Visible Casting Seam</h2>	
<b>SB-21-15-003</b> May 26, 2021			
<b>Classification</b>		<b>Section/Group</b>	<b>Mobile Service</b>
Repair Bulletin		15 - Interior Trim	Can Perform (where permitted)
<b>Model Year</b>	<b>Model</b>	<b>Country/Region</b>	<b>Version</b>
2021	Model Y	North America, South Korea	All
<small>The model(s) and model year(s) listed are a general approximation of the affected VIN list. Refer to the VIN/Bulletin Tracker or Customer/Vehicle profile to determine applicability of this bulletin for a particular vehicle.</small>

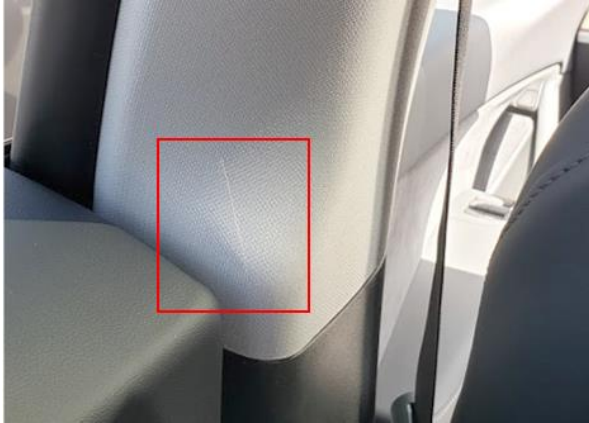
Certain Model Y vehicles might have a visible casting seam in the upper B-pillar trim. This seam is cosmetic only, and does not affect the functionality or performance of the trim.

✘ **Figure 1 – Casting seam**

1. Open the LH rear door and inspect where the upper B-pillar trim meets the lower B-pillar trim.
  - If there is a seam at the corner of the trim (Figure 1), replace the upper B-pillar trim (refer to Service Manual procedure [15183002](#)).
  - If there is no seam visible at the corner of the trim (Figure 2), continue to the next step.

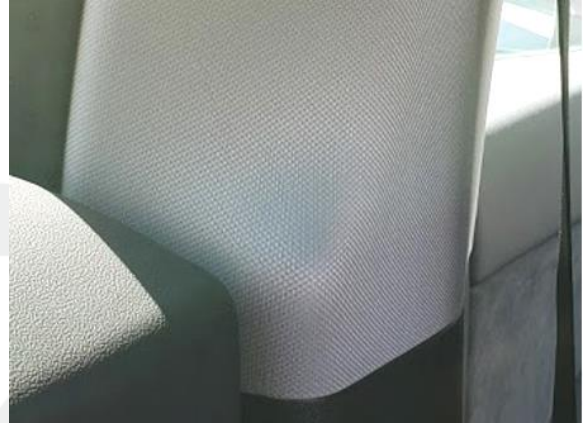
✔ **Figure 2 – No casting seam**
