<b>Tesla, Inc.</b> <b>Service Bulletin</b>		<h2 style="margin: 0;">Inspect Front Lower Lateral Links</h2>	
<b>SB-21-31-003</b> December 2, 2021		<b>R3</b>	
<b>Classification</b> Recall Bulletin		<b>Section/Group</b> 31 - Suspension	<b>Mobile Service</b> Limited
<b>Model Year</b> 2019–2021	<b>Model</b> Model 3, Model Y	<b>Country/Region</b> All	<b>Version</b> All
<small>The model(s) and model year(s) listed are a general approximation of the affected VIN list. Refer to the VIN/Bulletin Tracker or Customer/Vehicle profile to determine applicability of this bulletin for a particular vehicle.</small>

### Condition

On certain Model 3 and Model Y vehicles, the bolts that secure the front lower lateral links to the subframe may not have been torqued to internal specification.

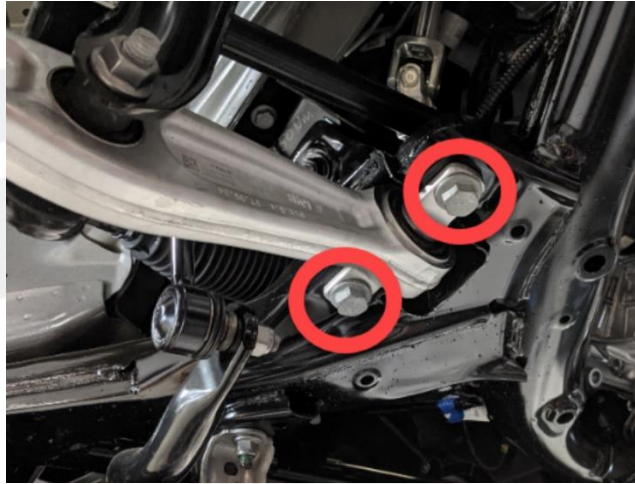
Figure 1 – LH shown; RH similar

1. Remove the front aero shield panel (refer to Service Manual procedure 12030102; [Model 3](#), [Model Y](#)).
2. Perform a torque check on the bolts that attach the LH and RH front lower lateral links (4 bolts total) to the front subframe (115 Nm) (Figure 1).

**⚠ CAUTION:** Check that the bolt heads are fully flush with the lateral link flanges and that there are no gaps between the bolt heads, flanges, and subframe. Gaps between these components are a sign of possible cross threading and should be investigated.

- If all 4 bolts are already torqued to specification and no signs of cross threading are observed, the subframe does not need replacement. Take note and skip to step 7.
  - If any of the 4 bolts are missing, damaged, not already torqued to specification, or if signs of cross threading are observed, continue to step 3.
3. Inspect the front lateral link and front subframe to lateral link attachment point (Figure 2), noting damage such as cracks, bent arms/flanges, or damaged bolts.

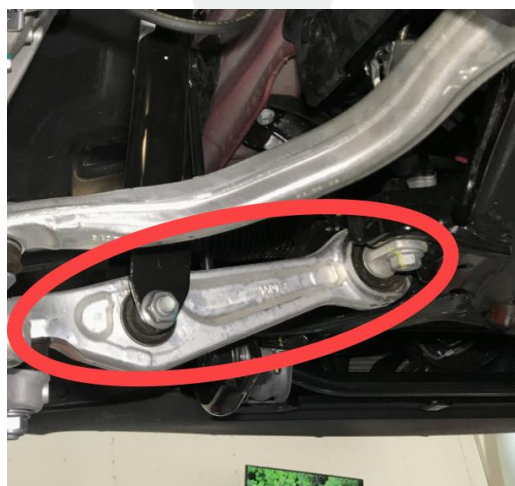
Figure 2 – LH shown; RH similar

- If damage to the front subframe has been observed in steps 2 or 3 (such as cross threading, cracks, bent arms/flanges, or damaged bolts), take note and skip to step 6.
- If damage to the front subframe is not observed, take note and continue to step 4.

4. Remove any damaged front lower lateral links, and then hand tighten new lateral link(s) to the front knuckle and front strut. Do not attach the new lateral link(s) to the front subframe yet (refer to Service Manual procedure 31013402; [Model 3](#), [Model Y](#)).
5. Where front lateral link to subframe bolt(s) are missing, damaged, or not torqued to specification, attempt to install new bolt(s) (115 Nm) (Figure 1).

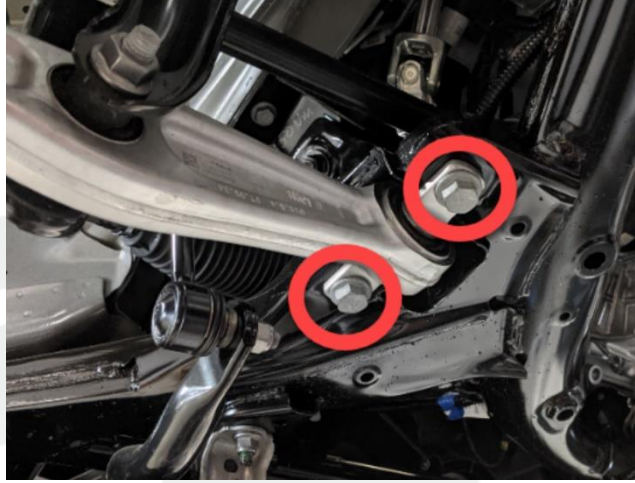
Figure 7 – LH shown; RH similar

8. Perform a torque check on the bolts that attach the LH and RH front lower lateral links (4 bolts total) to the front subframe (115 Nm) (Figures 7-9).

**⚠ CAUTION:** Check that the bolt heads are fully flush with the lateral link flanges and that there are no gaps between the bolt heads, flanges, and subframe. Gaps between these components are a sign of possible cross threading and should be investigated.

- If all 4 bolts are already torqued to specification and no signs of cross threading are observed, the subframe does not need replacement. Install all parts that were removed for access and close this bulletin using Correction Code S132131003.
- If any of the 4 bolts are missing, damaged, not already torqued to specification, or if signs of cross threading are observed, install all parts that were removed for access, and tow the vehicle to a Service Center for further inspection. Use Correction Code 31000010 to track work performed, but DO NOT close the bulletin.
