Tesla, Inc. Service Bulletin		<h2>Replace Front Drive Unit Halfshafts</h2>	
SB-21-39-001 December 10, 2021		R2	
Classification Repair Bulletin		Section/Group 39 - Front Drive Unit	Mobile Service Cannot Perform
Model Year 2014 - 2020	Model Model S, Model X	Country/Region All	Version All
<small>The model(s) and model year(s) listed are a general approximation of the affected VIN list. Refer to the VIN/Bulletin Tracker or Customer/Vehicle profile to determine applicability of this bulletin for a particular vehicle.</small>

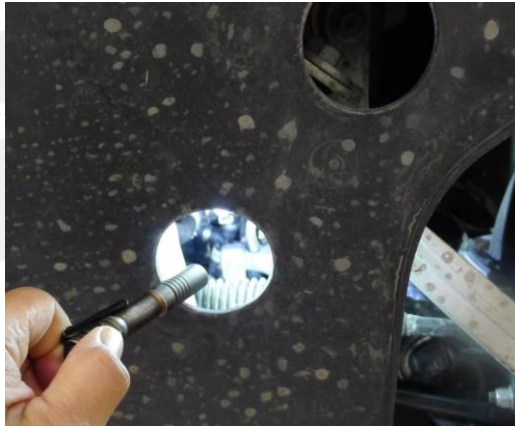
Figure 1

1. Raise and support the vehicle (refer to Service Manual procedure 10000205; [Model S](#), [Model X](#)).
2. Shine a light into the front aero shield LH front caster adjustment opening (Figure 1) and inspect the flanges of the front drive unit clevis that attach to the side rail.
 - If the clevis flanges are squared and fastened with hex bolts (Figure 2), clevis and halfshaft replacement are necessary; skip to step 3.
 - If the clevis flanges are rounded and fastened with External Torx bolts with large washers that obscure the flange (Figure 3), clevis replacement is not necessary; however, the halfshafts must be replaced. Skip to step 4.

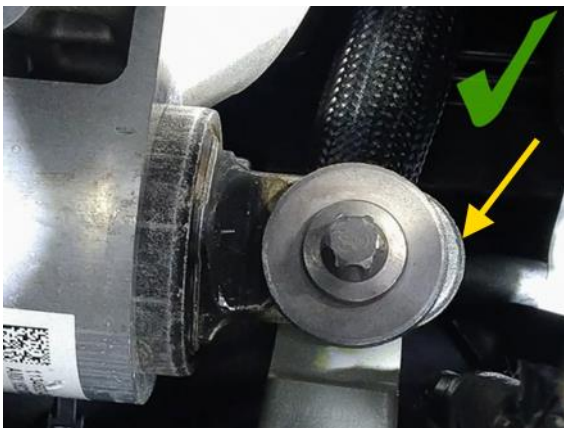
Figure 5

1. Remove the LH front drive unit halfshaft (refer to Service Manual procedure 39303102; [Model S](#), [Model X](#)).
2. **Vehicles built on April 25 or April 26, 2019:**
 - a. Inspect the foremost mounting bolt on the front drive unit clevis.
 - If the clevis is visible past the front edge of the foremost washer (Figure 5), the clevis does not require repositioning; skip to step 3.
 - If the clevis is not visible past the front edge of the foremost washer (Figure 6), the clevis requires repositioning; continue to step 2.b.
