Tesla, Inc.
Service Bulletin

Disable Rear Fog Light Functionality

SB-22-00-005
April 14, 2022

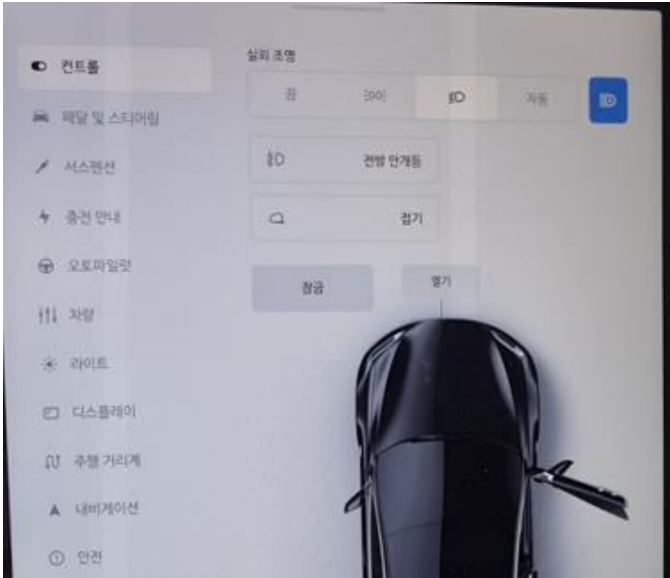
✓ Figure 1

1. Open the LH front door.
2. On the vehicle touchscreen, touch **Controls > Lights**, and then see if the “Rear Fog Light” button is not present (Figures 1 and 2).
 - If the rear fog light icon is present, refer to Toolbox article [6287100](#) for more information.
 - If the rear fog light icon is not present, continue to the next step.
