Tesla, Inc. Service Bulletin		<h2 style="margin: 0;">Inspect Restraint Control Module Configuration</h2>	
SB-22-20-002 April 22, 2022			
Classification		Section/Group	Mobile Service
Recall Bulletin		20 - Safety and Restraint	Can Perform (where permitted)
Model Year	Model	Country/Region	Build Location
2022	Model 3	Europe	Giga Shanghai
<small>The model(s) and model year(s) listed are a general approximation of the affected VIN list. Refer to the VIN/Bulletin Tracker or Customer/Vehicle profile to determine applicability of this bulletin for a particular vehicle.</small>

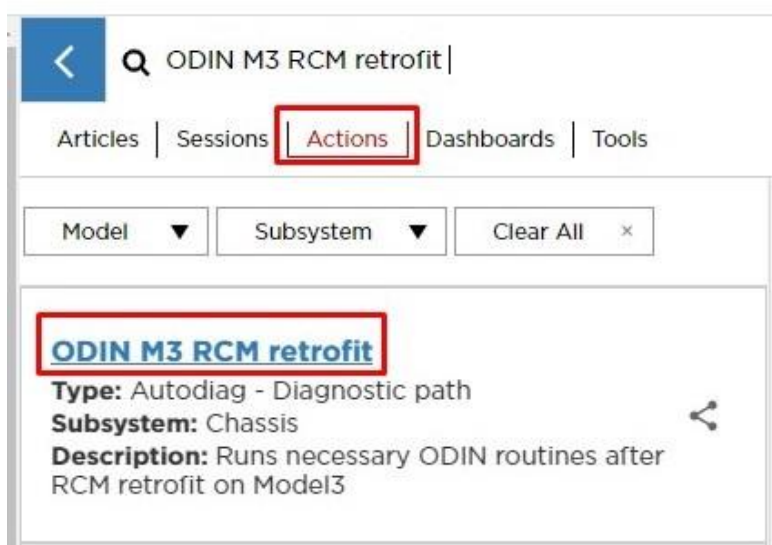
Figure 1

1. Connect a laptop with Toolbox 3 to the vehicle.
2. Select the **Actions** tab, and then search for "ODIN_M3_RCM_retrofit" (Figure 1).

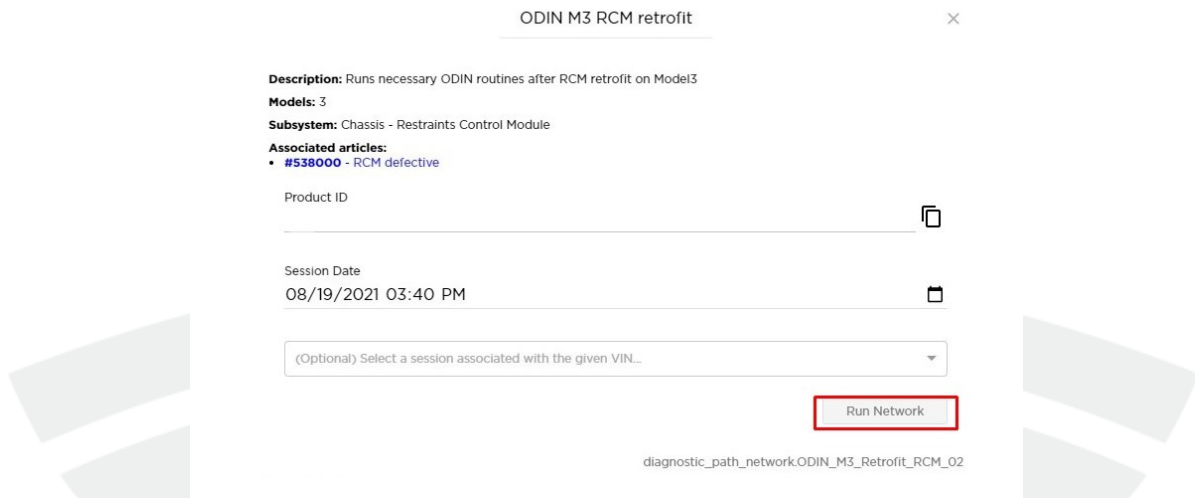
Figure 2

3. Select **ODIN M3 RCM retrofit**, and then click **Run Network** (Figure 2). Allow the routine to complete before continuing.

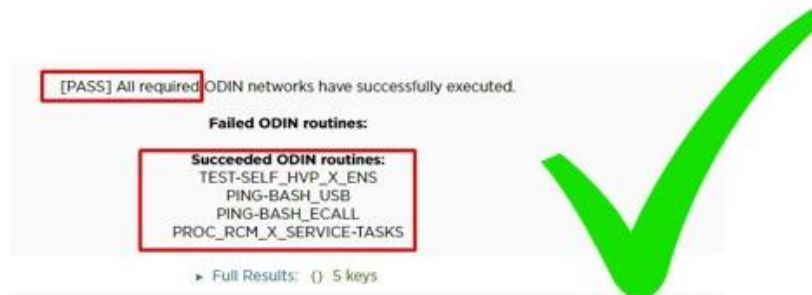
Figure 3

4. Examine the result after the routine has completed.
 - If the result shows [PASS] (Figure 3), go to step 6.

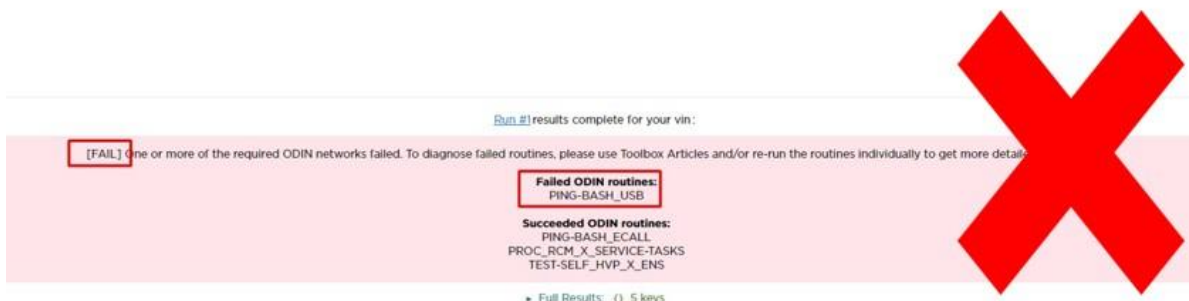
Figure 4

- If the result shows [FAIL] (Figure 4), go to the next step.

5. Create a toolbox session, using Toolbox article [6001900, ODIN M3 Retrofit RCM Service fails](#) as a starting point. Diagnose the problem. If you require additional support, escalate the session.
6. Disconnect the laptop from the vehicle.
