TN-21-16-001 December 15, 2021

Tesla, Inc. Technical Note
Model:	Vehicle System:	Region:
Model S Palladium Model X Palladium	16 - Battery System	All

Inspect the Model S Palladium and Model X Palladium HV Battery for Underside Damage

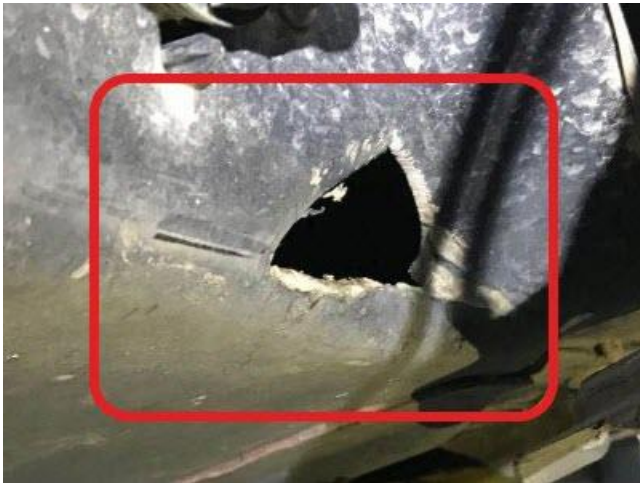
⚠ WARNING: If the HV battery is compromised with a **visible open hole, crack, or tear** (Figures 1 and 2), the Service Center should not perform any additional inspections, and recommend the customer replace the HV battery. No further diagnosis is needed as Tesla recommends an HV battery replacement for any visible open hole, crack, or tear to meet Tesla's standards of quality and safety.

Figure 1 – Visible open hole

☰ NOTE: If at any point during the inspection the damage requires a HV battery, advise the customer that the HV battery requires replacement to meet Tesla's standards of quality and safety. Tesla does not recommend driving the vehicle until the HV battery is replaced. Since the new HV battery replacement is not covered under the vehicle warranty, the Service Center should recommend that the customer replace the HV battery and provide the customer a price quote for the HV battery replacement. The warranty does not cover the HV battery damage because it was caused by an external impact.

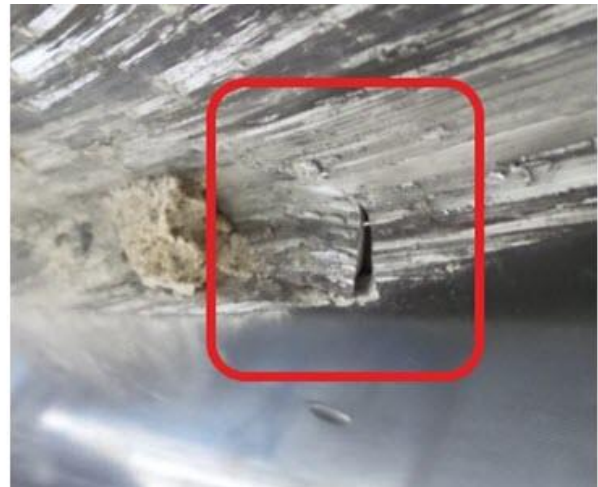
Figure 2 – Visible open crack

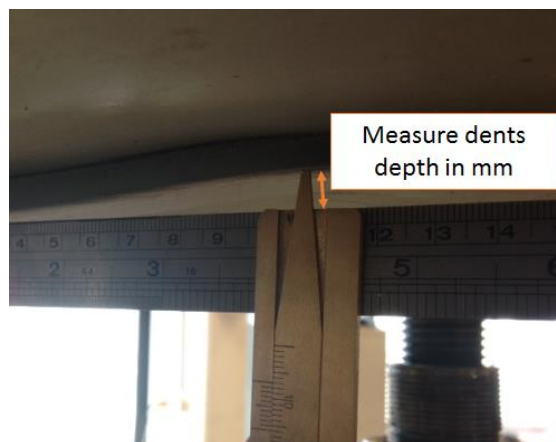
Figure 7 – Measuring the depth of enclosure damage

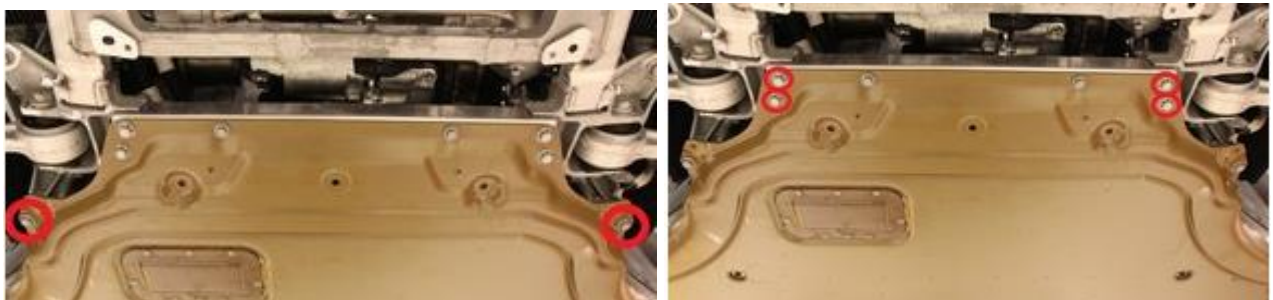
Figure 10 – Front Skidplate Fasteners

1. Visually inspect the skidplate for tears, dents, or breaches (Figure 10).
2. Remove the front skidplate (refer to Service Manual procedure 30011002; [Model S](#), [Model X](#)).

- Deburr the area with a hand deburring tool to remove the sharp edges if sharp edges are found.
- Recommend the replacement of the front skidplate if the frontskid plate, or part of the skidplate, is detached.
- Recommend the replacement of the HV cables if the HV cables are damaged above the front skidplate.
- Recommend the replacement of the passthrough if a passthrough is damaged above the front skidplate.
- Recommend the replacement of the fastener if a fastener attaching the front skidplate to the vehicle is damaged or stripped.
- Re-tap the fastener hole if a fastener hole is damaged and the fastener cannot withstand full torque.
- Recommend HV battery replacement if:
 - The HV battery enclosure fails the leak test due to impact.
 - The HV battery enclosure has low isolation due to impact.

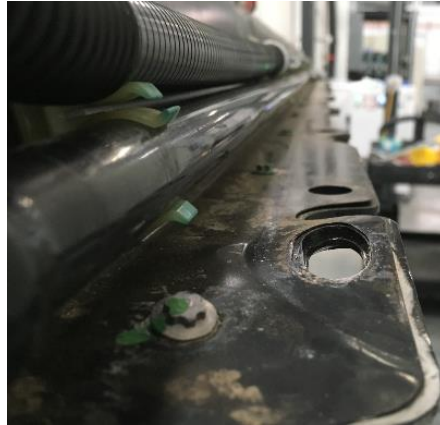
Figure 12 – Deburr the area to remove sharp edges

- Recommend HV battery replacement if:
 - The side ski, or part of the ski, is detached from the HV battery.
 - The HV battery enclosure fails the leak test due to impact.
 - The HV battery enclosure has low isolation due to impact.
- Recommend the replacement of the jack pad if a jack pad has extensive damage where it cannot be used to safely lift the vehicle.
- Re-tap fastener hole if a fastener hole is damaged and the fastener cannot withstand full torque.
- Deburr the area with a hand deburring tool to remove the sharp edges if sharp edges are found (Figure 12).

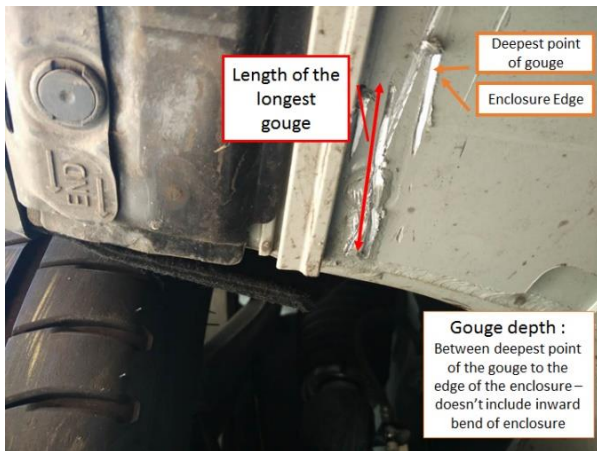
Figure 14 – Debur area to remove sharp edges

- Deburr the area with a hand deburring tool to remove the sharp edges if sharp edges are found (Figure 14).
- Recommend HV battery replacement if:
 - A dent is **7 mm** or more in depth (Figure 15).
 - The HV battery enclosure fails the leak test due to impact.
 - The HV battery enclosure has low isolation due to impact.

- Deburr the area with a hand deburring tool to remove the sharp edges if sharp edges are found (Figure 14).
- Recommend HV battery replacement if:
 - A dent is **3 mm** or more in depth (Figure 15).
 - The HV battery enclosure fails the leak test due to impact.
 - The HV battery enclosure has low isolation due to impact.

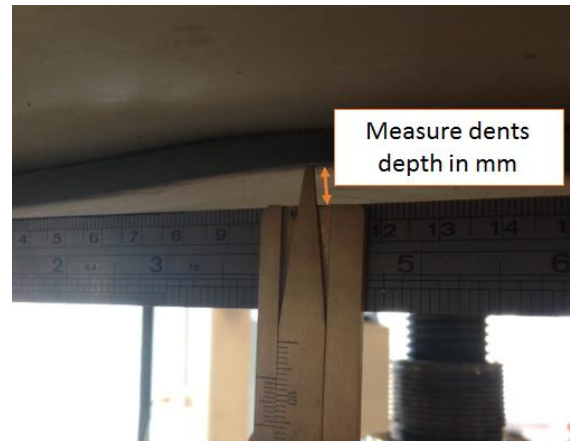
Figure 15 – Dents in the Baseplate
