This Service Document supersedes SB-20-10-003, dated 9-Jul-20. Each content change is marked by a vertical line in the left margin. Discard the previous version and replace it with this one.

On some Model Y vehicles, front fascias with an injection date in a certain date range might have potential delamination/peeling issues.

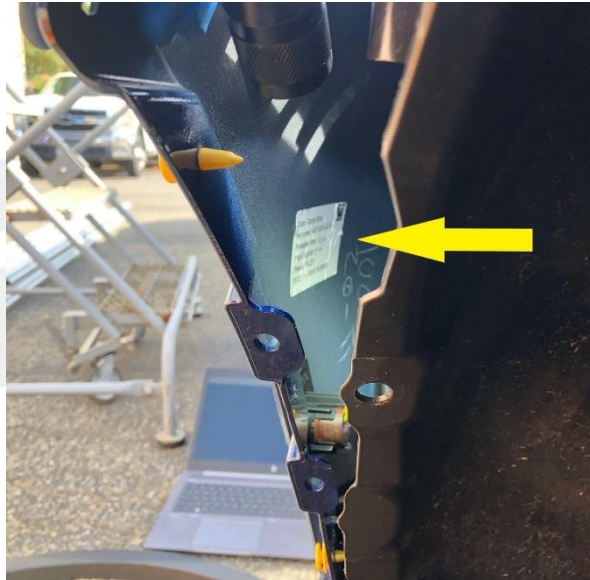
- If the “Date & Time” printed on the label is 22/02/2020 through 03/03/2020, replace the front fascia (refer to Service Manual procedure [10011002](#)).
- If the “Date & Time” printed on the label is before 22/02/2020 or after 03/03/2020, no repairs are needed. Install all parts that were removed for access, and then discontinue this procedure.
