Panoramic Roof Creaking

Classification	Repair Bulletin	Section/Group	24 - Roof	Country/Region	All
Year	2012-2013	Model	Model S	Version	All

This Service Bulletin supersedes SB-13-24-004 R3, dated 03-Jan-14. Each content change is marked by a vertical line in the left margin. Discard the previous version and replace it with this one.

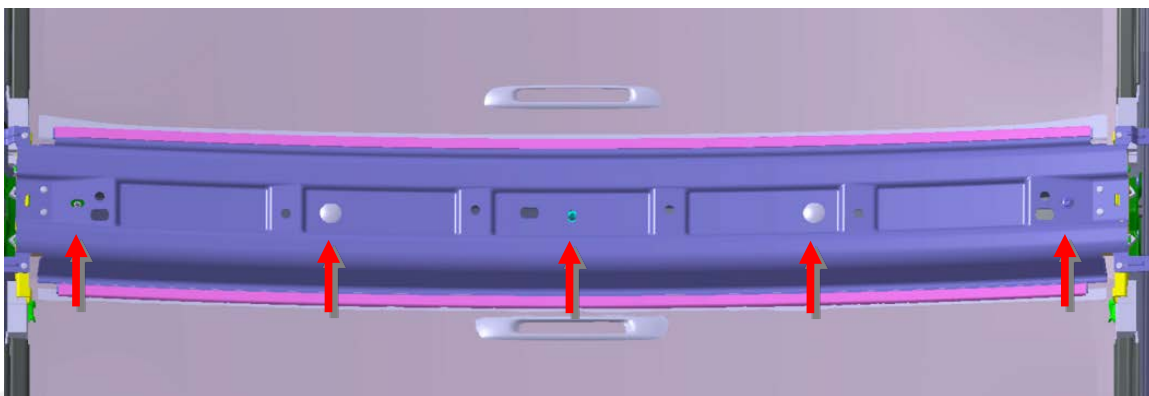
Figure 1

3. If equipped, remove the 3 screws and 2 trim buttons from the bottom side of the sunshade carrier (Figure 1). If the vehicle does not have a sunshade carrier, skip to step 5.

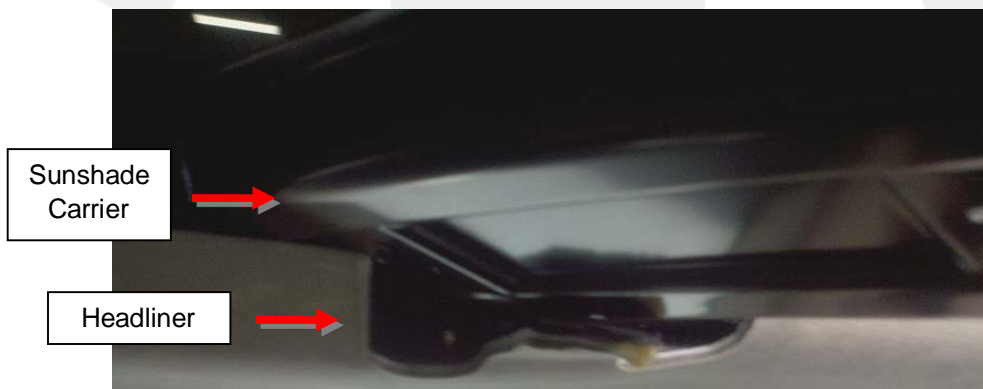
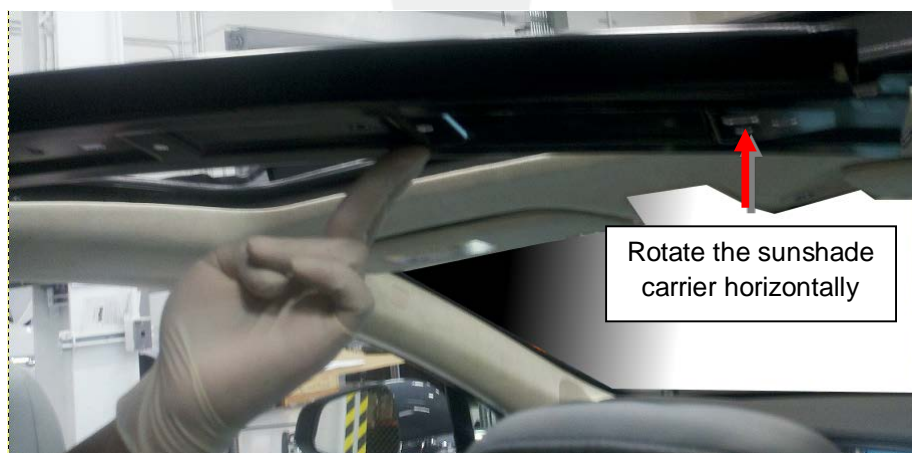
Figure 2

4. If equipped, lift both sides of the sunshade carrier (Figure 2). Remove the sunshade carrier by rotating one side towards the front of the car and the other side towards the rear of the car (Figure 3).

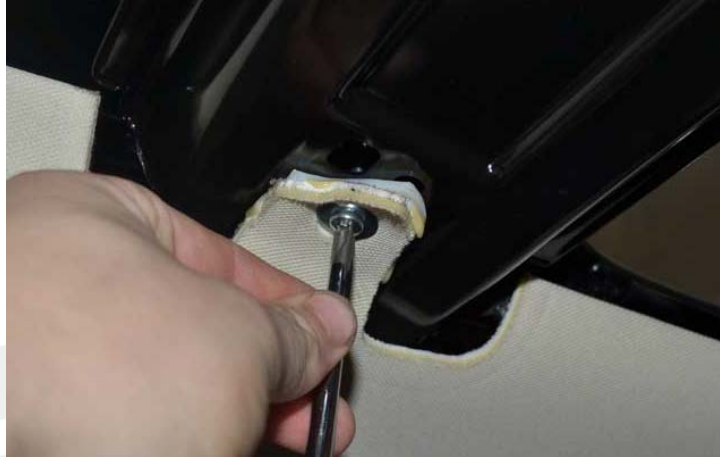
Figure 4 (LH side shown)

5. If the vehicle has a bolt that secures each side of the headliner to the B-Pillar crossmember, remove the 2 bolts (torque 3 Nm) (Figure 4)

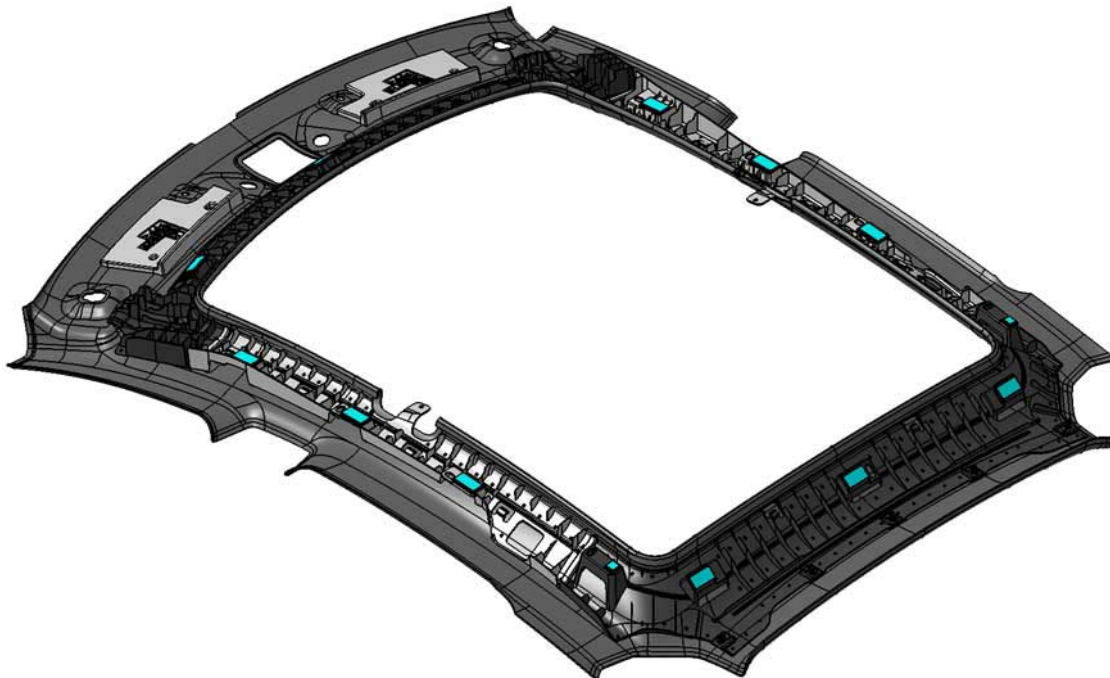
Figure 5 (Dual Lock shown in blue)

6. Lower the headliner enough to expose the B-Pillar brackets. On most vehicles, the headliner is secured with Dual Lock (Figure 5).

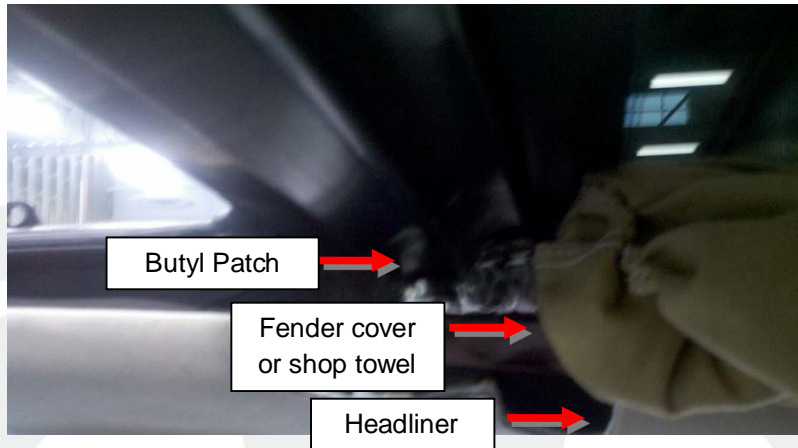
Figure 6

NOTE: If the vehicle has butyl patches covering the B-Pillar brackets, remove the butyl patches. Use fender covers or shop towels to create more clearance and protect the headliner from staining (Figure 6). Thoroughly clean all residual adhesive.

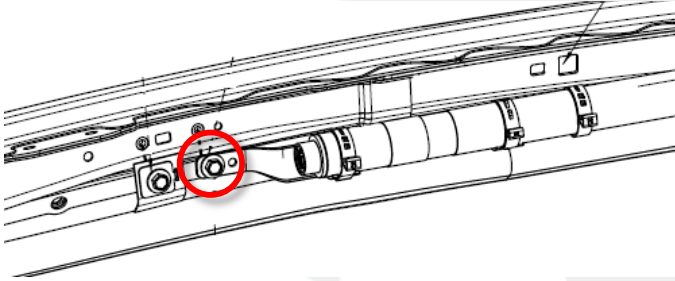
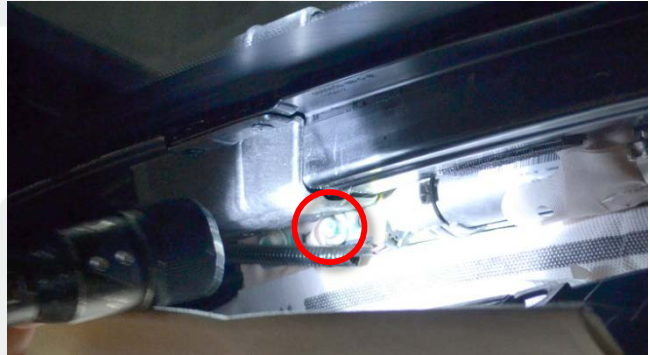
Figure 7

2. Loosen the forward bolt that secures the curtain airbag bracket to the body (torque 10 Nm), but do not fully remove it (Figures 7 and 8).

6. Tighten the forward bolt that secures the curtain airbag bracket to the body (torque 10 Nm) (Figures 7 and 8).

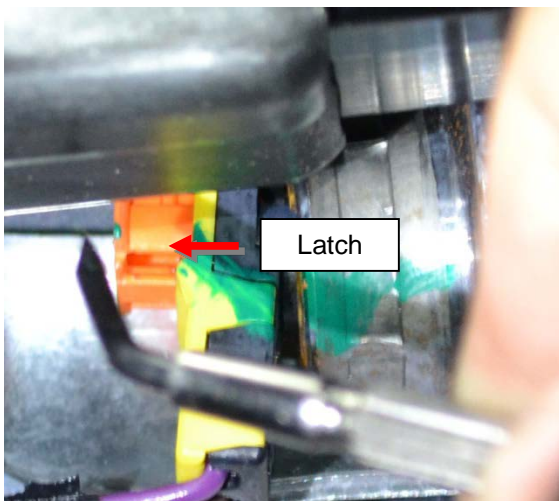
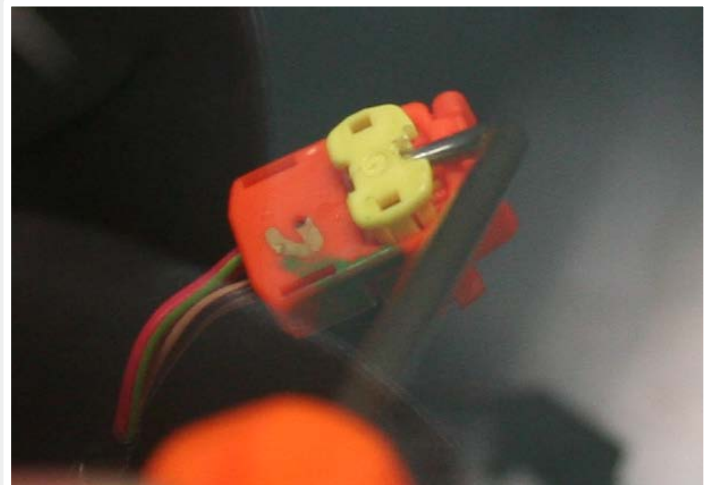
Figure 9

3. Use a pick or similar tool to pull out the latch on the curtain airbag harness connector (Figures 9 and 10). Disconnect the harness.

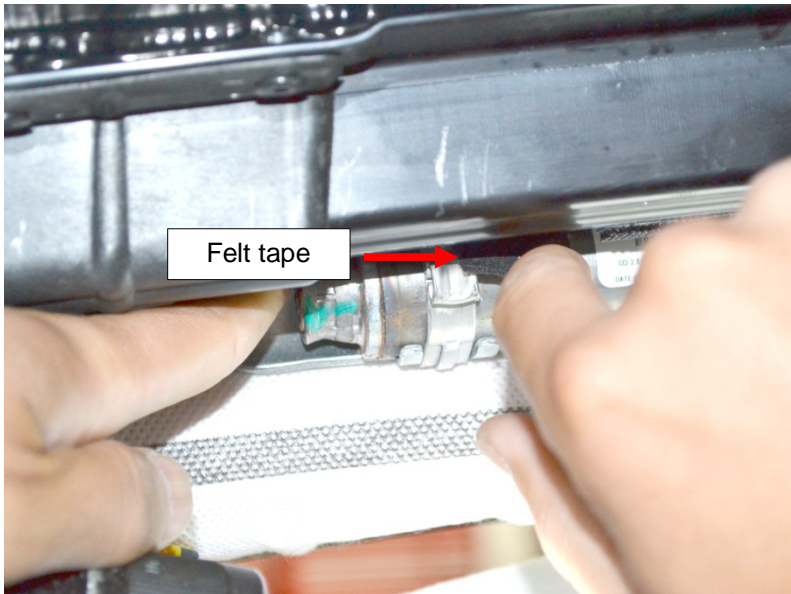
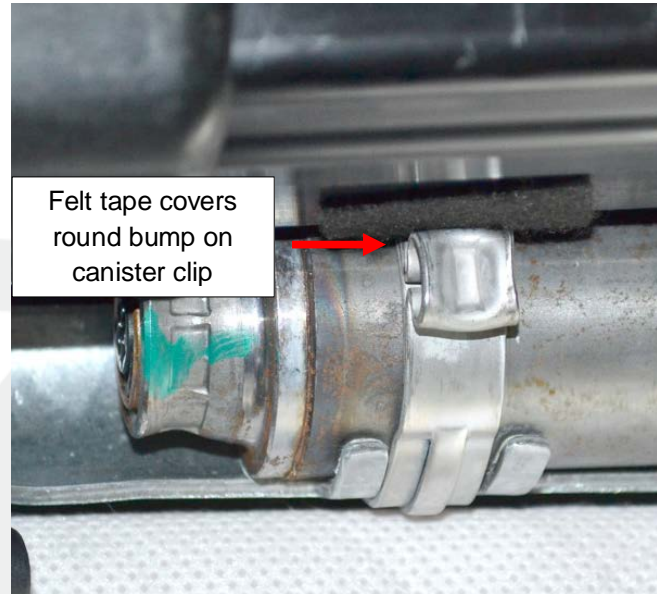
Figure 11

4. Pull down very gently on the curtain airbag canister. Insert a piece of felt tape between the clip on the canister and the panoramic roof track (Figure 11). Ensure that the tape protrudes far enough to cover the round protrusion on the clip (Figure 12).

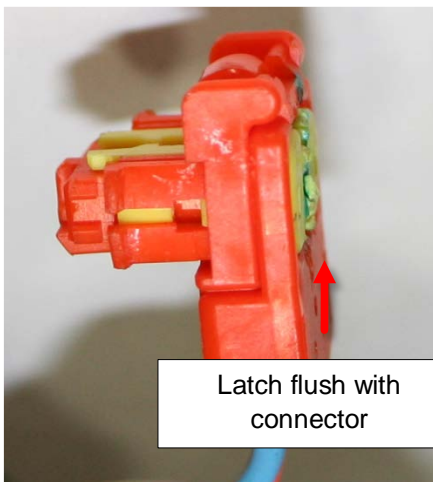
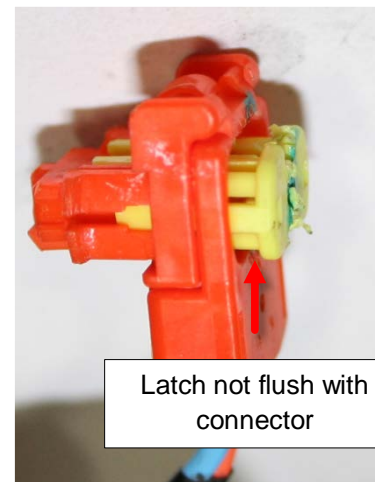
5. Reconnect the curtain airbag harness. After reconnecting the harness, press in on the latch so that it is flush with the face of the connector (Figures 13 and 14). Gently try to pull the connector out again without releasing the latch to ensure that the connection is tight.

✓ Correct
Figure 13

✗ Incorrect
Figure 14

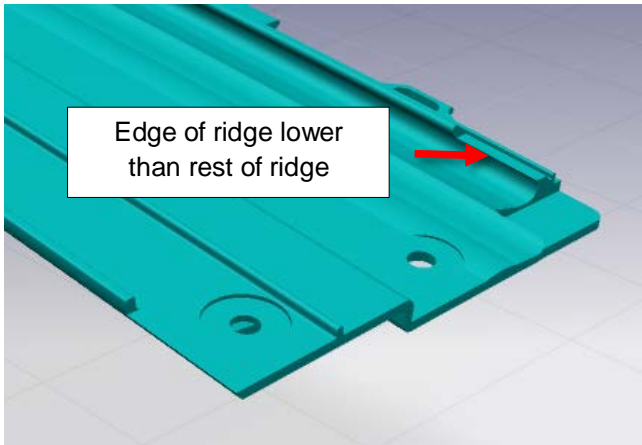
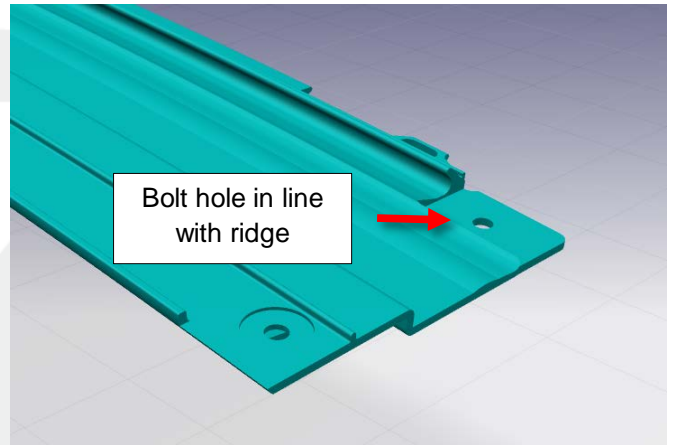
Figure 15 (RH side shown)

NOTE: Before performing the procedure in this section, inspect the outboard edges on the front ridge of the B-Pillar crossmember. Do not perform this procedure if:

- The edges of the ridge appear to have been ground down or are noticeably lower than the rest of the ridge (Figure 15).
- There are bolt holes in line with the ridge (Figure 16).

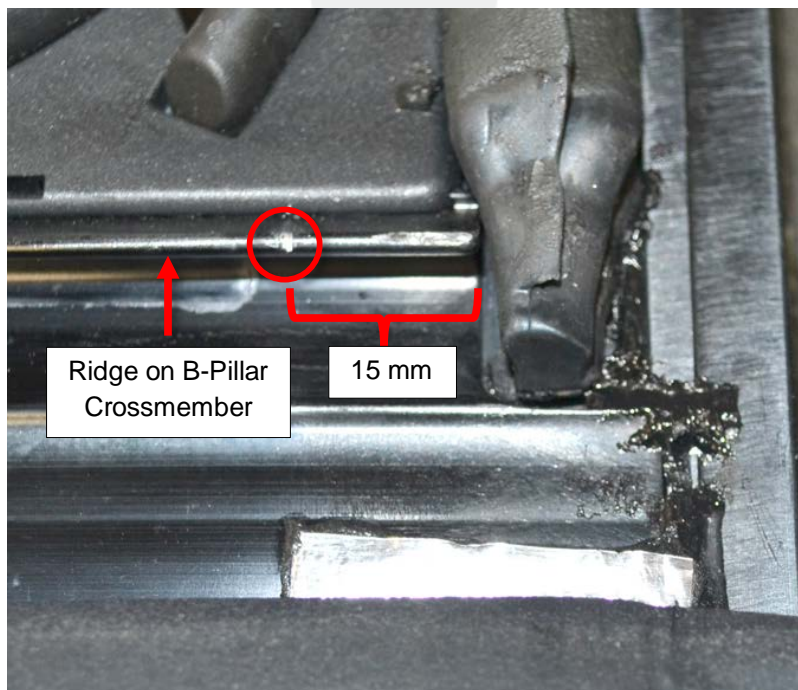
Figure 17

1. On the ridge at the front of the B-Pillar crossmember, draw a mark 15 mm inward from the edge (Figure 17).

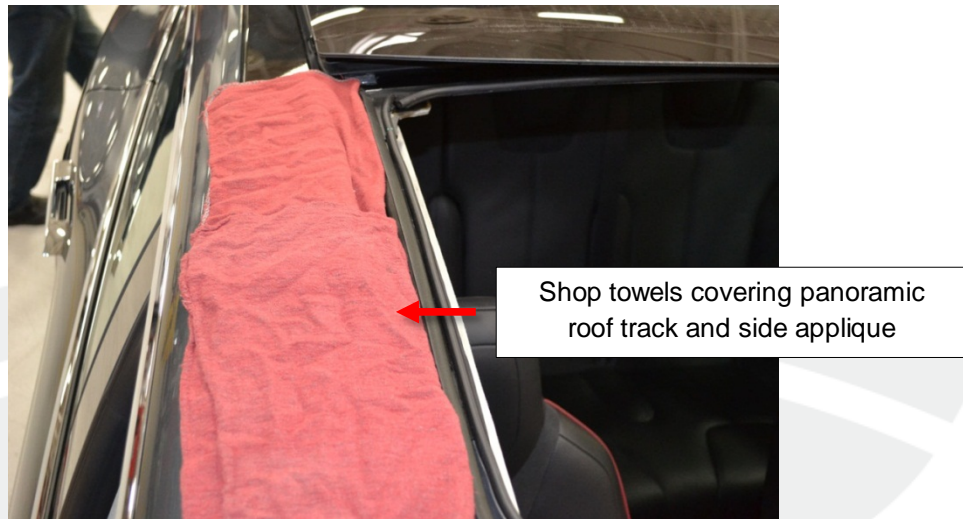
Figure 18

2. Cover the panoramic roof track and side applique with shop towels (Figure 18). This prevents debris from entering the panoramic roof track or scratching the body when using the rotary multi-tool in a later step.

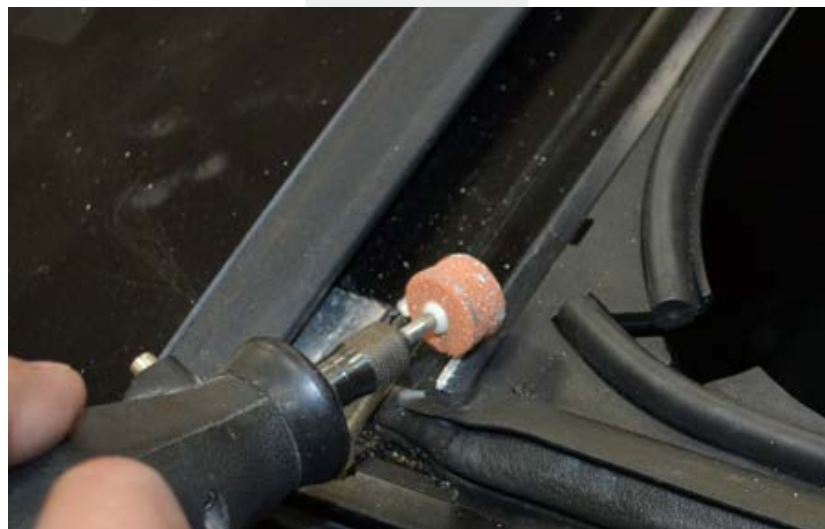
Figure 19

3. Use a rotary multi-tool (for example, Dremel tool) with a deburring or grinding bit to grind down 2 mm of the 15 mm section on the ridge of the B-Pillar crossmember that was marked in step 1 (Figure 19).

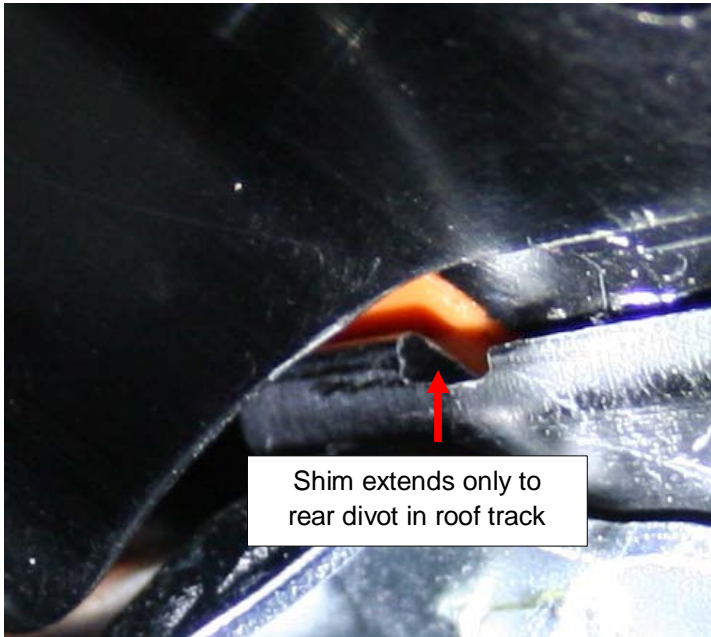
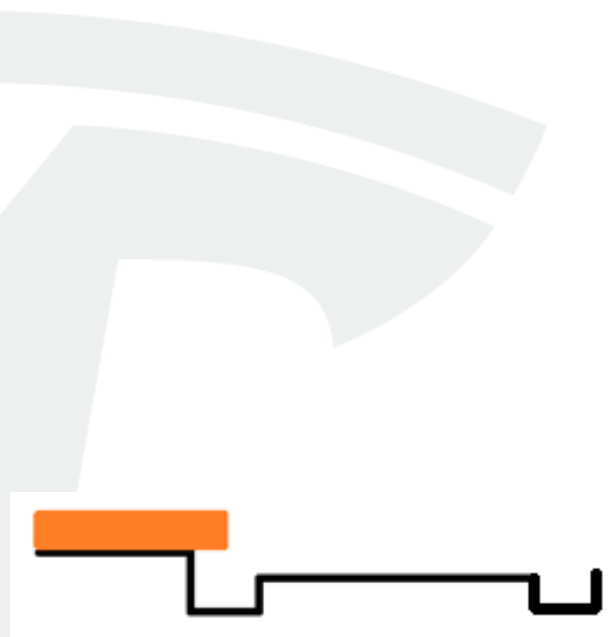
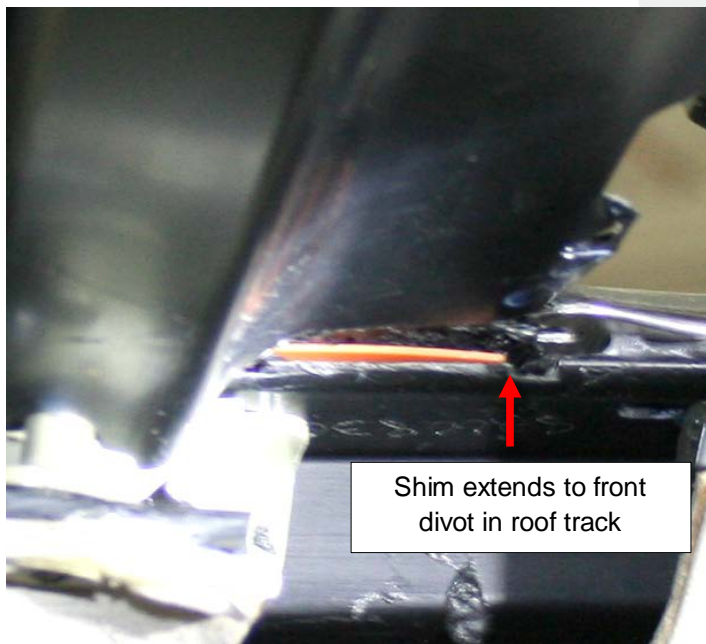
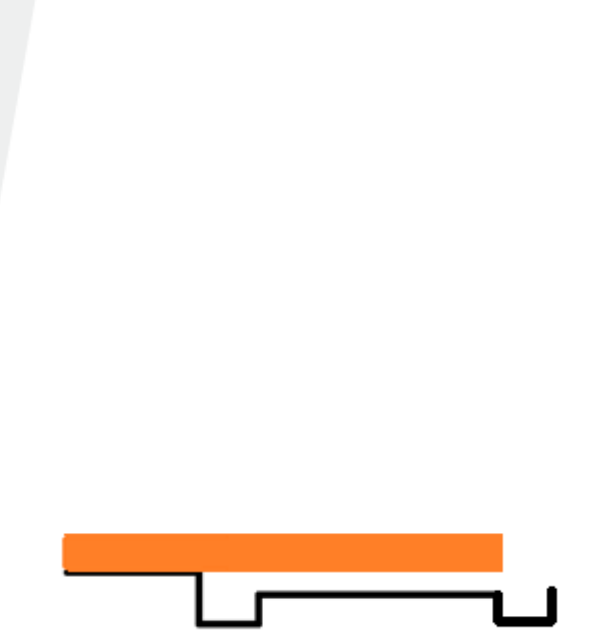
NOTE: Only perform the procedure in this section on founders' series vehicles, North American signature series vehicles, release candidate (RC) vehicles, and production VINs prior to P09800. Before beginning this section, check the area around the forward screw that secures the B-pillar crossmember and panoramic roof tracks. If no orange shim stock is present, perform this section. If shim stock is present but only covers the rear divot in the roof track (Figures 20 and 21), remove the shim stock and perform steps 4-12 of this section. If the shim extends to the forward divot in the roof track (Figures 22 and 23), do not perform this section.

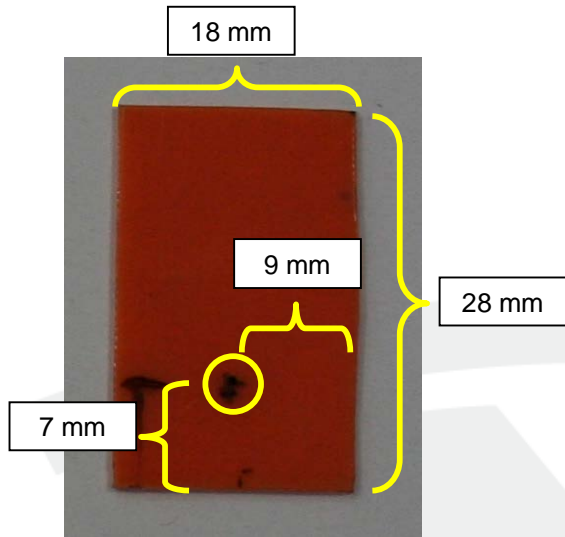
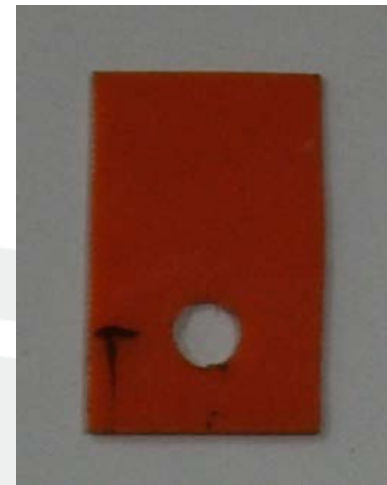
Figure 24

1. Cut 2 pieces of shim stock 28 mm x 18 mm. Place a drill mark 7 mm from one of the short edges and centered 9 mm from each long edge on each shim (Figure 24). Drill the marked area with a 13/64 in bit on each shim (Figure 25).

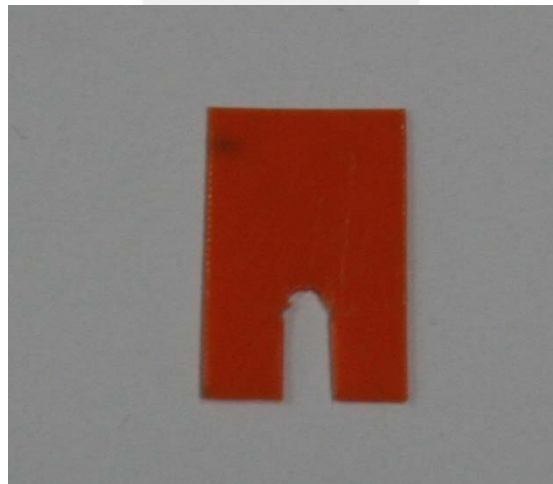
Figure 26

2. Extend the hole on both shims to the closest short (18 mm) edge (Figure 26).

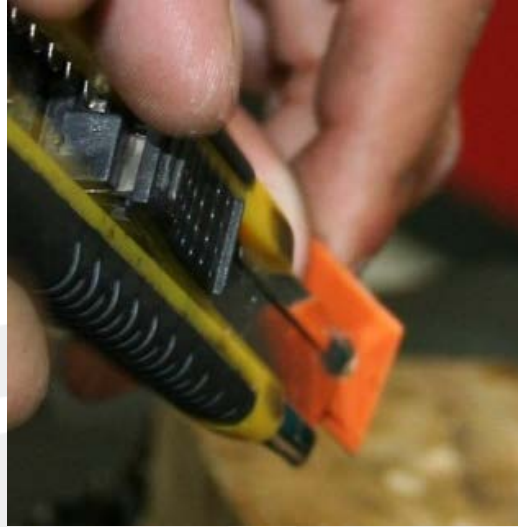
Figure 27

3. Remove any leftover material from the holes in the shims (Figure 27).

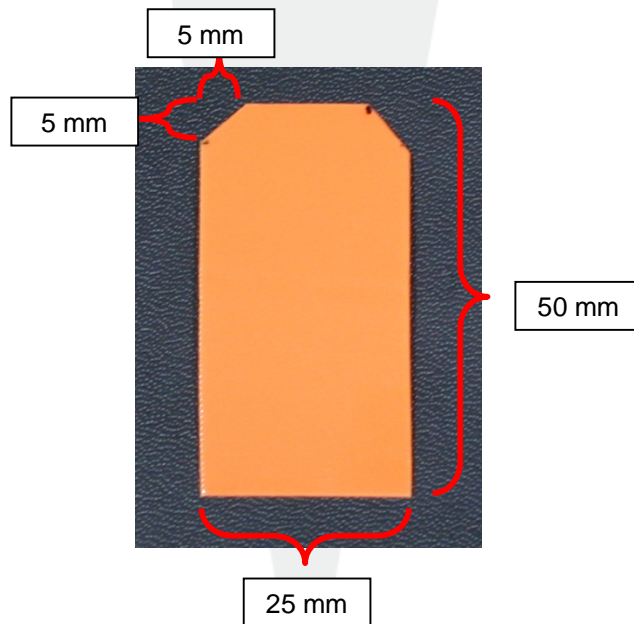
Figure 28

4. Cut 2 pieces of shim stock 50 mm x 25 mm. On one of the short (25 mm) edges, cut off the corners 5 mm inward from each side (Figure 28).

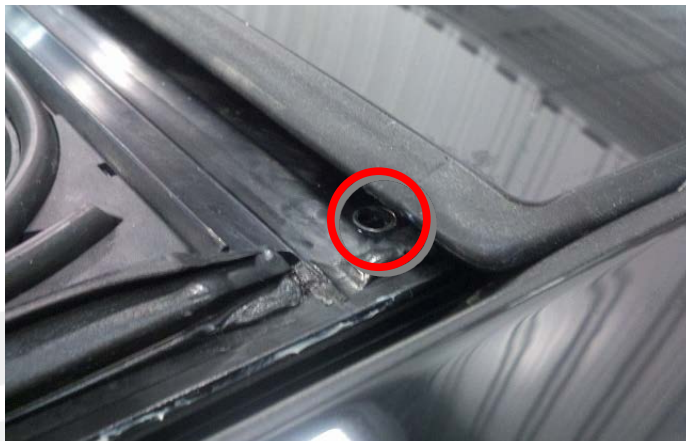
Figure 29 (LH side shown)

5. From the top of both sides of the vehicle, remove the front screw (torque 3 Nm) that secures the B-Pillar bracket, panoramic roof track, and B-Pillar crossmember (Figure 29).

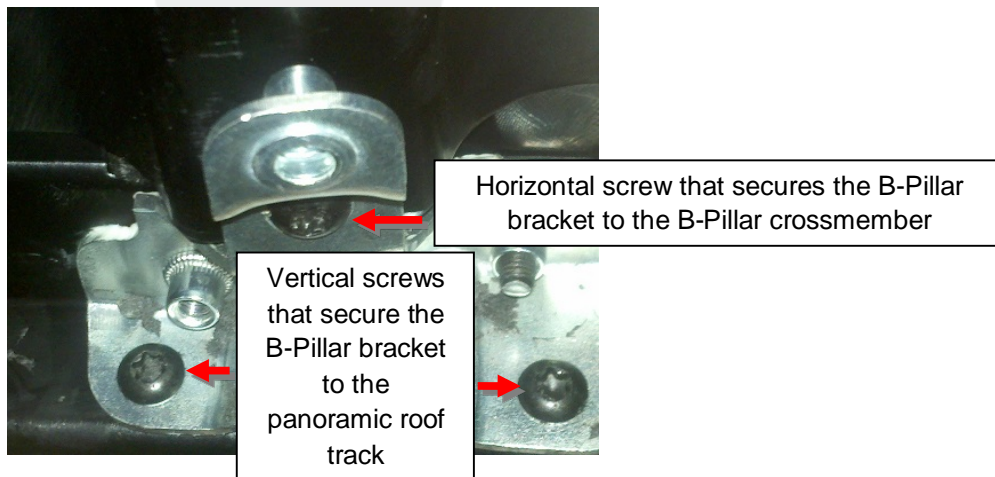
Figure 30

6. Remove the 3 screws (torque 5 Nm) from each B-Pillar bracket (Figure 30).

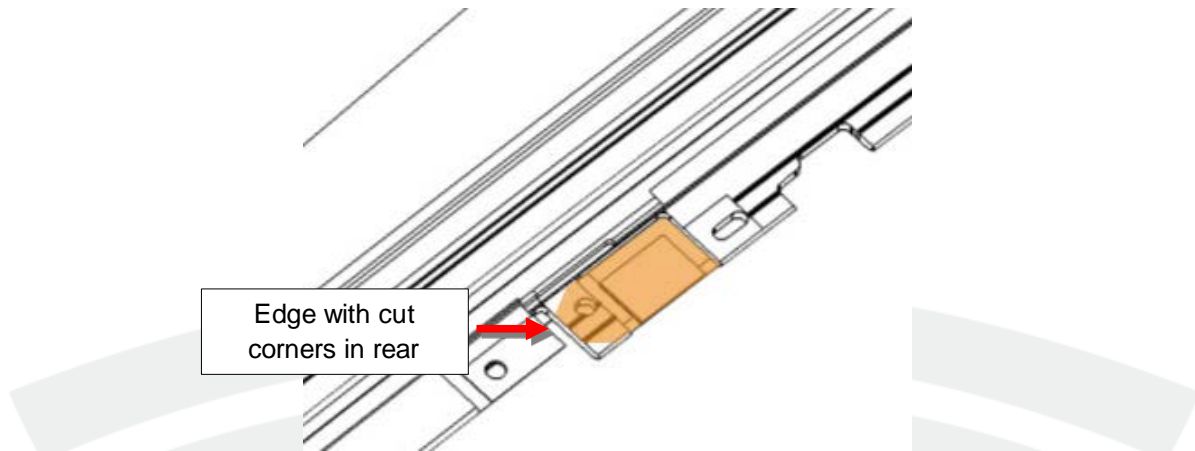
Figure 31 (LH side shown)

NOTE: The goal of steps 7-14 is to position the 50 mm x 25 mm shims between the B-pillar crossmember and the panoramic roof tracks (Figure 31).

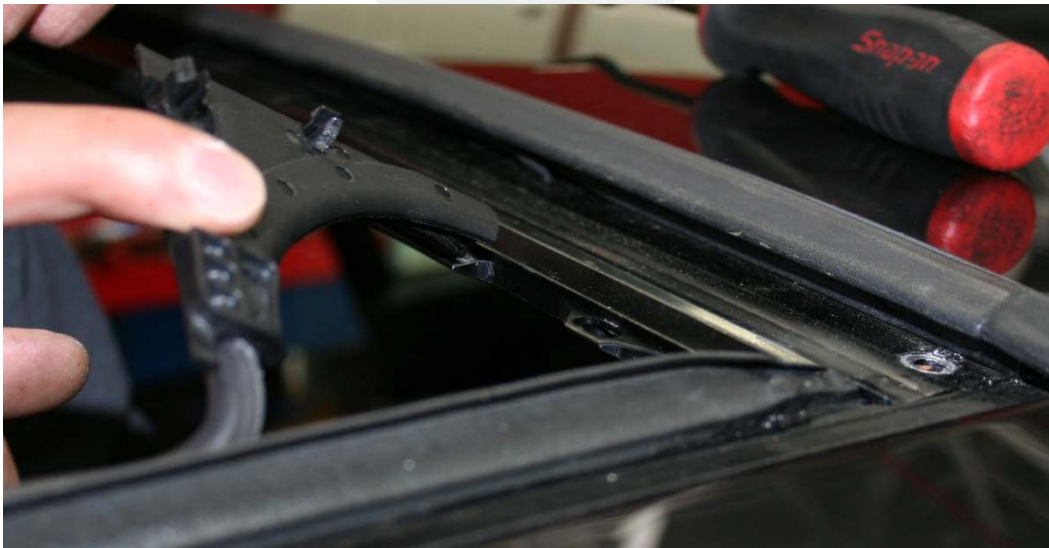
Figure 32 (LH side shown)

7. Peel back the track seal on each side of the vehicle (Figure 32).

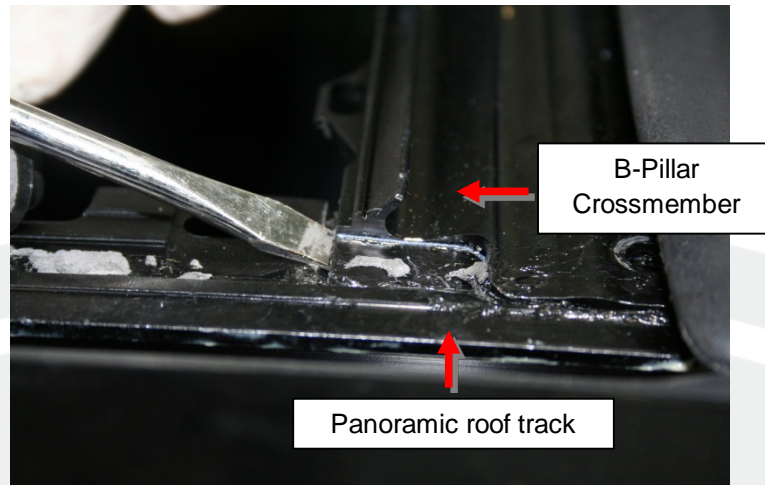
Figure 33 (LH side shown)

8. Use a screwdriver to gently pry apart the B-Pillar crossmember from the panoramic roof track (Figure 33).

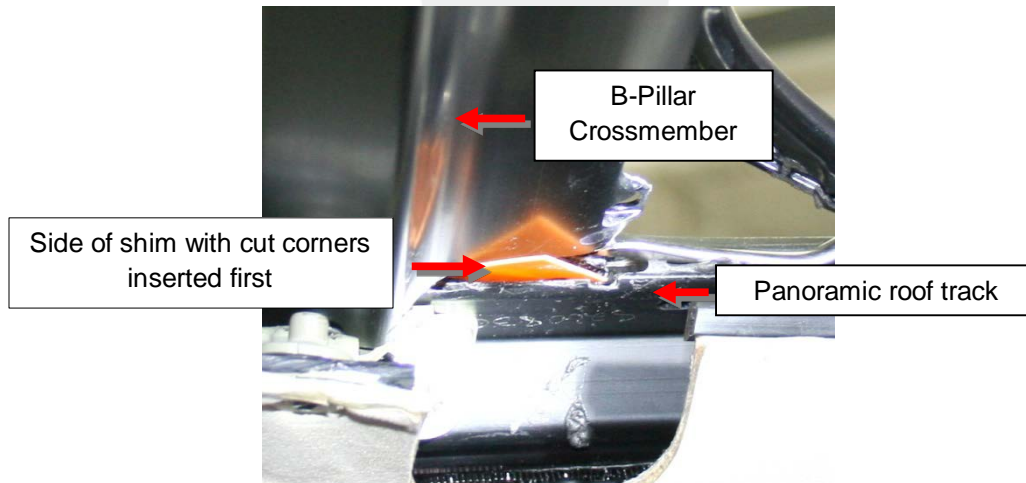
Figure 34 (LH side shown)

9. Insert the edge of the shim that has the cut corners between the B-Pillar crossmember and the panoramic roof track (Figure 34).

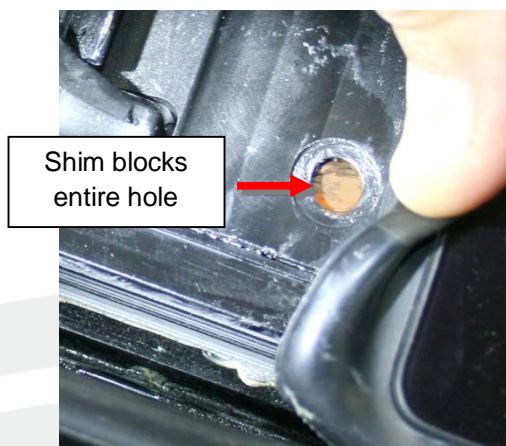
Figure 35 (View of left front hole from above)

10. Push the shim outboard and rearward until it entirely blocks the hole for the front screw that secures the B-Pillar bracket, panoramic roof track, and B-Pillar crossmember (Figure 35).

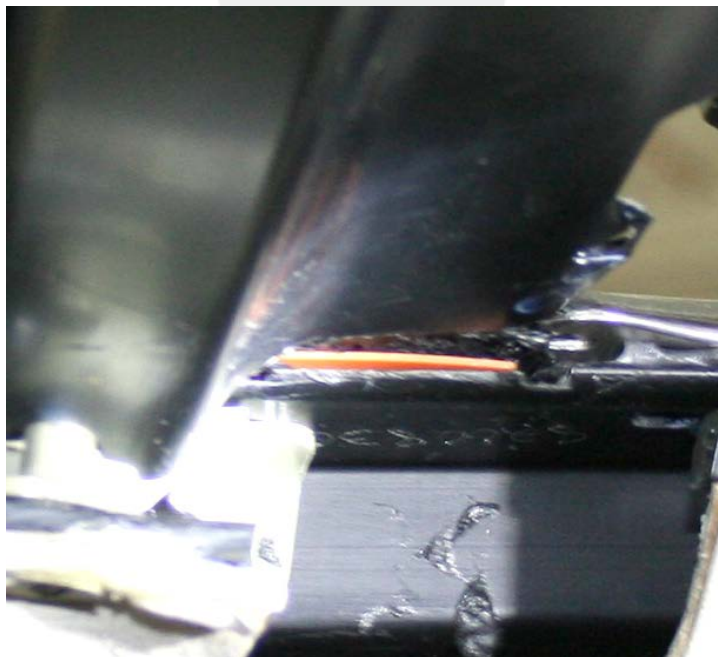
Figure 36 (LH side shown)

11. Rotate the shim into position lengthwise along the panoramic roof track (Figure 36). Use a pick to push it as far outboard as possible.

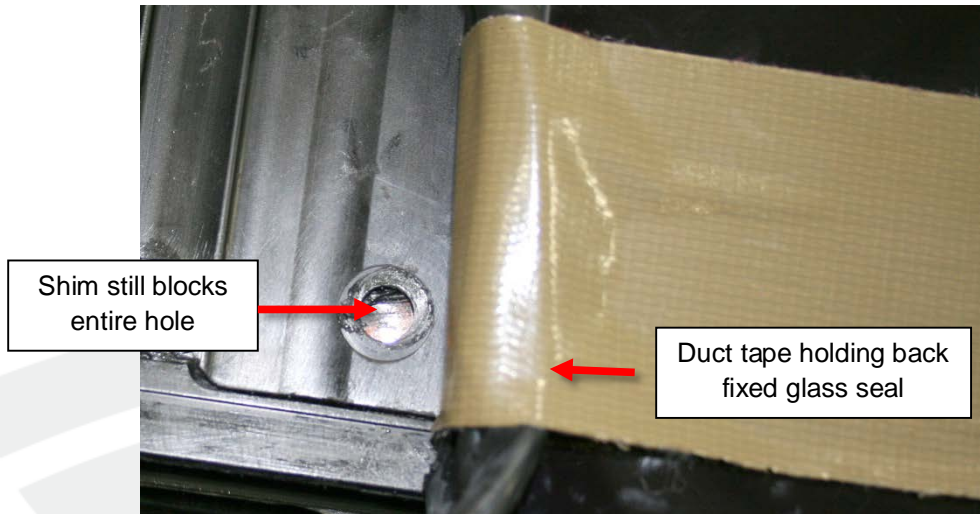
Figure 37

12. Peel back the fixed glass seal and secure it in place with duct tape. Ensure that the shim still blocks the entire hole for the front screw that secures the B-Pillar bracket, panoramic roof track, and B-Pillar crossmember (Figure 37).

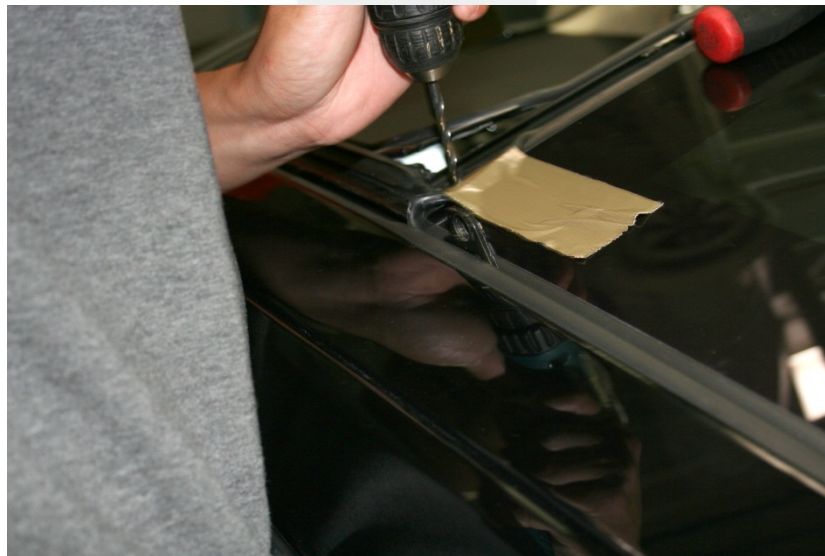
Figure 38

13. Using a 7/32 in (5.6 mm) drill bit, drill a hole in the shim stock (Figure 38).

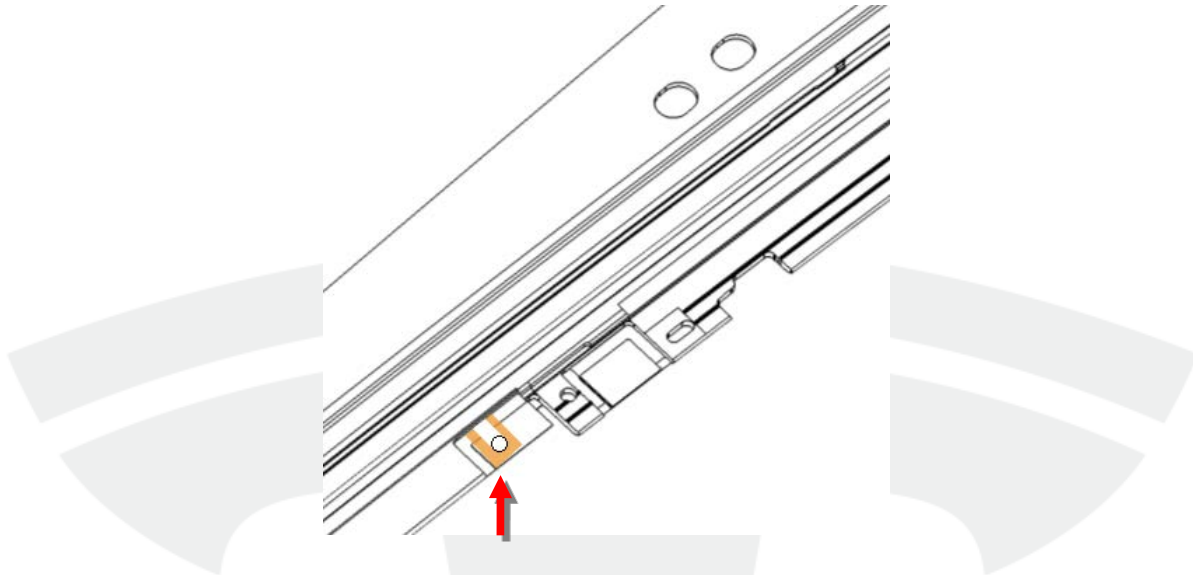
Figure 39 (LH side shown)

NOTE: The goal of steps 15-16 is to position the 28 mm x 18 mm shims between the B-pillar crossmember and the panoramic roof. The notch in each shim surrounds the rear hole for the bolt that secures the B-Pillar bracket, panoramic roof track, and B-Pillar crossmember (Figure 39).

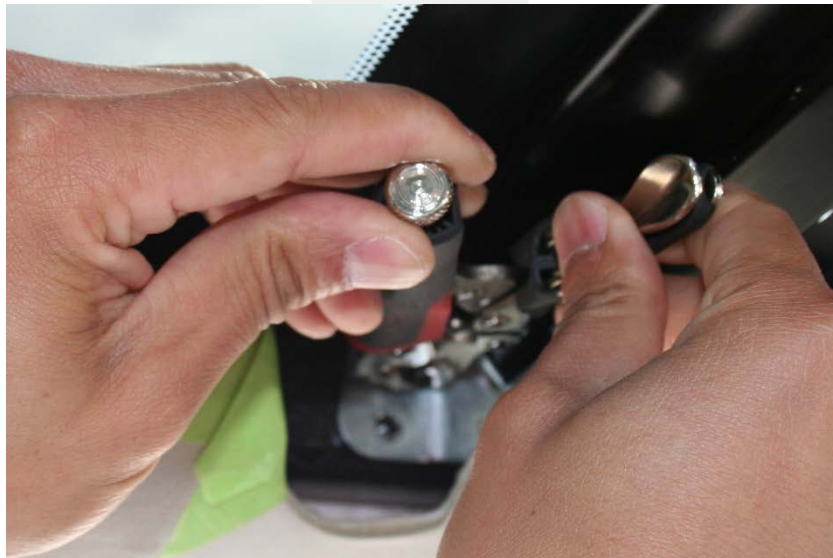
Figure 40 (LH side shown)

15. In order to provide a small amount of clearance between the B-Pillar crossmember and the panoramic roof track, use vise grips from inside the vehicle to loosen the rear screw by 2 threads (Figure 40).

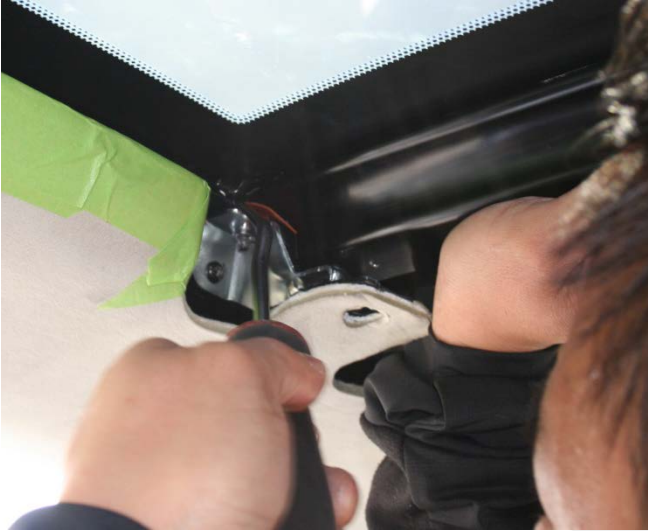
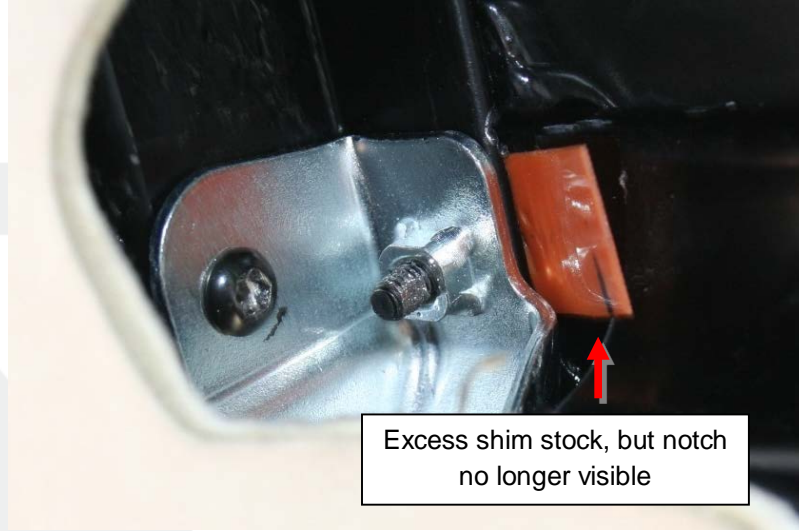
Figure 41 (LH side shown)

16. While pushing up on the B-Pillar crossmember with one hand, wedge the shim around the rear screw. Use a pick or similar tool to push the shim towards the outside of the vehicle until the notch is no longer visible (Figure 41).

NOTE: The rear shims cannot be inserted as far outboard as the forward shims; approximately 14 mm of shim remains exposed (Figure 42).

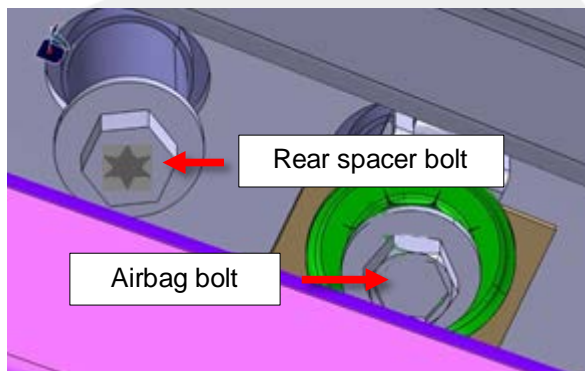
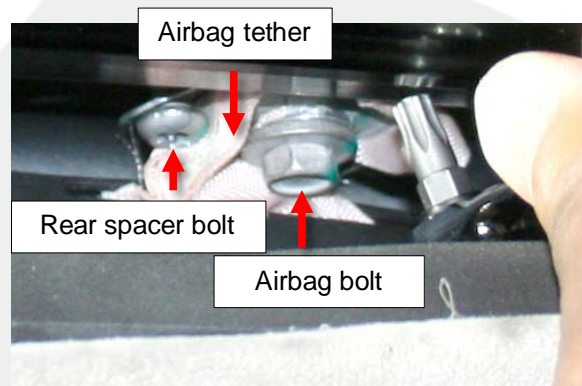
Figure 43 (LH side shown)

1. Unscrew the spacer bolt that is behind the side curtain airbag bolt as much as possible without completely removing it (Figures 43 and 44). The screw can back out approximately 12 mm and remain threaded in place.

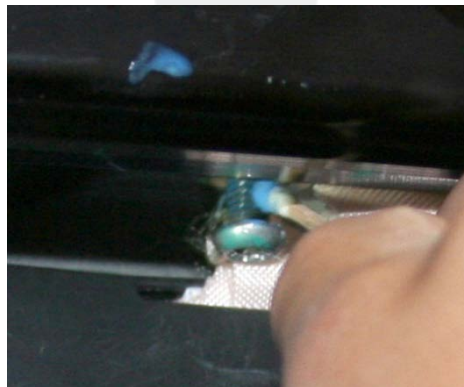
Figure 45 (LH side shown)

2. Use a cotton swab or similar item to apply Loctite 242 Threadlock to all exposed spacer bolt threads (Figure 45).

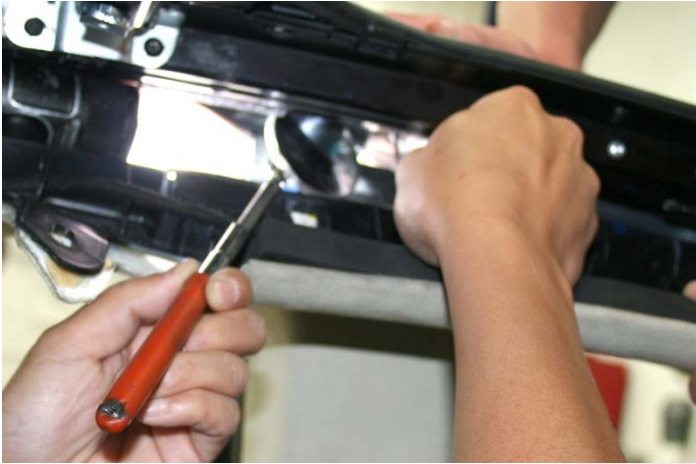
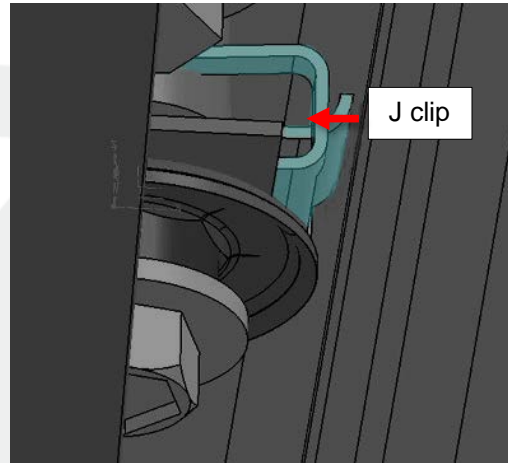
Figure 46 (LH side shown)

1. Use a mirror to locate the J clip on the airbag bolt above the body (Figures 46 and 47).

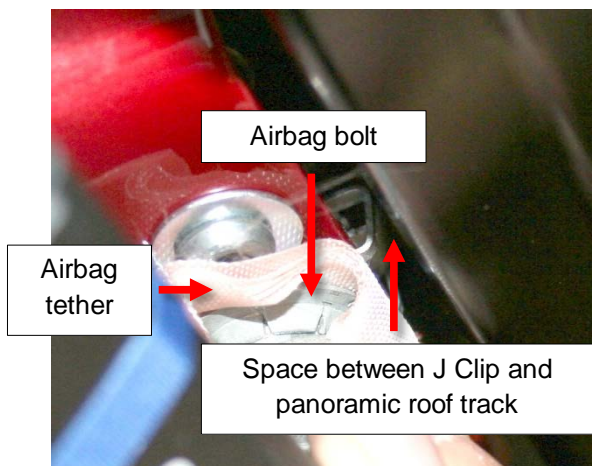
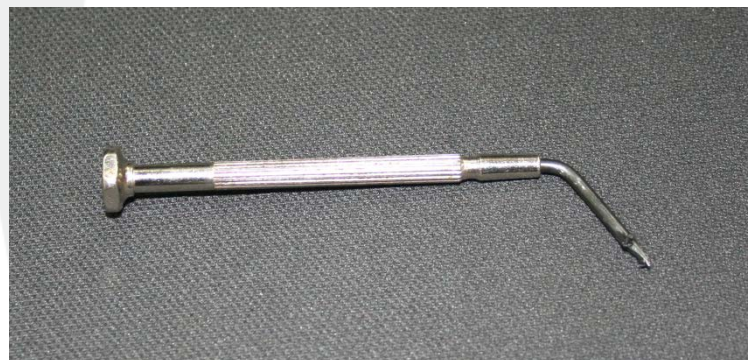
Figure 48 (LH side shown)

2. Ensure that the J clip does not touch the panoramic roof track (Figure 48). If it does, slightly loosen the airbag bolt (torque 10 Nm) and use a suitable tool, such as an elongated pick (Figure 49), to push the J clip outboard. Hold the J clip in place while retightening the airbag bolt.
