Rear Fascia with 4 Park Assist Sensors Retrofit

Classification	Repair Bulletin	Section/Group	10 - Body	Country/Region	All
Year	2012-2014	Model	Model S	Version	All

The Model S rear fascia design has been updated. The locations of the holes for the park assist sensors have changed.

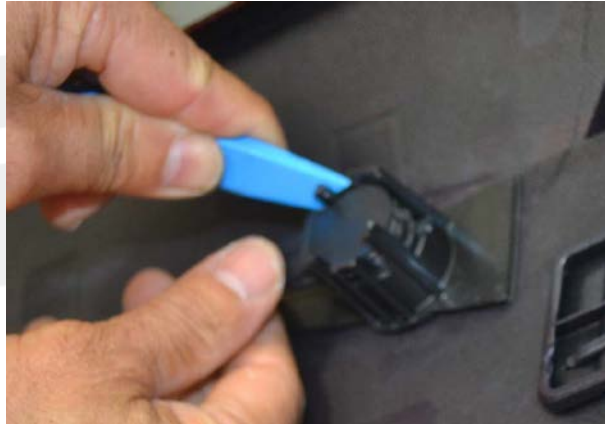
Figure 3

NOTE: It might be helpful to use the handle of a screwdriver to evenly apply force to the sensors. Ensure that the retainer rings remain smooth and do not get pinched. If necessary, use a trim stick to smooth out the retainer rings (Figure 3).

⚠ CAUTION: If any of the retainer rings are not smooth, the system produces a fault.

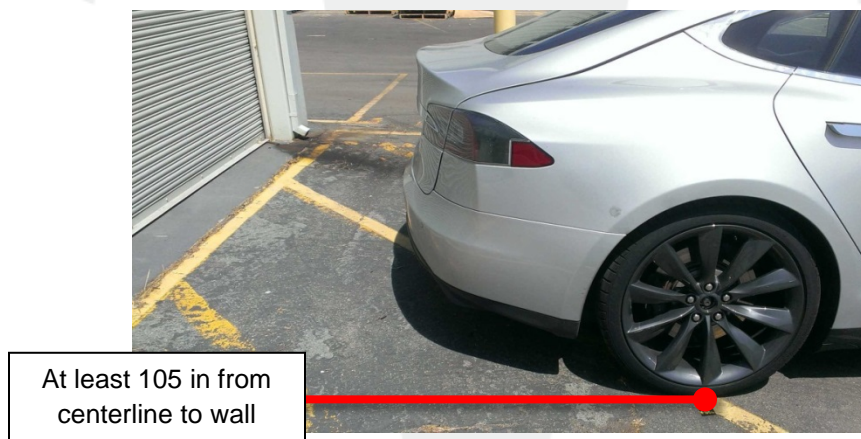
Figure 3

- d. Exit the vehicle and verify that the distance between the wall and the centerline of the rear wheels is at least 105 in (267 cm) (Figure 3).

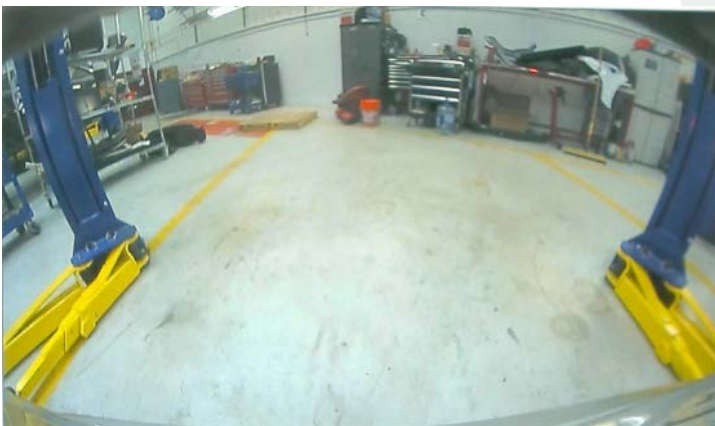
Figure 4

2. Drive the vehicle in reverse through a standard 2-post lift (Figure 4). Ensure that both the left and right park assist warnings appear on the instrument cluster (Figure 5).
