2nd Generation Premium Center Console Retrofit

Classification	Parts and Accessories Bulletin	Section/Group	15 - Interior Trim	Country/Region	All
Year	2012-2016	Model	Model S	Version	All

This Service Bulletin supersedes SB-16-15-001, dated 11-Mar-16. Each content change is marked by a vertical line in the left margin. Discard the previous version and replace it with this one

The 2nd generation premium center console is now available. This is a customer pay retrofit. Use the following job lines when creating the Repair Order:

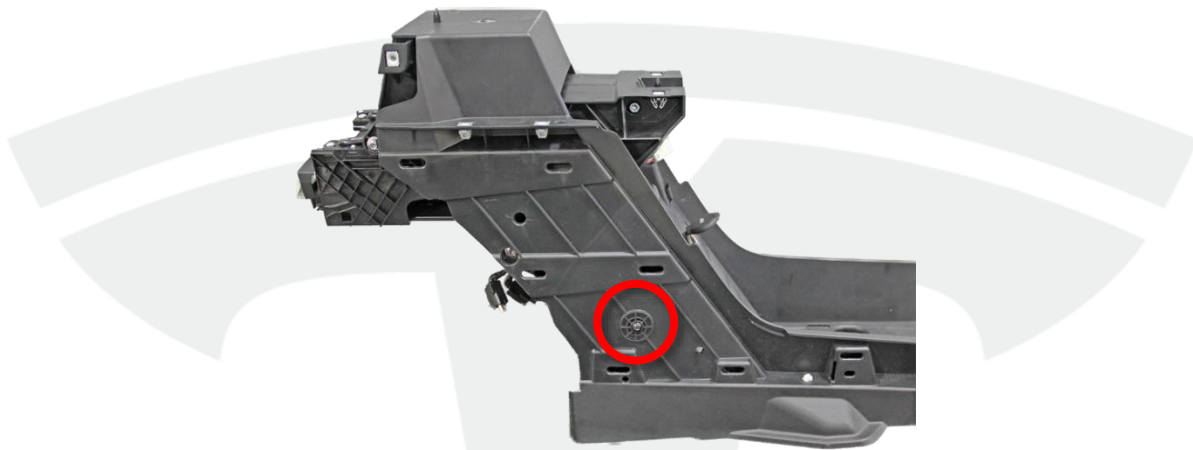
Figure 1

1. Remove the LH and RH rear wrapped center console panels (refer to Service Manual procedure 15193002).
2. Remove the center console armrest trim (refer to Service Manual procedure 15191602).
3. On both sides of the center console assembly, remove and discard the bolt that secures the rear center console bracket to the back of the center console carrier (Figure 1). Remove the rear center console bracket from the center console carrier.

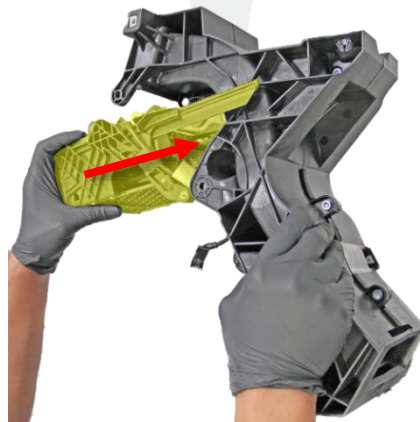
a. Push the rear cup holder towards the rear center console bracket (Figure 6) until the 4 bolt holes are aligned.

Figure 6 (Rear cup holder assembly highlighted)

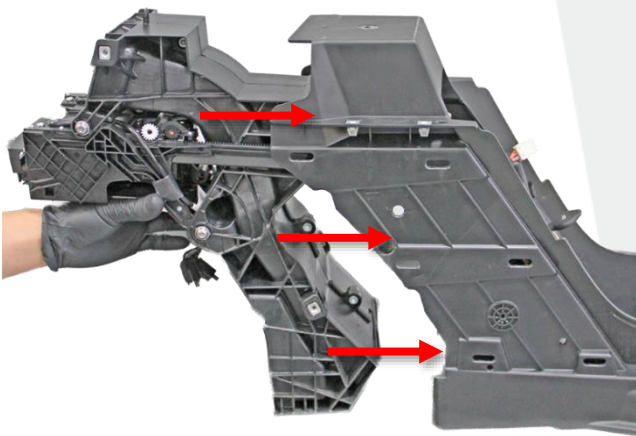
Figure 8

11. Insert the rear center console bracket assembly into the back of the center console carrier (Figure 8) and secure it with 2 new bolts (torque 2.5 Nm) (Figure 9).

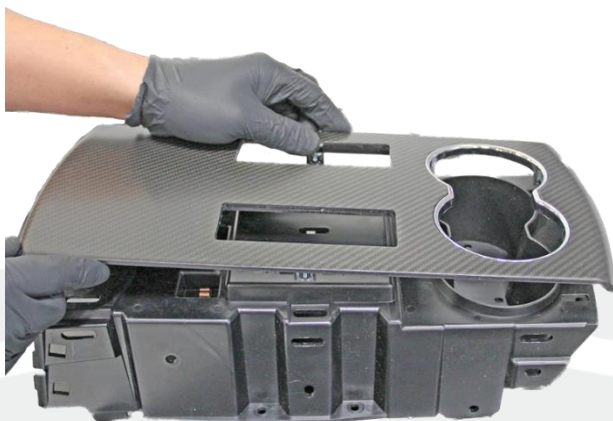
Figure 10

- a. Carefully press the armrest trim straight down until the clips are secured to the new armrest base (Figure 10).

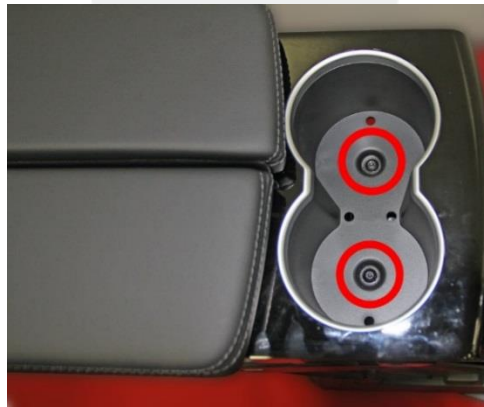
Figure 13

- a. Install 2 new bolts inside the cup holders (torque 2.5 Nm) (Figure 13).

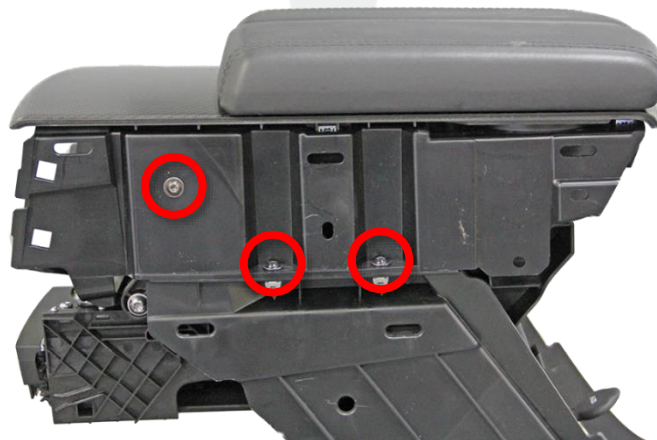
- b. On the LH and RH side of the center console carrier, install 3 new bolts that secure the armrest base to the center console carrier (torque 2.5 Nm) (Figure 14).

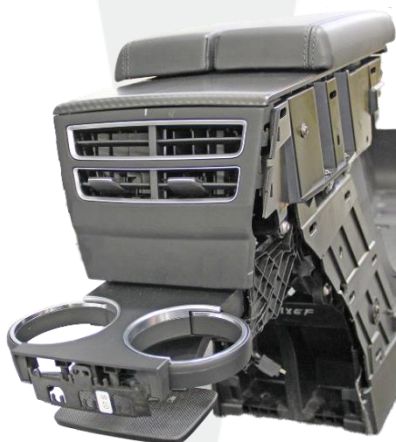
Figure 16

17. Temporarily secure the rear vent assembly to the center console carrier by carefully pushing it in towards the center console carrier (Figure 16).

NOTE: Installing the rear vent assembly allows the rear cup holder assembly to be aligned properly. The rear vent assembly is removed and reinstalled later in this procedure.

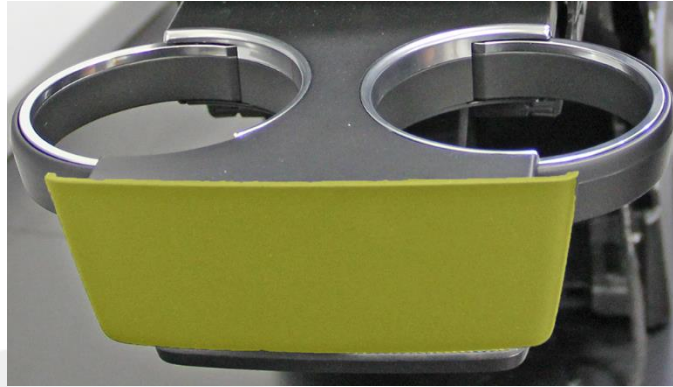
18. Install the rear cup holder trim panel (Figure 17). Ensure that all clips are fully secure.

Figure 17 (Rear cup holder trim panel highlighted)

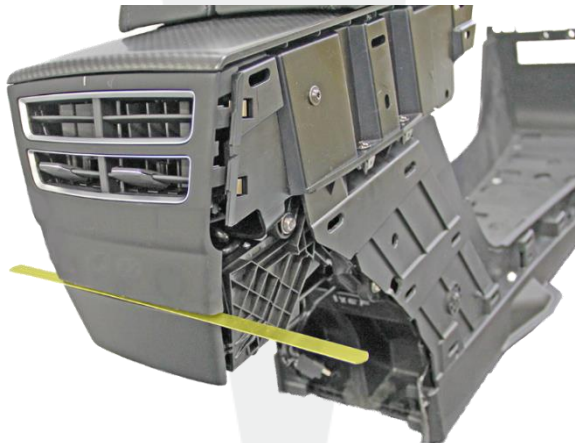
- a. Insert the 0.9 mm feeler gauge in the gap between the rear cup holder and rear vent assembly (Figure 18).

NOTE: The feeler gauge represents the appropriate gap between the rear cup holder and the rear vent.

Figure 18 (Feeler gauge highlighted)

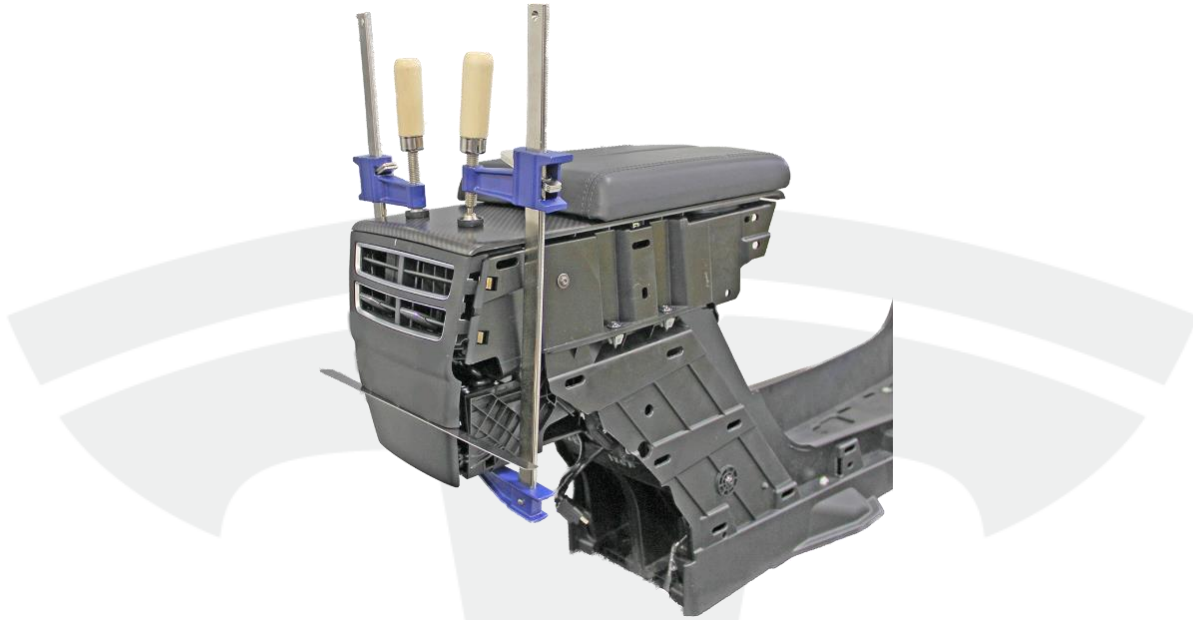
Figure 19

- b. Carefully secure the 2 clamps so that the top rests on the cup holder trim and the bottom touches the underside of the cup holder assembly (Figure 19).

NOTE: Do not block access to the bolts that secure the rear cup holder assembly to the rear center console bracket.

- c. Slowly tighten the 2 clamps until the feeler gauge is snug between the rear cup holder and rear vent assembly.

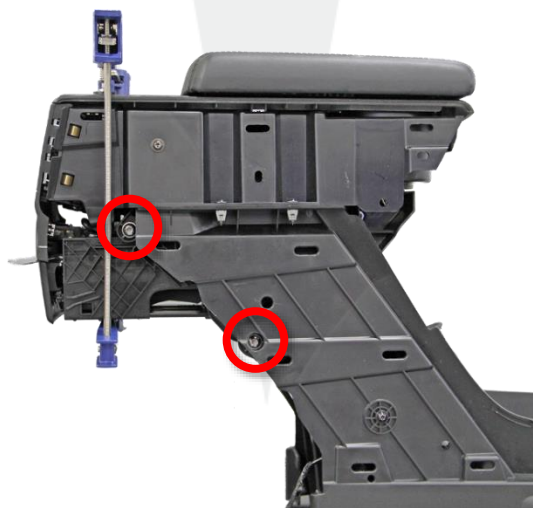
Figure 20

- d. On the LH and RH side of the center console assembly, fully tighten the 2 bolts that secure the rear cup holder assembly to the rear center console bracket (torque 2.8 Nm) (Figure 20).

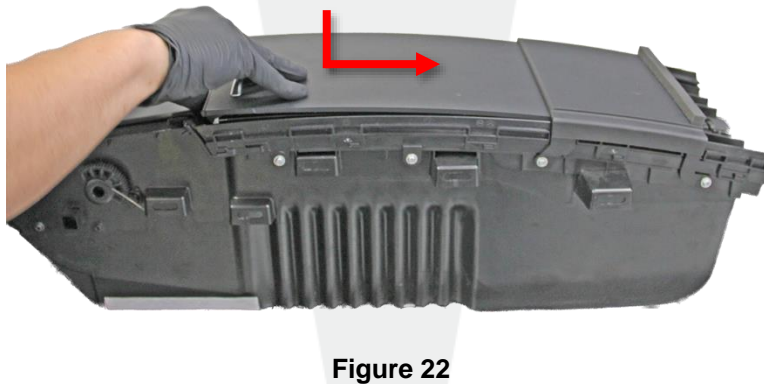
- b. Carefully press the sliding lid décor downwards and towards the front of the center console insert (Figure 22) until the sliding lid décor snaps into place.

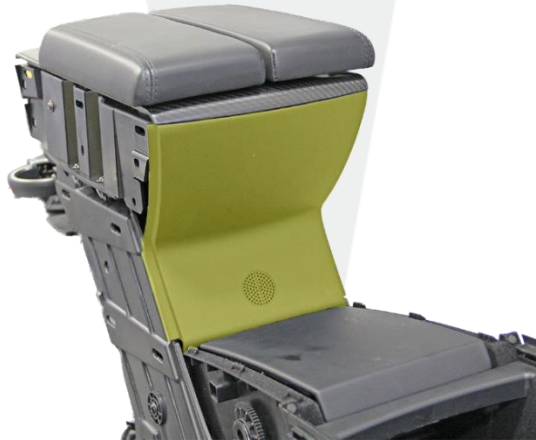
- e. Install the 2 bolts that secure the center console insert to the center console carrier (torque 2.5 Nm).
- 24. Connect the in-vehicle temperature sensor electrical connector.
 - 25. Secure the front closeout panel assembly to the center console (Figure 24). Ensure that all clips are fully secure.

Figure 24 (Front closeout panel highlighted)

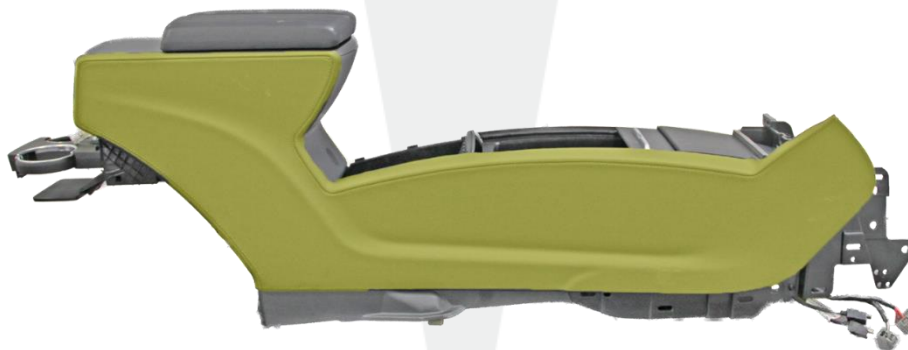
28. Install the LH and RH center console closeout panels (Figure 26).

NOTE: It is necessary for the closeout panels to be attached to the center console before it is installed in the vehicle, but the front and rear portions of the closeout panels are loosened later in this procedure. Ensure that the middle section of each closeout panel is fully secure.

Figure 26 (RH center console closeout panel highlighted)

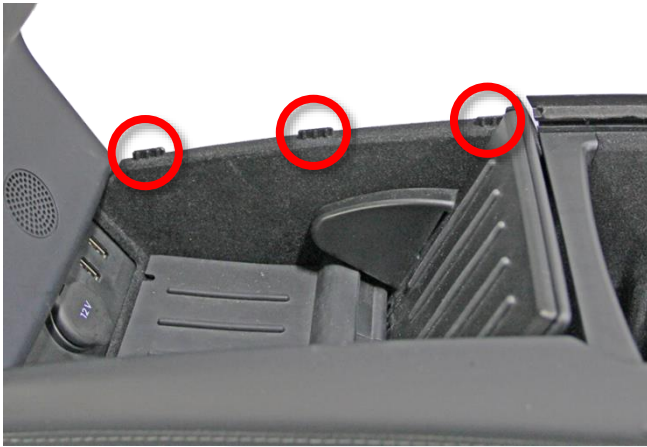
Figure 27

⚠ CAUTION: Take care not to damage the upper tabs on the center console insert (Figure 27) when installing the closeout panels. If necessary, use a trim tool to maneuver the closeout panels over the upper tabs (Figure 28).

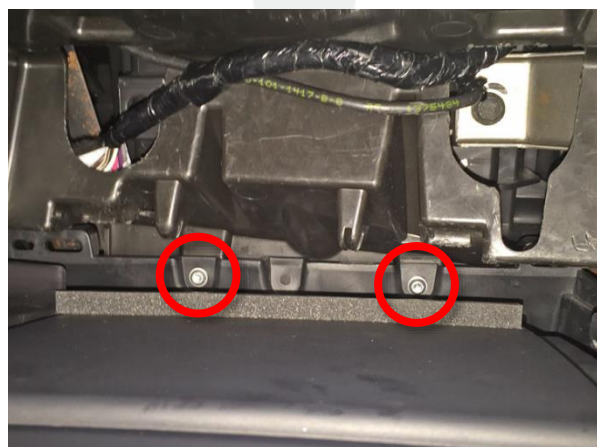
Figure 29

- a. 2 screws that secure the front of the center console to the instrument panel (Figure 29).

33. Fully torque the 8 fasteners that secure the center console assembly:
 - a. 2 screws that secure the front of the center console to the instrument panel (torque 2.5 Nm).
 - b. 2 screws that secure the front of the center console to the crosscar beam (torque 2.5 Nm).
 - c. 2 bolts that secure the rear of the center console to the body (torque 7.5 Nm).
 - d. 2 bolts that secure the center console insert to the body (torque 2.5 Nm).

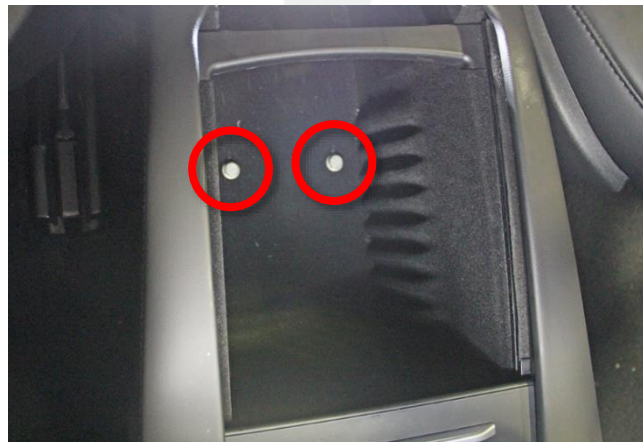
Figure 32

- d. 2 bolts that secure the center console insert to the body (Figure 32).

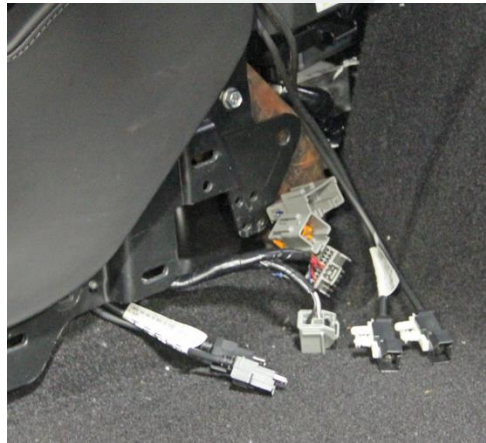
Figure 33

38. Connect all electrical connectors on the RH side of the center console assembly (Figure 33). Secure the fir tree clips to the center console as necessary.

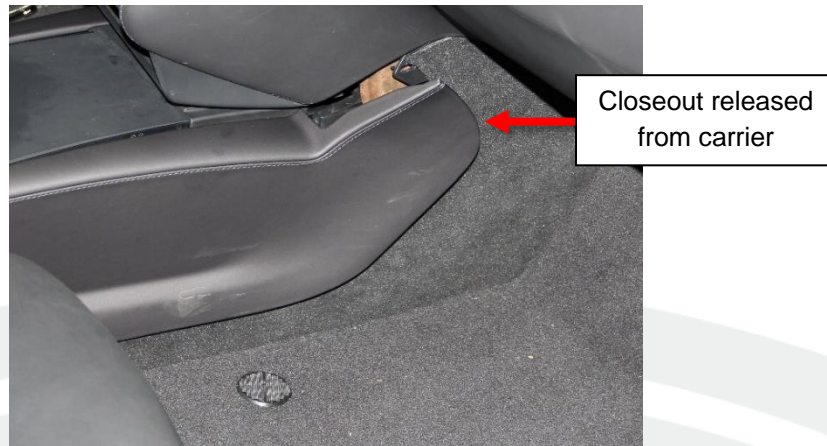
Figure 34

39. With the front portion of the LH and RH center console closeouts still released from the center console carrier, install the LH and RH center console closeout extensions (Figure 34).

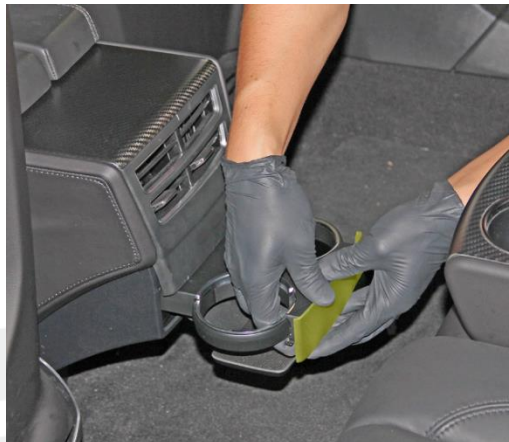
Figure 35

44. Install the rear cup holder trim panel (Figure 35).
