Replace Rear Door Hinge Bolts and Inspect Front Seat Belts

Classification	Campaign Bulletin	Section/Group	10 - Body	Country/Region	North America
Year	2017, 2018	Model	Model 3	Version	All

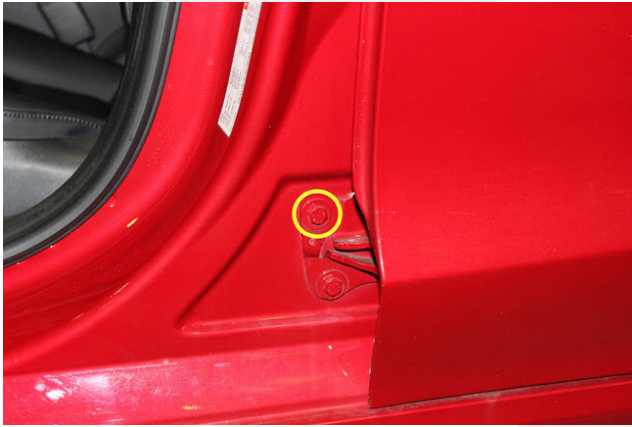
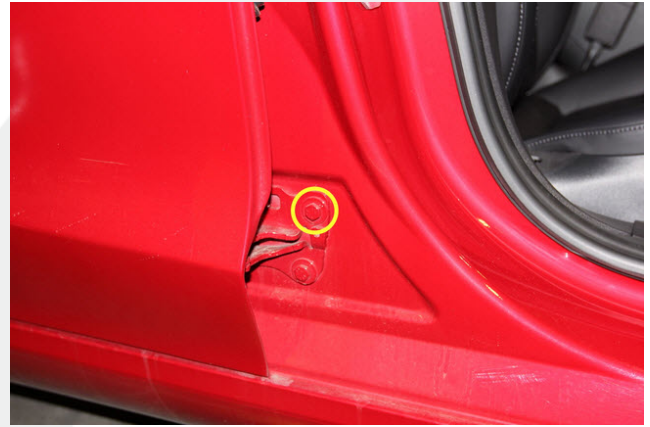
2. Fully lower the windows.
3. Remove and discard the upper bolt from the LH and RH lower rear door hinges (Figures 1 and 2).

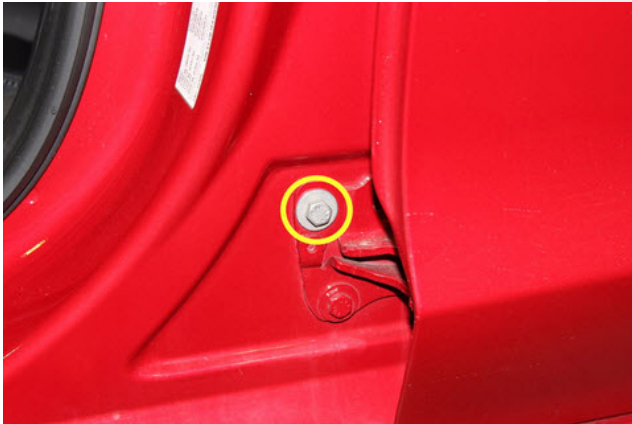
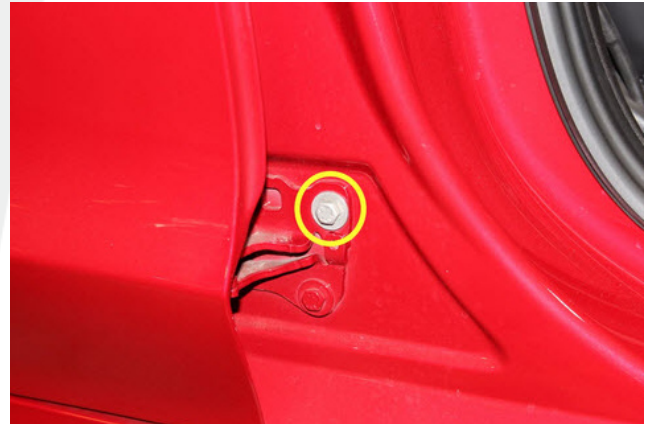
4. Install new bolts into the lower rear door hinges (torque 24 Nm)(Figures 3 and 4).

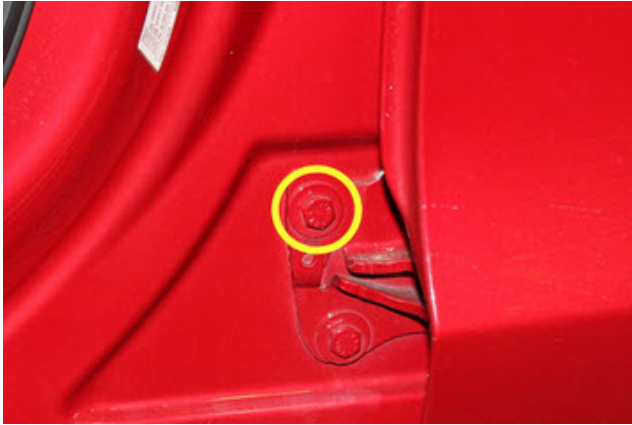
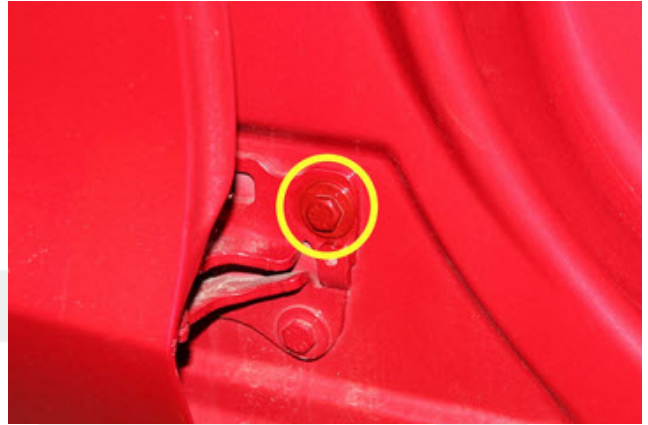
7. Apply a first coat of touch-up paint to the bolt heads and washers, and allow at least 20 minutes to dry (Figures 5 and 6).

13. Apply a second coat of touch-up paint to the bolt heads and washers, and allow at least 20 minutes to dry (Figures 5 and 6).

16. Apply a third coat of touch-up paint to the bolt heads and washers, and allow at least 20 minutes to dry (Figures 5 and 6).

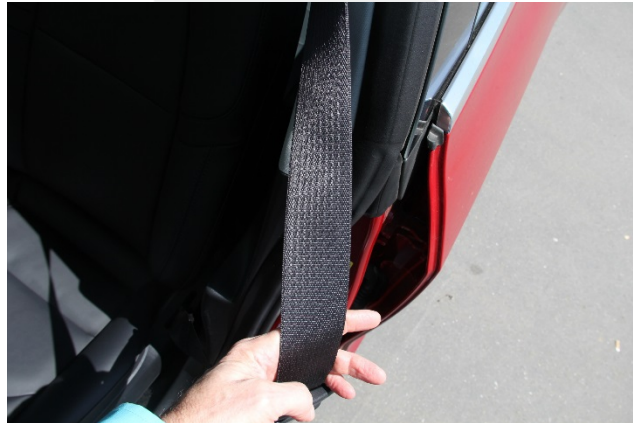
Figure 7

8. While waiting for the touch-up paint to dry, inspect the front seat belts.
9. Position the front LH seat belt so that light sheens from its surface (Figure 7).

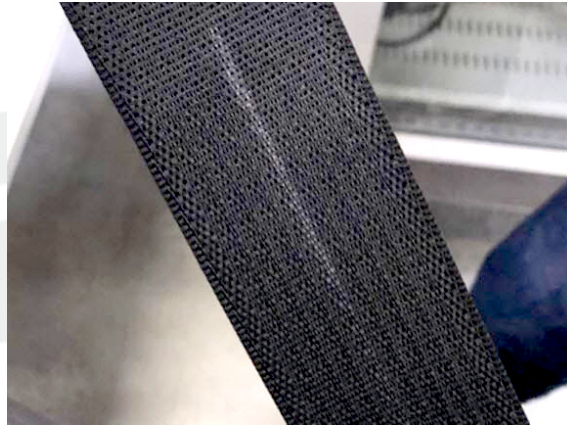
10. Slowly pull the belt from the B-pillar, and look for any marks on the belt surface (Figure 8).

Figure 8 (Mark caused by bolt rubbing on belt)

- If any marks are seen, remove the seat belt (refer to Service Manual procedure 20054102).

NOTE: Do not install the replacement belt at this time.

- If no marks are seen, retract the belt back into the B-pillar, and repeat steps 9 and 10 for the other side of the belt.
