Liftgate Drain Plugs Retrofit

Classification Campaign Bulletin **Section/Group** 11 - Closures **Country/Region** All

Year 2012 - 2015 **Model** Model S **Version** All

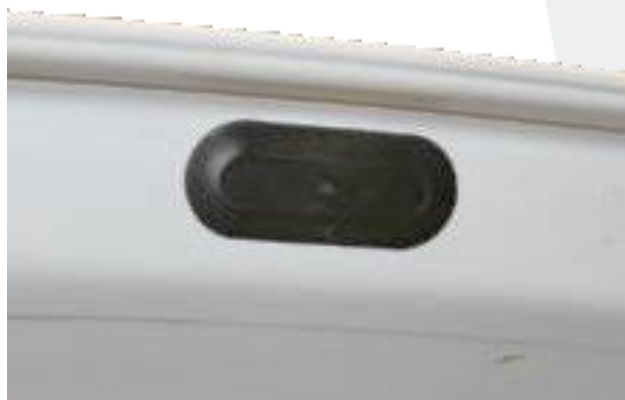
Figure 1 ❌

On certain Model S vehicles, the liftgate has plugs that do not allow water to drain (Figure 1), causing condensation to build up inside the tail light assembly. Tail light functionality is not affected. The retrofit of updated drain-type liftgate plugs allows water to escape the liftgate and keep the tail lights dry (Figure 2).

Retrofit the original liftgate plugs with updated liftgate drain plugs.

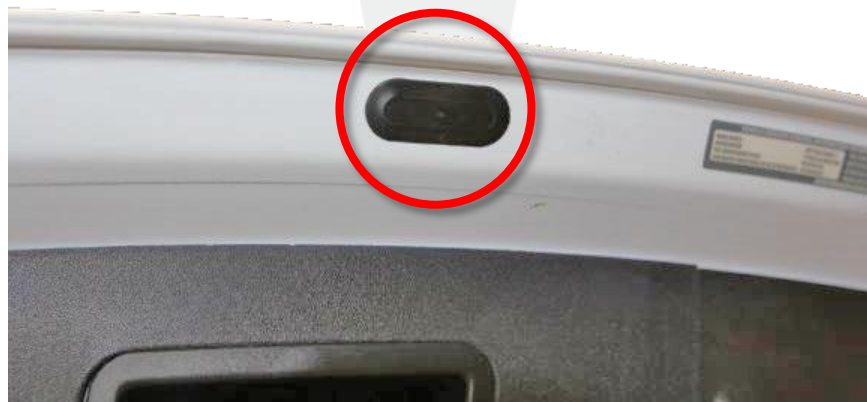
Figure 1 (Original LH liftgate plug, RH similar)

1. Open the liftgate.
2. Inspect the LH and RH liftgate plugs:
 - If the liftgate plugs are as shown in Figure 1, continue to the next step.
 - If the liftgate plugs are the drain-type plugs as shown in Figure 2, the vehicle has the updated liftgate drain plugs. Discontinue this procedure.
3. Remove the original LH and RH liftgate plugs using a plastic trim tool (Figure 1).

⚠ CAUTION: Avoid paint damage when removing the liftgate plugs.

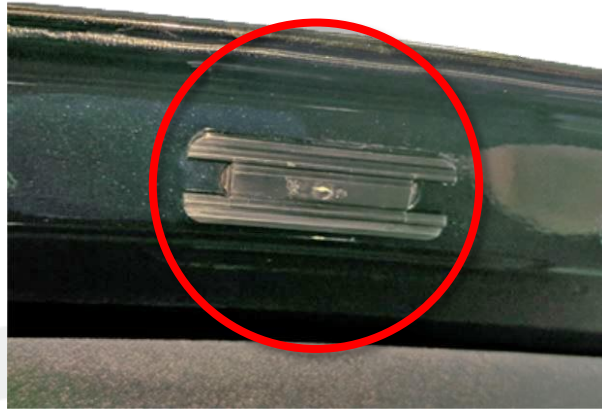
Figure 2 (Updated drain-type LH liftgate plug installed, RH similar)

5. Install the updated drain-type LH and RH liftgate plugs (Figure 2). Make sure that they are fully seated.
