Tesla, Inc. Service Bulletin		<h2 style="margin: 0;">Inspect 2nd Row Seatbelt Bolts</h2>	
SB-21-20-002 May 27, 2021			
Classification Recall Bulletin		Section/Group 20 - Safety and Restraint	Mobile Service Can Perform (where permitted)
Model Year 2019 - 2021	Model Model Y	Country/Region North America	Version All
<small>The model(s) and model year(s) listed are a general approximation of the affected VIN list. Refer to the VIN/Bulletin Tracker or Customer/Vehicle profile to determine applicability of this bulletin for a particular vehicle.</small>

Some Model Y LH or RH 2nd row seatbelt retractor bolts may have been cross-threaded upon installation.

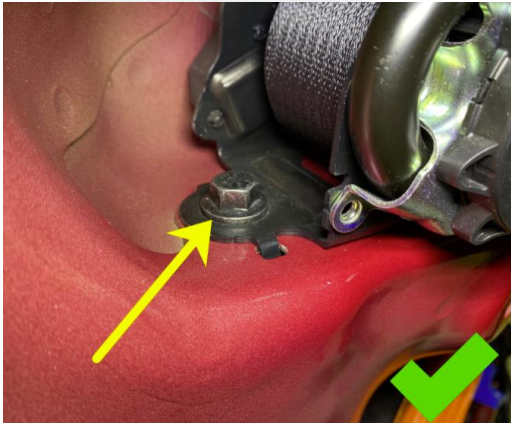
Figure 1 – LH shown; RH similar

3. Wiggle the LH 2nd row seatbelt retractor and inspect for a gap between the retractor and the body.
 - If the retractor does not wiggle and is tight against the body (Figure 1), the retractor bolt and weld nut do not require inspection; torque the bolt (torque 30 Nm), take note, and then skip to step 20.
 - If the retractor wiggles or is not tight against the body (Figure 2), the retractor bolt and weld nut require inspection; take note and continue to step 4.

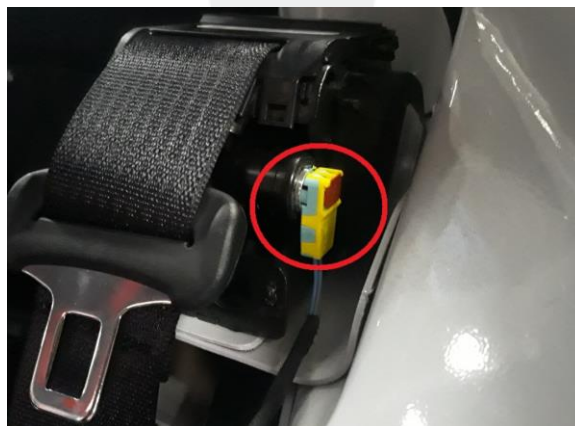
Figure 3 – LH shown; RH similar

4. Release the locking tab, and then disconnect the electrical harness from the LH 2nd row seatbelt retractor (Figure 3).

19. Connect the electrical harness on the LH 2nd row seatbelt retractor (Figure 3).
20. Repeat steps 2–19 for the RH 2nd row seatbelt, and after returning to this step, continue to step 21.

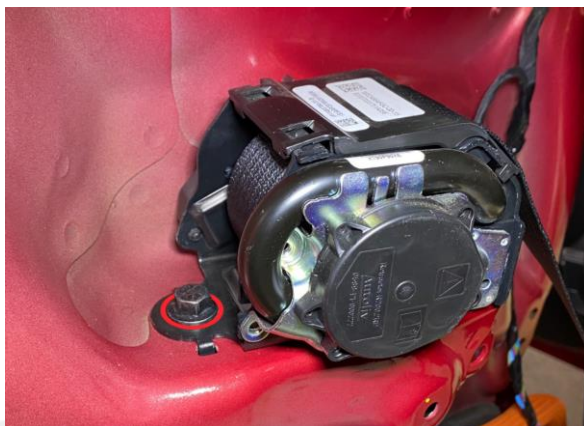
Figure 4 – LH shown; RH similar

5. Remove the bolt that attaches the LH 2nd row seatbelt retractor to the body (torque 30 Nm) (Figure 4).

16. Install the LH 2nd row retractor with a new bolt (torque 30 Nm) (Figure 4).

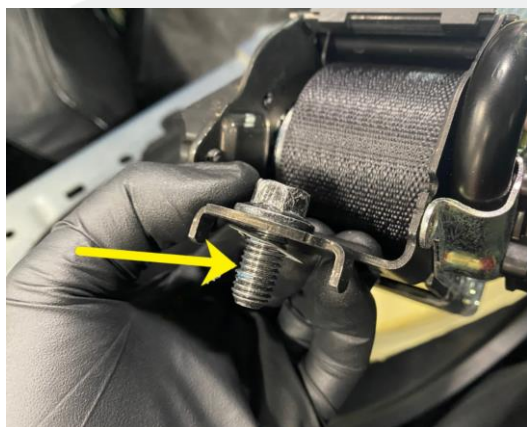
Figure 5 – LH shown; RH similar

6. Remove the LH 2nd row seatbelt retractor from the vehicle and inspect the retractor bolt (Figure 5) and weld nut threads (Figure 6).

- If the bolt or nut threads are damaged, repair is necessary. Take note and skip to step 7.
- If the bolt **and** nut threads are undamaged, repair is not necessary. Reinstall parts by performing steps 5 and 4 in reverse order, and then skip to step 20.

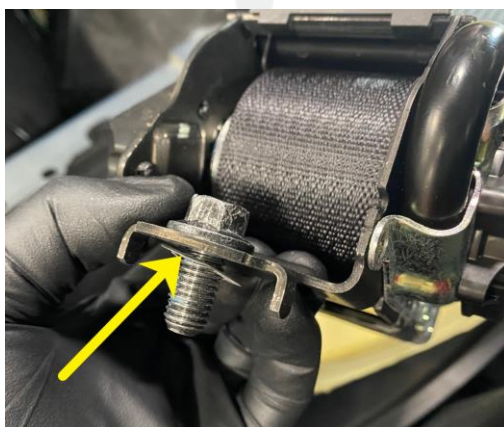
Figure 7 – LH shown; RH similar

7. Hold the LH 2nd row seatbelt retractor captive washer (yellow arrow, Figure 7) in place with vise grips, and then remove the bolt from the retractor. Set the bolt aside if the seatbelt retractor weld nut threads (Figure 6) are damaged; otherwise, discard the bolt.

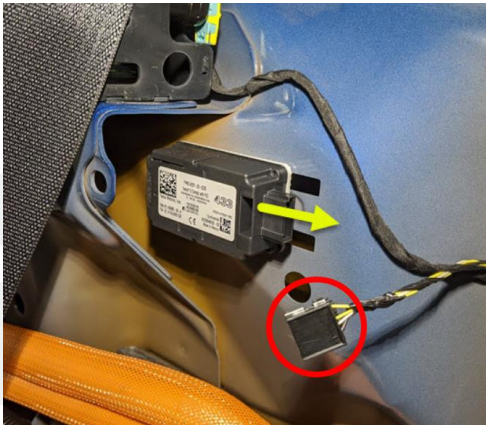
Figure 8

8. Position a new bolt on the LH 2nd row seatbelt retractor.
9. Proceed depending on the condition of the weld nut:
 - If the weld nut is undamaged, skip to step 16.
 - If the weld nut is damaged, continue to step 10.
10. Disconnect the electrical harness from the TPMS ECU (Figure 8).

18. If disconnected, connect the electrical harness on the TPMS ECU (Figure 8).

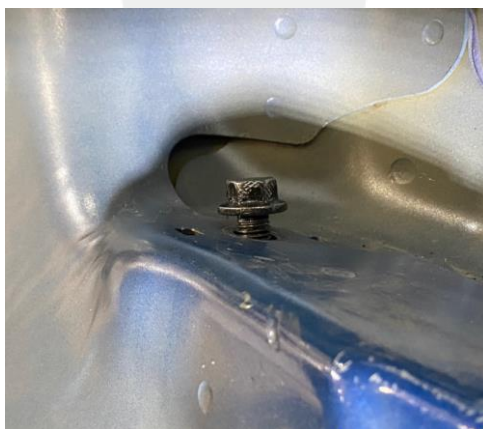
Figure 9 – LH shown; RH similar

11. Slide the TPMS ECU towards the front of the vehicle to release it, and then remove the TPMS ECU from the vehicle.
12. Loosely install the old retractor bolt on the LH 2nd row seatbelt retractor weld nut (Figure 9).

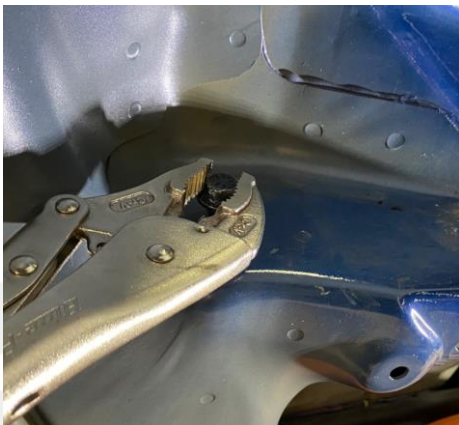
Figure 10 – LH shown; RH similar

13. Hold the retractor bolt with vise grips (Figure 10), and then use the vise grips to dislodge the weld nut from the body.

TIP: Use a deadblow hammer if unable to dislodge the weld nut with vise grips.

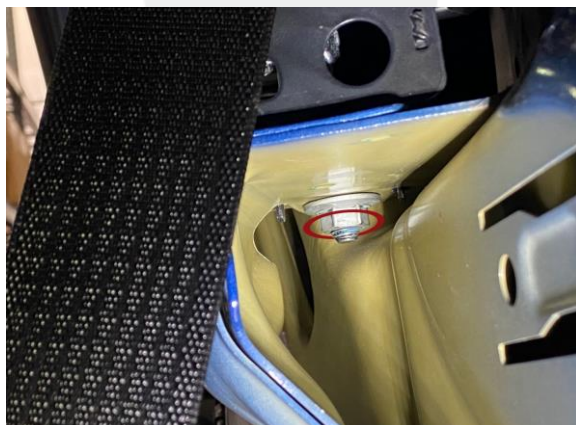
Figure 11 – LH shown; RH similar

15. Using a 13 mm socket, hold a new nut in position under the LH 2nd row seatbelt mounting point (Figure 11).

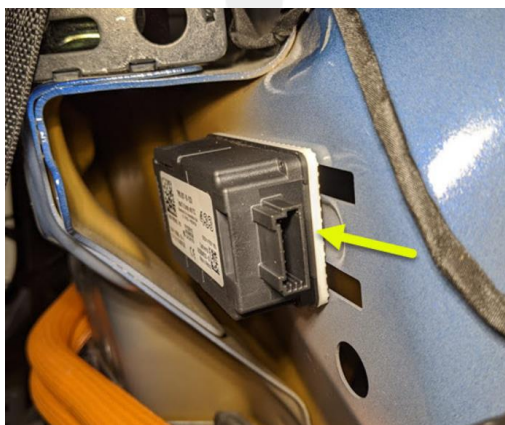
Figure 12

17. If removed, position the TPMS ECU on the vehicle, and then slide the TPMS ECU towards the rear of the vehicle to install it (Figure 12).
