Light/Rain Sensor Update

Classification Repair Bulletin **Section/Group** 17 - Electrical **Country/Region** North America

Year 2012 **Model** Model S **Version** All

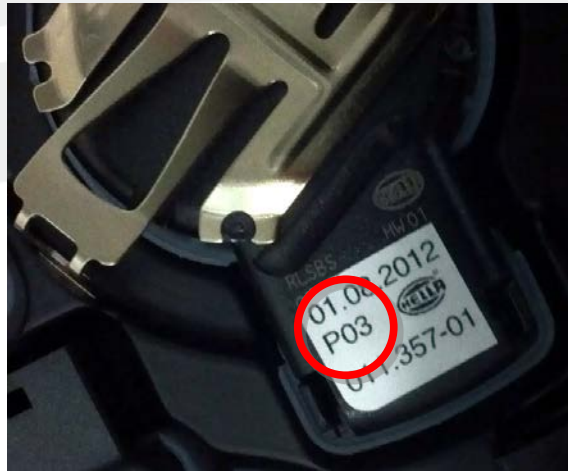
Figure 1

The light/rain sensor has an inaccurate solar calibration, which could cause a complaint of inadequate cooling when the HVAC system is in automatic mode.

1. Remove the trim from the rear view mirror (refer to Service Manual procedure 15050802).
2. Check the label on the light/rain sensor (Figure 1).
 - If the revision code is P03, the sensor is the updated version and replacement is not necessary; discontinue this procedure.
 - If the revision code is P01 or P02, replace the sensor (refer to Service Manual procedure 10200502).

Upon customer complaint, replace the light/rain sensor with an updated version that has a new calibration.
