Installation of Updated Defrost Grille, Europe

Classification	Repair Bulletin	Section/Group	14 - Instrument Panel & Pedals	Country/Region	Europe
Year	2013	Model	Model S	Version	All

This Service Bulletin supersedes SB-13-14-004 R1, dated 22-Jan-2014. Each content change is marked by a vertical line in the left margin. Discard the previous version and replace it with this one.

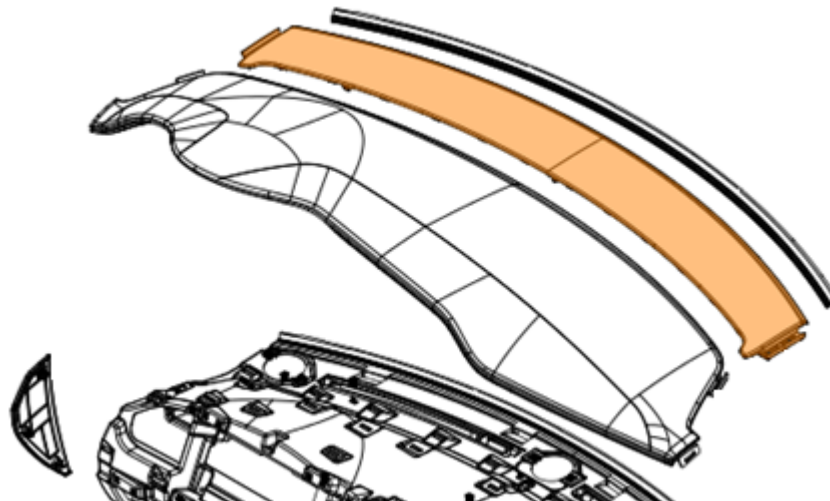
Figure 1

Some vehicles were shipped to Europe with the standard version of the defrost mesh grille. Although this grille promptly defrosts the windshield and is in full compliance with ECE requirements, the updated grille improves windshield clearing performance in the edges near the LH and RH A-Pillars.

Upon customer complaint, replace the defrost mesh grille with the updated part (Figure 1).

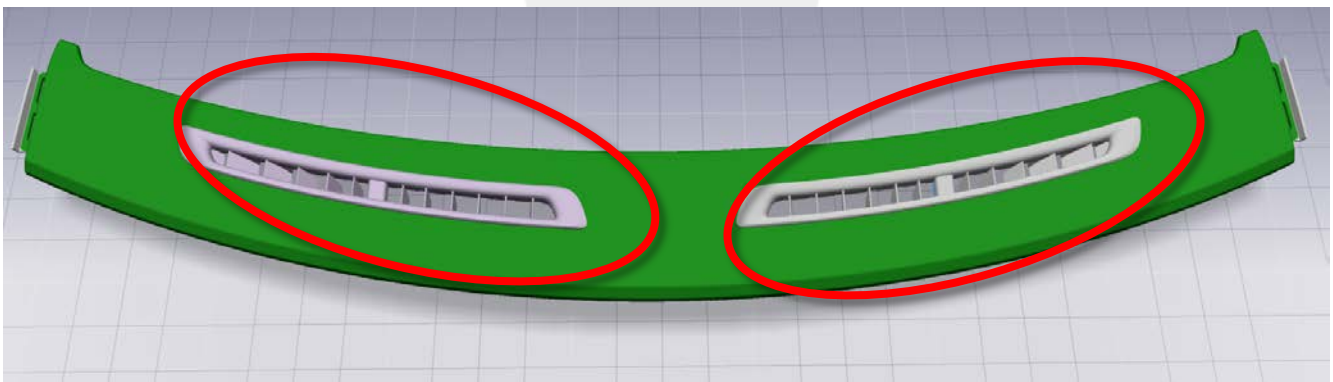
Figure 2

1. Inspect the defrost mesh grille that is inside the vehicle. If the grille has vents that direct air toward the A-Pillars (Figure 2), then the new grille is already installed and no more work is needed.

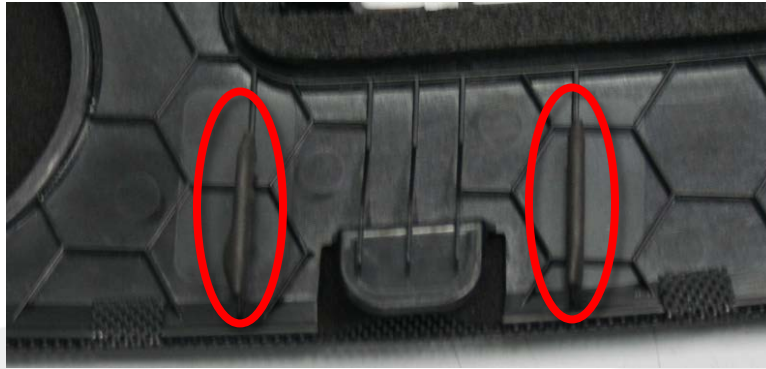
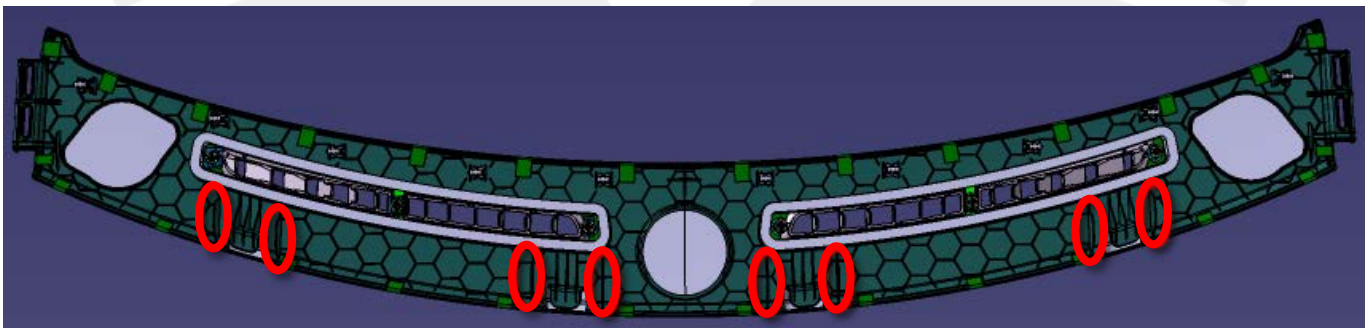
4. Inspect the underside of the new defrost mesh grille. If the risers on each side of the 4 retaining clips are covered with foam tape, skip to the next step. If not, cover each of the 8 risers with foam tape (Figures 3 and 4).

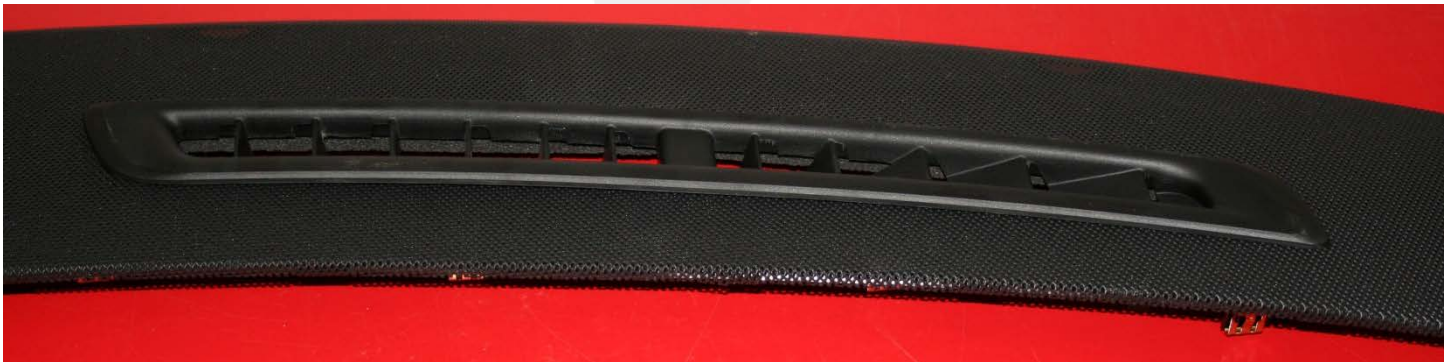
Figure 5

5. Turn the grille over so that the top side faces up.
6. Insert the RH bezel into the RH cutout of the grille (Figure 5).

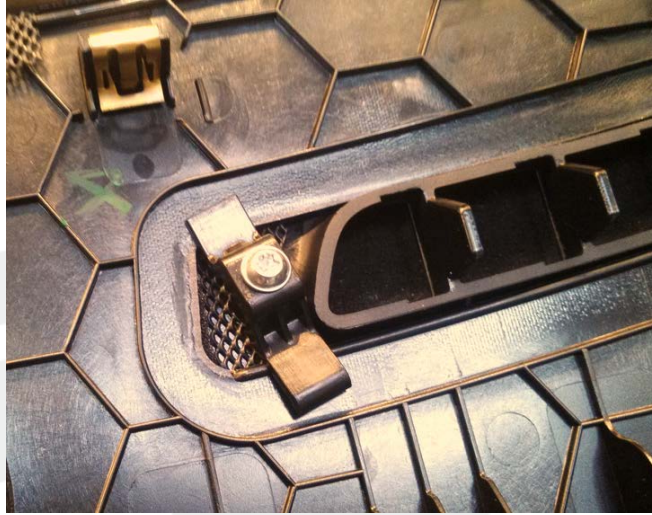
Figure 6

8. Position a bezel bridge over the hole on the inboard side of the bezel. Screw the bezel bridge into the bezel (torque 2 Nm).

NOTE: It might be necessary to angle the bezel bridge in order to make it fit securely (Figure 6).

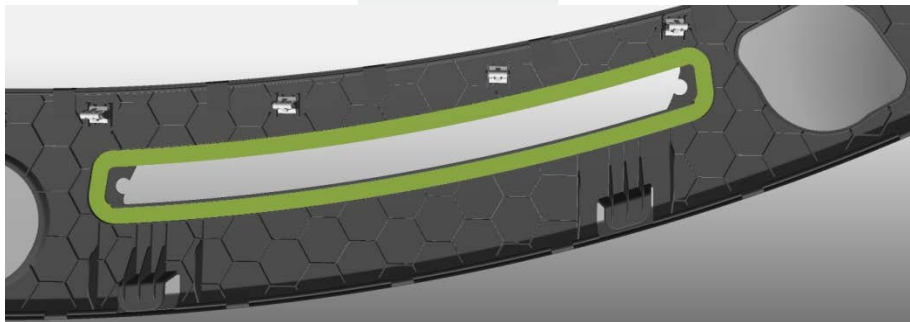
9. Repeat step 8 for the holes in the center and outboard size of the bezel.
10. Ensure that the bezel is seated firmly in the new grille.
11. Remove the adhesive backing from one of the foam seals. Secure the seal around the cutout in the grille (Figure 7). Ensure that the seal covers the edges of the bezel bridges (Figure 8).

Figure 7 (Shown with bezel and spacers removed for clarity)

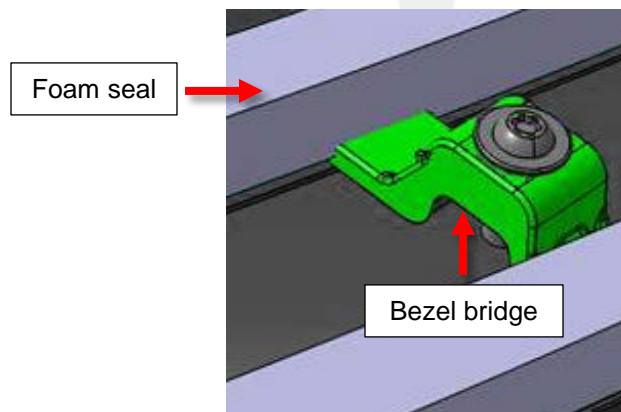
Figure 8 (Shown with bezel removed for clarity)
