# Liftgate Trough Trim Upgrade

<b>Classification</b>	Repair Bulletin	<b>Section/Group</b>	15 - Interior Trim	<b>Country/Region</b>	United States and Canada
<b>Year</b>	2012	<b>Model</b>	Model S	<b>Version</b>	All

This Service Bulletin supersedes SB-13-15-001, dated 15-Jan-13. Each content change is marked by a vertical line in the left margin. Discard the previous version and replace it with this one.

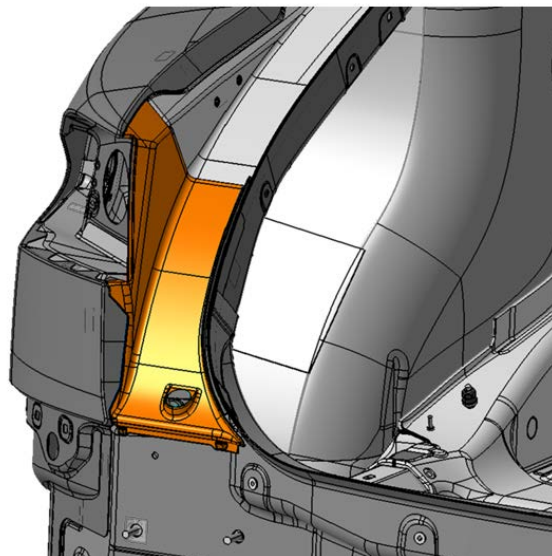
Figure 1 (LH side shown)

Higher quality liftgate trough trim panels are now available. The new panels fit better and have a grained finish to provide a more aesthetically pleasing appearance.

Upon complaint, replace the LH and RH liftgate trough trim panels with higher quality parts (Figure 1).
