Front Lower Control Arm Washer Installation

Classification	Campaign Bulletin	Section/Group	31 - Suspension	Country/Region	North America, Europe
Year	2012-2013	Model	Model S	Version	All

This Service Bulletin supersedes SB-13-31-003 R1, dated 16-Mar-15. Each content change is marked by a vertical line in the left margin. Discard the previous version and replace it with this one.

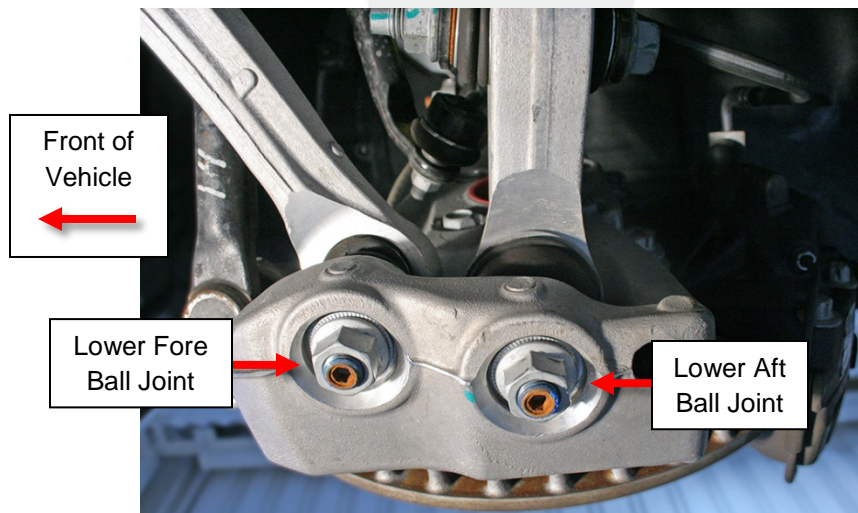
Figure 1 (RH side shown)

1. Remove the front wheels (refer to Service Manual procedure 34012401).
2. Check the front fore and aft lower control arms for visible play at the connections to the knuckle (Figure 1).
 - If there is no visible free play, skip directly to the “Wedge-Lock Washer Installation” section of this document.
 - If visible free play is found, continue to the next step in this procedure.

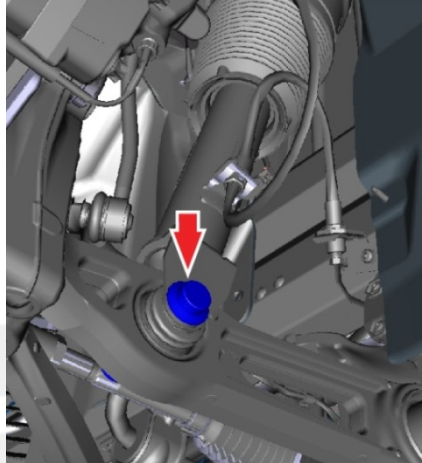
Figure 2

6. Remove the bolt and nut that hold the spring module to the lower aft arm (torque 140 Nm) (Figure 2).

7. Release the spring module from the lower aft arm.

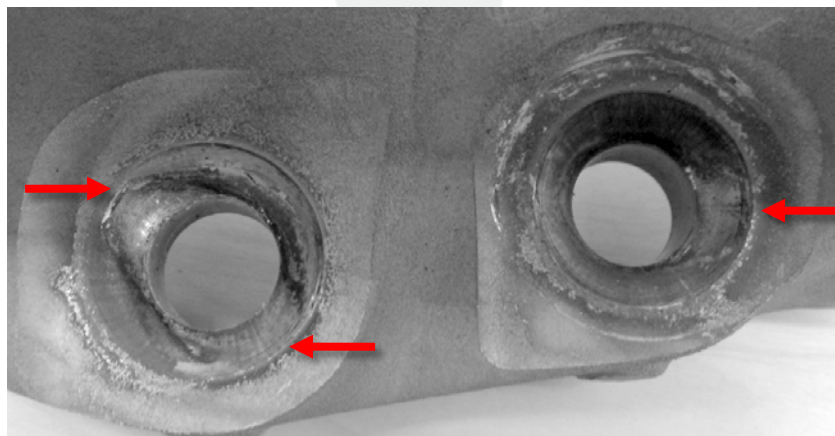
Figure 3

8. Hold the lower aft ball joint with a hex tool. Remove and discard the nut that holds the ball joint to the knuckle (torque 195 Nm).
9. Disconnect the lower aft control arm from the knuckle.
10. Inspect the ball joints and seating surfaces on the knuckles for shiny, oval-shaped wear marks. Examples of damage to the knuckle seating surfaces are shown in Figure 3.

11. Replace the knuckles if they have visible wear marks (refer to Service Manual procedure 31010102).
12. Replace the lower control arms if the ball joints have visible wear marks (refer to Service Manual procedure 31013402 or 31013602).
13. Continue to the “Wedge-Lock Washer Installation” section of this document.

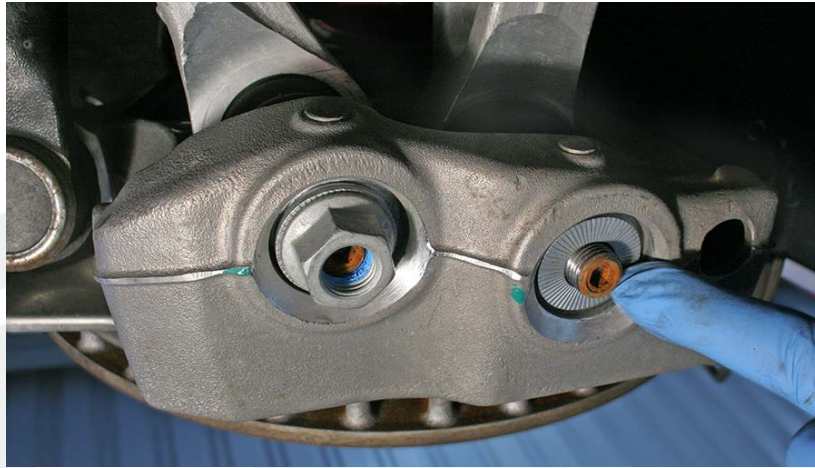
Figure 4 (RH side shown)

1. Remove and discard the 4 nuts that hold the lower control arm ball joints to the knuckle.
2. Install a wedge-lock washer on each ball joint stud, then loosely install a new nut (Figure 4).

3. Hold each lower control arm ball joint with a hex tool while torquing the nut to 195 Nm.
4. Check that there is no visible free play at the lower fore and aft control arms' connections to the knuckle.
5. Reinstall the wheels.
6. If the air springs were deflated, use Toolbox to inflate both front air springs.
