Install Electric Park Brake Harness Connector Covers

Classification Repair Bulletin **Section/Group** 17 - Electrical **Country/Region** All

Year 2012-2014 **Model** Model S **Version** All

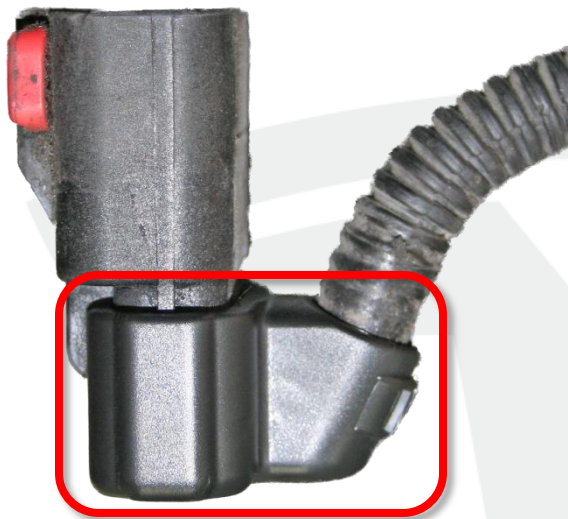
Figure 1

- If the harness has a connector cover installed (Figure 1), no additional work is required; discontinue this procedure.
- If the harness is secured by electrical tape and a cable tie (Figure 2), continue this procedure.

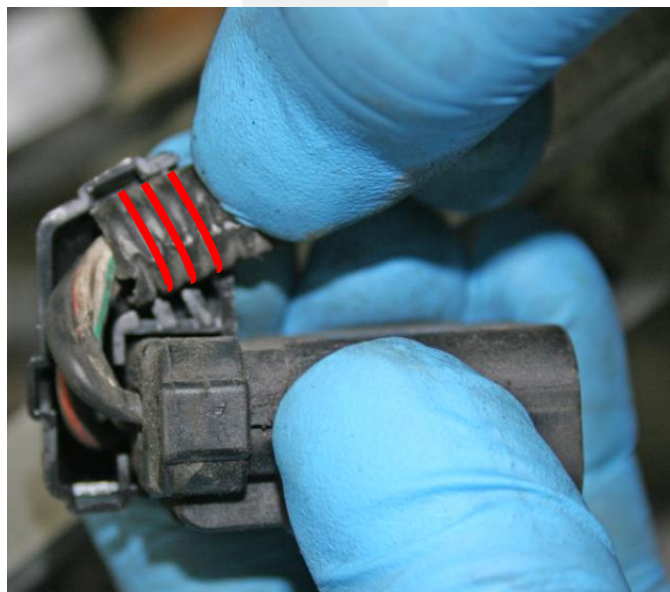
Figure 3

3. Place the EPB caliper harness wires into one side of the connector cover so that 3 of the corrugated tubing ribs are concealed within the connector cover (Figure 3).

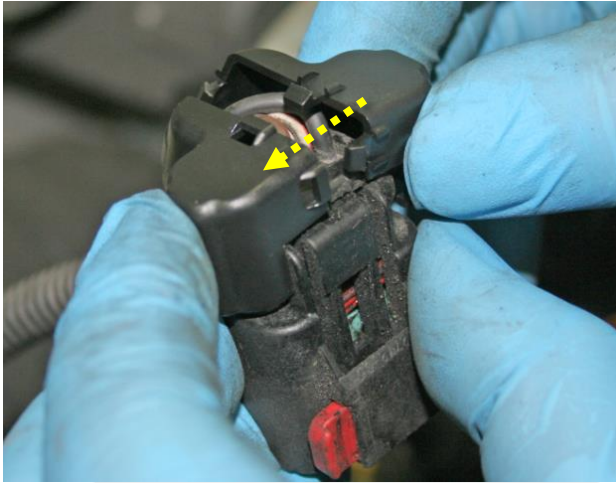
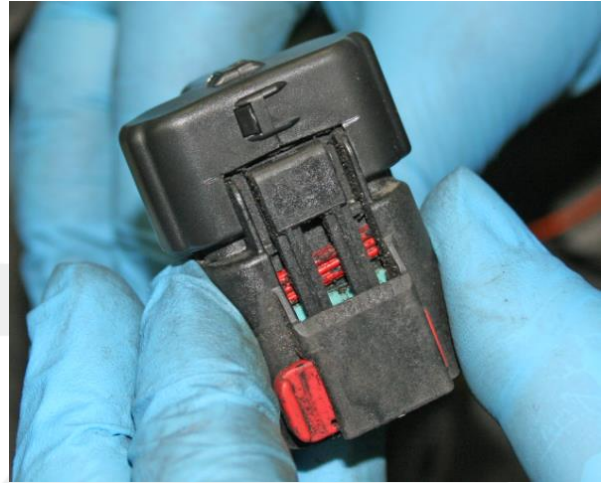
4. Press the other half of the connector cover over the wires and corrugated tubing so that the 3 clips lock into place (Figures 4 and 5).
