Retrofit Model S Door Handle LEDs

Classification	Campaign Bulletin	Section/Group	11 - Closures	Country/Region	Canada, Europe
Year	2015	Model	Model S	Version	Premium Interior and Lighting Package

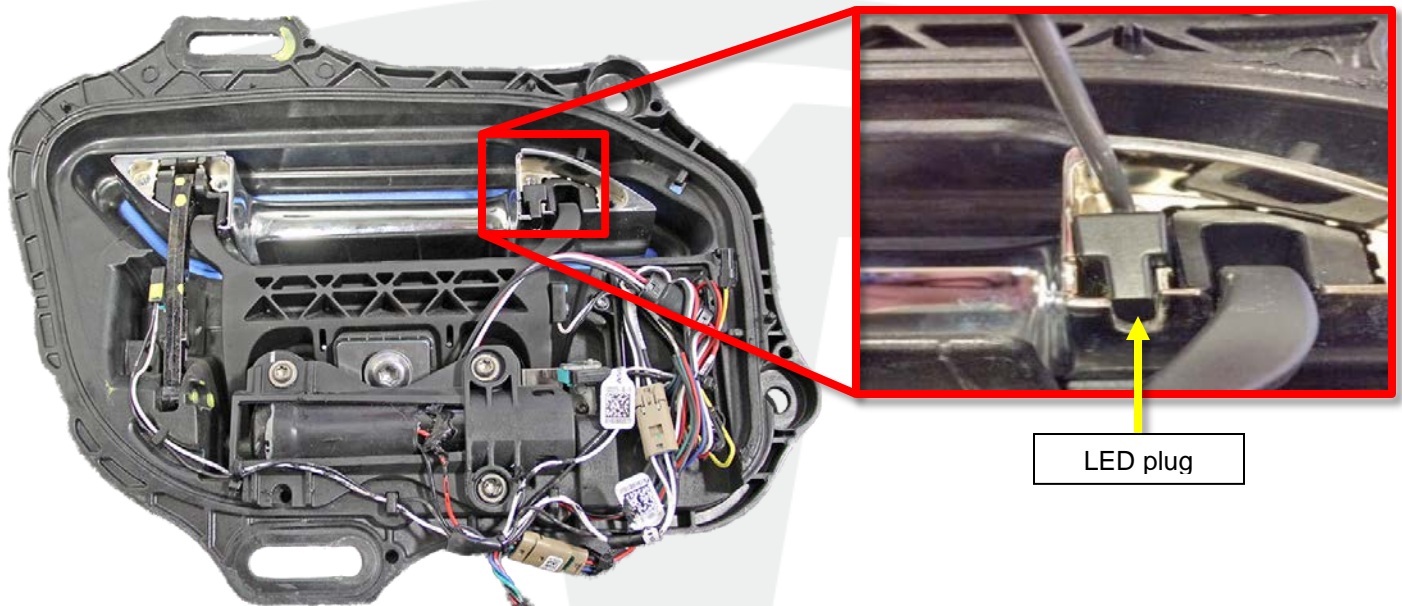
Figure 1

1. Inspect the exterior door handles for LEDs:
 - If the exterior door handles already have LEDs, discontinue this procedure.
 - If the exterior door handles do not have LEDs, continue this procedure.
2. Remove the front LH exterior door handle back plate (refer to Service Manual procedure 11454002).
3. Use a pick to remove and discard the LED plug from the exterior door handle (Figure 1).

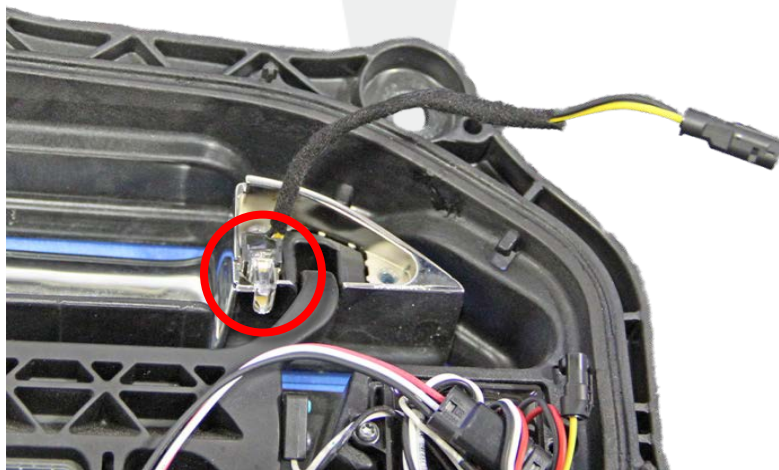
Figure 2

4. Inspect the LED cavity for moisture. Clean the LED cavity if moisture is found.
5. Install the LED into the location where the plug was removed in step 3 (Figure 2).

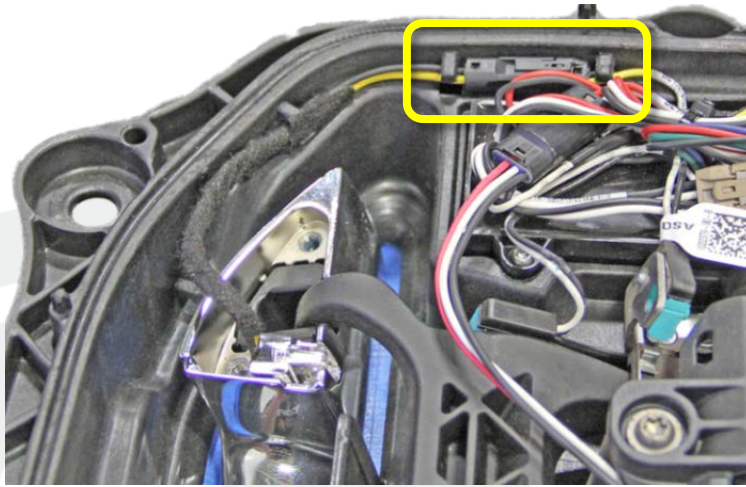
Figure 3

7. Connect the LED electrical connector and route the yellow/black LED harness as shown (Figure 3).

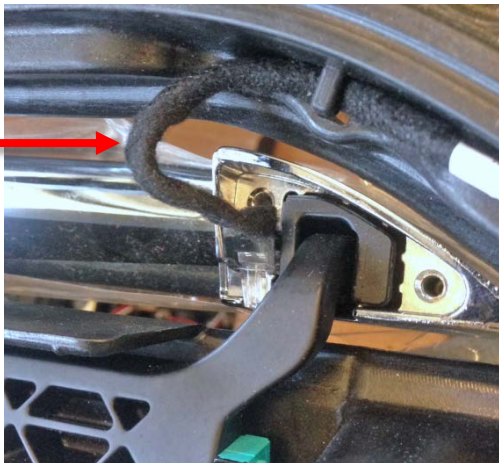
8. Push the door handle out completely to ensure that there is sufficient slack in the LED harness (Figures 4 and 5).

✓ Figure 4 (Sufficient slack)

⚠ CAUTION: Insufficient slack can result in damage to the LED harness when the door handles are presented.

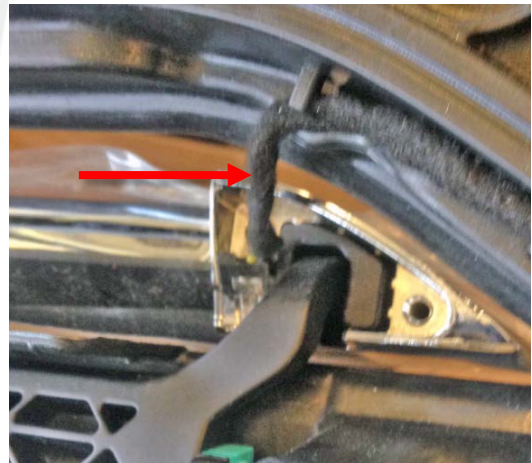
✗ Figure 5 (Insufficient slack)
