# Install 12V Battery Terminal Cover, RHD

<b>Classification</b>	Campaign Bulletin	<b>Section/Group</b>	17 - Electrical	<b>Country/Region</b>	United Kingdom, Asia Pacific
<b>Year</b>	2015	<b>Model</b>	Model S	<b>Version</b>	RHD

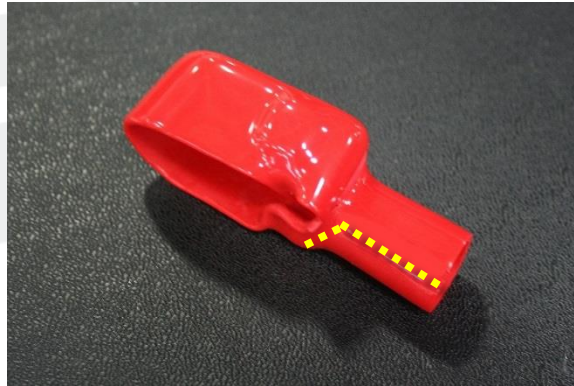
Figure 1

1. Disconnect 12V power:
  - Rear Wheel Drive vehicles, refer to Service Manual procedure 17010100.
  - Dual Motor vehicles, refer to Service Manual procedure 17010200.
2. Disconnect the 12V battery positive cable terminal.
3. Cut a slit in the cover in the lower side portion of the collar (yellow line shown in Figure 1).

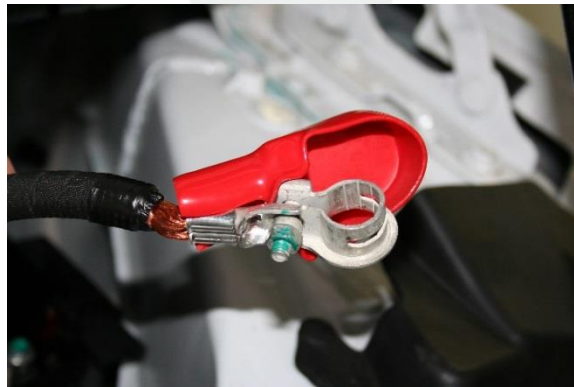
Figure 2

4. Insert the positive cable terminal into the cover (Figure 2).

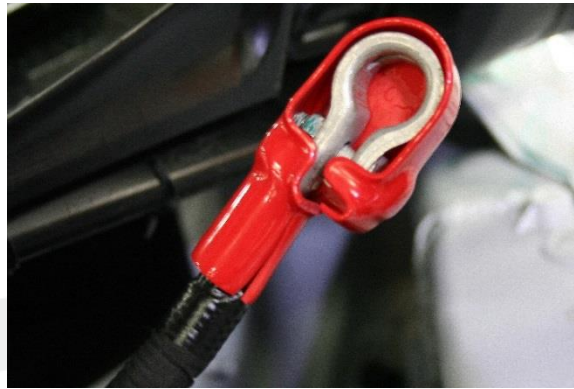
**Figure 3**

5. Adjust the cover to properly fit over the cable terminal (Figure 3).

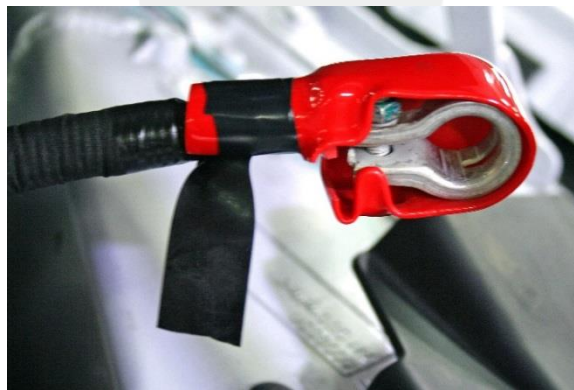
**Figure 4**

6. Wrap the cover 3 times with electrical tape around the collar, then continue to wrap until the tape extends 50 mm beyond the collar (Figure 4).
