# Install Key Battery Positive Contact Clip

**Classification** Campaign Bulletin    **Section/Group** 17 - Electrical    **Country/Region** United States

**Year** 2016    **Model** Model X    **Version** All

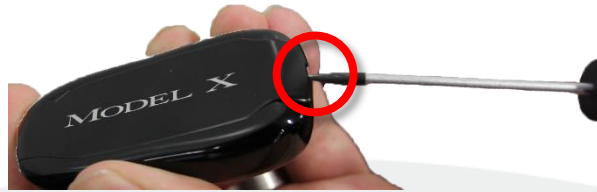
Figure 1

1. Remove the lid on the back of the key using a small flat screwdriver or similar tool (Figure 1).

**⚠ CAUTION:** Do not damage the key casing when removing the lid.

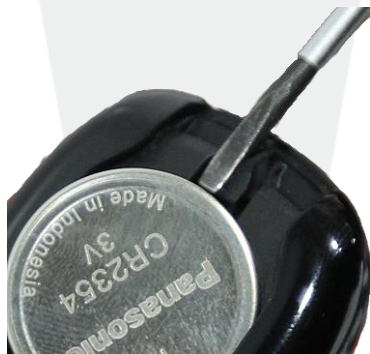
Figure 2

2. Remove the battery using a small flat screwdriver or similar tool (Figure 2).

**⚠ CAUTION:** If the battery brand is Rayovac, discard the battery and replace it with a new Panasonic battery (Tesla part number 1061712-00-A or later). Rayovac batteries are incompatible with the new battery positive contact clip and can damage the key.

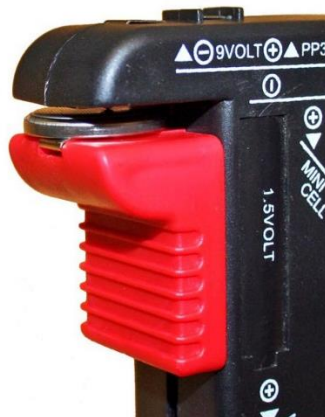
Figure 3

3. Check the battery voltage using the battery tester (Figure 3):

- If the voltage reading is 2V or higher, continue to the next step.
- If the voltage reading is lower than 2V, discard the battery and replace it with a new Panasonic battery (Tesla part number 1061712-00-A or later).

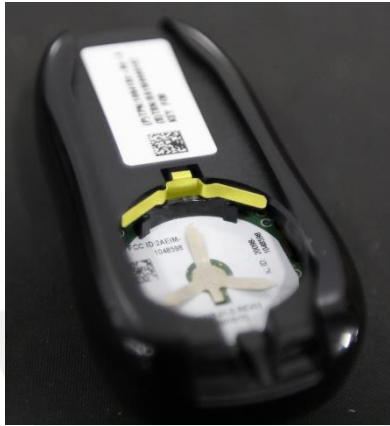
- Check the battery side terminal for damage (Figure 4). If the terminal is broken, discard and replace the key.
- If the key battery positive contact clip is already installed (Figure 5), skip to step 6.

Figure 4 (Battery side terminal highlighted)

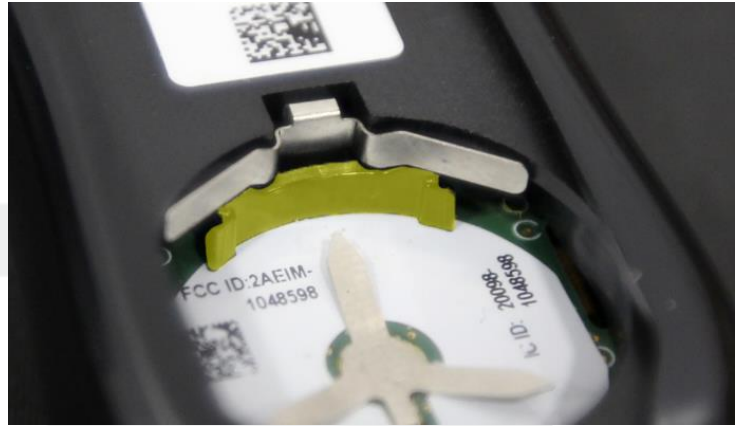
Figure 5 (Positive contact clip highlighted)
