Replace LH Upper Trough Plug

Classification Campaign Bulletin **Section/Group** 10 - Body **Country/Region** United States

Year 2017 **Model** Model 3 **Version** All

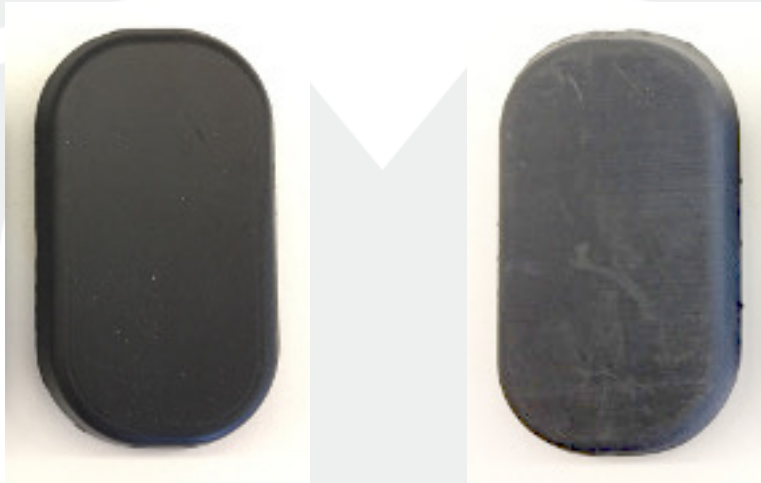
On some Model 3 vehicles, a pre-production LH upper trough plug is installed. The pre-production plug is completely functional, however, it does not cosmetically match the grommet on the RH upper trough.

Figure 1 (Production trough plug is black with smooth texture)

Figure 2 (Pre-production trough plug is dark gray with rough texture)

1. Open the trunk lid.
2. Inspect the area to the right of the LH trunk hinge.
 - If the body is solid, and there is no trough plug, discontinue this procedure.
 - If a production trough plug (Figure 1) is installed, discontinue this procedure.
 - If a pre-production trough plug (Figure 2) is installed, or it is unclear which plug is installed, continue the procedure.

2. Carefully remove the trough plug from the body.

NOTE: Make sure not to scratch the vehicle finish.
3. Clean any residue or adhesive from the area with an IPA wipe.
4. Apply P-80 emulsion grease to the mounting lip of the new trough plug, and wipe off any excess.
5. Insert the new trough plug into the hole, and make sure the plug is secure in the hole.
6. Close the trunk lid.
