Wrinkles in Front Seat Upholstery

| Classification | Repair Bulletin | Section/Group | 13 - Seats | Country/Region | All |
| Year | 2016-2017 | Model | Model S, Model X | Version | Premium Seats |

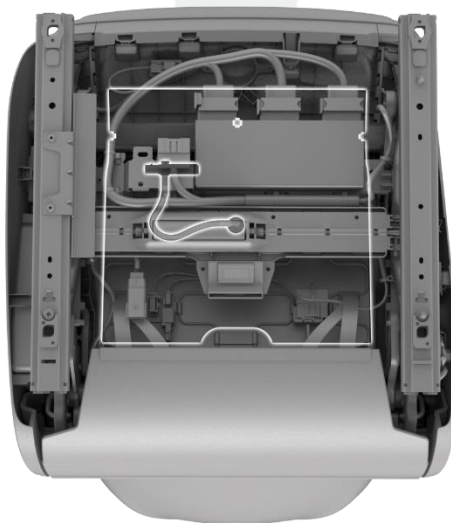
⚠ CAUTION: Do not perform this procedure on seats that have an Occupant Classification System (OCS) sensor. Vehicles equipped with an OCS sensor have a visible tube on the underside of the seat assembly (Figure 1).

Figure 1 (OCS tube highlighted)

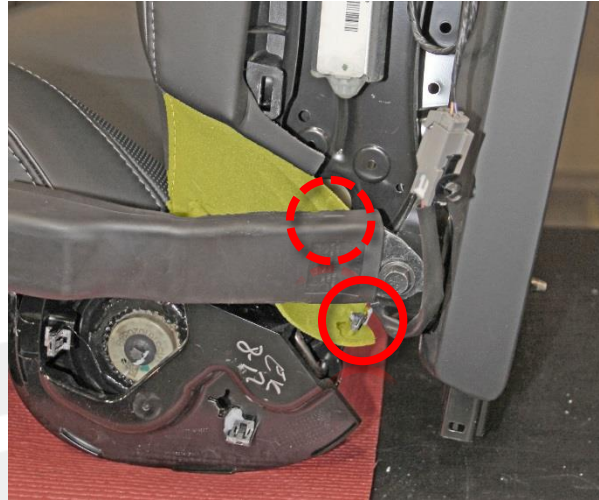
Figure 5 (Seat belt buckle trim panel highlighted)

8. Release the clips that secure the seat belt buckle trim panel to the seat frame (Figure 5).

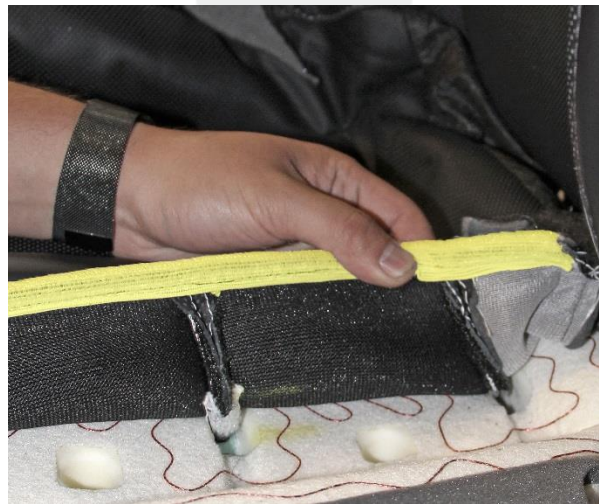
Figure 8 (Hook-and-loop material highlighted in yellow)

NOTE: The strip of hook-and-loop material is folded into a cylindrical channel. The following steps explain how to insert a retention rod inside the channel of hook-and-loop material.

1. Fold the LH edge of the seat base upholstery inboard to expose the strip of hook-and-loop material that secures the seat base upholstery to the foam cushion (Figure 8).
