Adjust Upper Rear Door Racetrack Or Hinge Cover

Classification	Campaign Bulletin	Section/Group	15 - Interior Trim	Country/Region	All
Year	2017	Model	Model X	Version	All

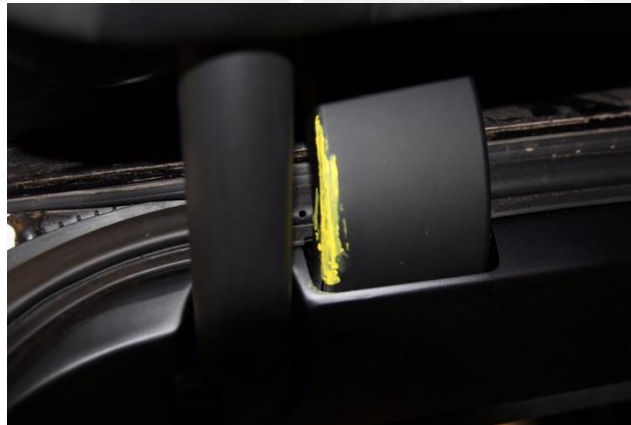
Figure 1

1. Fully open the rear door, and listen for a mechanical noise.
2. Inspect the rear hinge cover:
 - If the rear hinge cover moves when touched by hand, skip to the “Procedure” section of this document.
 - If the rear hinge cover is firmly attached to the vehicle, continue to the next step.
3. Visually inspect the rear hinge cover for evidence of contact with the upper racetrack.
 - If the rear hinge cover has visual signs of rubbing, such as witness marks, skip to the “Procedure” section of this document.
 - If the rear hinge cover does not show visual signs of damage, continue to the next step.
4. Use a tire crayon to mark the exterior edge of the rear hinge cover (Figure 1).

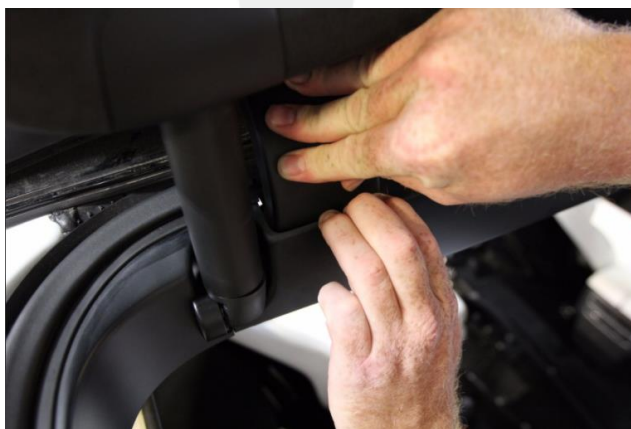
Figure 2

5. Apply pressure to the primary hinge cover and upper racetrack to encourage contact between the components (Figure 2).

6. Close the rear door, and then open it again.
7. Visually inspect the rear hinge cover for evidence of contact with the upper racetrack.
 - If the tire crayon has transferred to the racetrack or show additional signs of contact, skip to the “Procedure” section of this document.
 - If the rear hinge cover does not show signs of contact, continue to the next step.
8. Use glass cleaner to remove the tire crayon from the rear hinge cover.
9. Repeat steps 1 – 8 on the other door.

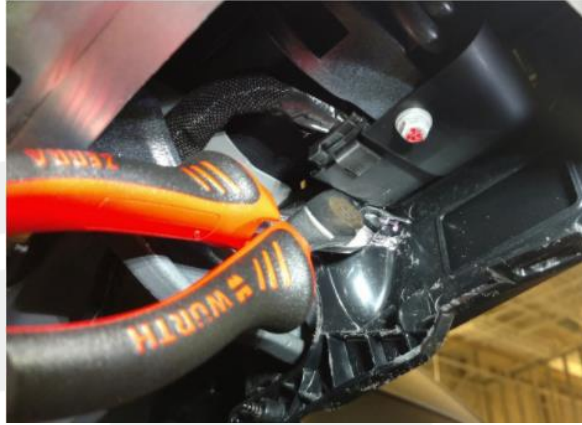
Figure 5

5. Use a diagonal cutter to remove ¼ in (6 mm) of material from the racetrack (Figure 5).

6. Close the rear door, and make sure that the mechanical noise is not present.
7. If necessary, repeat steps 1 – 7 on the other door.
8. Install any component that was removed for access.
