Replace Penthouse Bolts

Classification	Campaign Bulletin	Section/Group	16 - HV Battery System	Country/Region	United States, Canada
Year	2018	Model	Model 3	Version	All

On certain Model 3 vehicles, some bolts within the high voltage (HV) battery penthouse were insufficiently torqued to internal specifications during manufacturing.

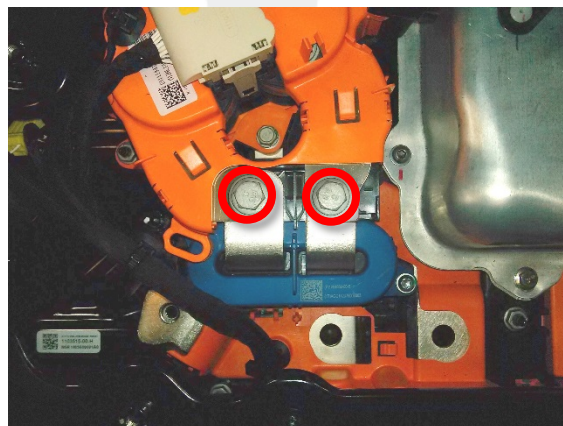
Figure 1

1. Drain the penthouse coolant (refer to Service Manual procedure 16202000).
2. Remove the HV battery negative contactor (refer to Service Manual procedure 16302002).
3. Remove the power conversion system coolant outlet tube (refer to Service Manual procedure 16202202).
4. Remove the HV battery probing guide (refer to Service Manual procedure 16303802).
5. Remove and discard the bolts that attach the HV battery fast charge contactor to the positive and negative busbars (Figure 1).

7. Install new bolts to attach the HV battery fast charge contactor to the positive and negative busbars, and then mark the bolts with a paint pen after they are torqued (torque 5 Nm +60°) (Figure 1).
8. **Dual Motor vehicles only:** Install new bolts to attach the positive and negative busbars to the front drive unit HV header, and then mark the bolts with a paint pen after they are torqued (torque 5 Nm +60°) (Figure 2).
9. Use the Hioki resistance meter to measure the resistance at the HV joint between the HV battery fast charge contactor positive output (LH side) and the positive busbar (Figure 3).

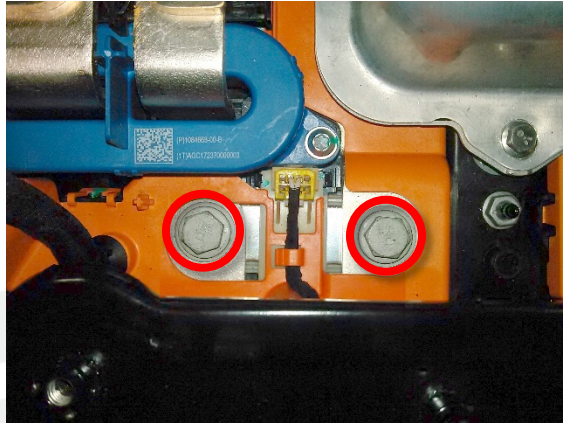
Figure 2

6. **Dual Motor vehicles only:** Remove and discard the bolts that attach the positive and negative busbars to the front drive unit HV header (Figure 2).

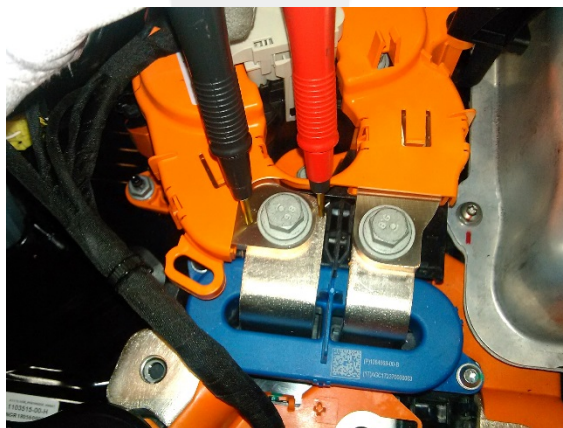
Figure 3

NOTE: The maximum acceptable resistance is 0.040 mΩ (40 μΩ). If the resistance is above this value, escalate a Toolbox session, as appropriate.

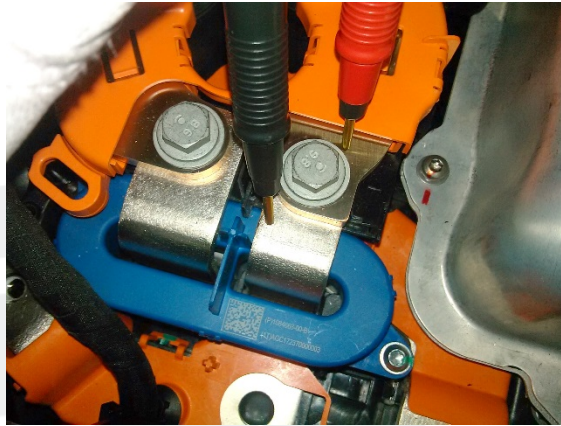
Figure 4

10. Use the Hioki resistance meter to measure the resistance at the HV joint between the HV battery fast charge contactor negative output (RH side) and the negative busbar (Figure 4).

NOTE: The maximum acceptable resistance is 0.060 mΩ (60 μΩ). If the resistance is above this value, escalate a Toolbox session, as appropriate.

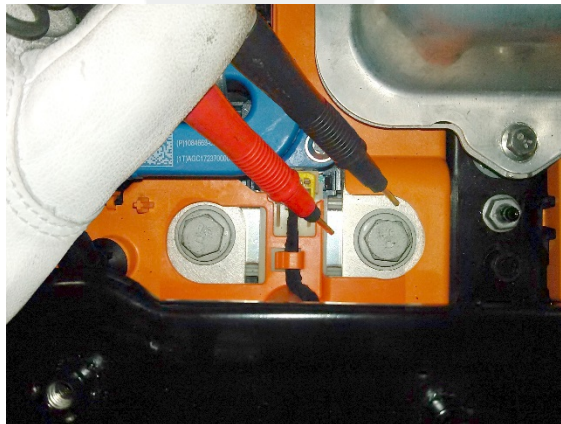
Figure 5

11. **Dual Motor vehicles only:** Use the Hioki resistance meter to measure the resistance at the HV joint between the front drive unit HV header and the busbar at each bolt (Figure 5).

NOTE: The maximum acceptable resistance is 0.070 mΩ (70 μΩ). If the resistance is above this value, escalate a Toolbox session, as appropriate.

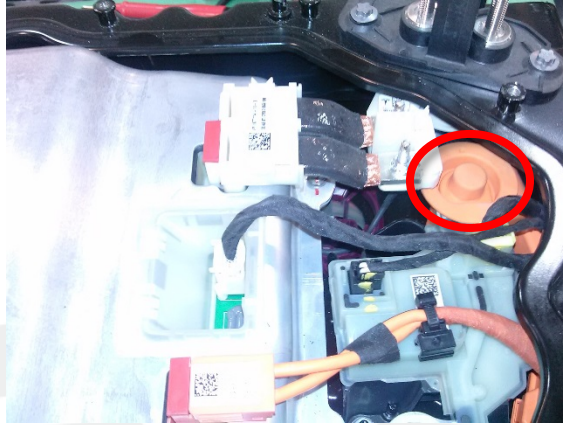
Figure 6

12. Remove the insulator cap from the HV battery positive contactor output terminal bolt (Figure 6).

16. Install the insulator cap onto the HV battery positive contactor output terminal bolt (Figure 6).
17. Raise the high voltage controller vertically, and then remove the fuse access insulator (Figure 9).

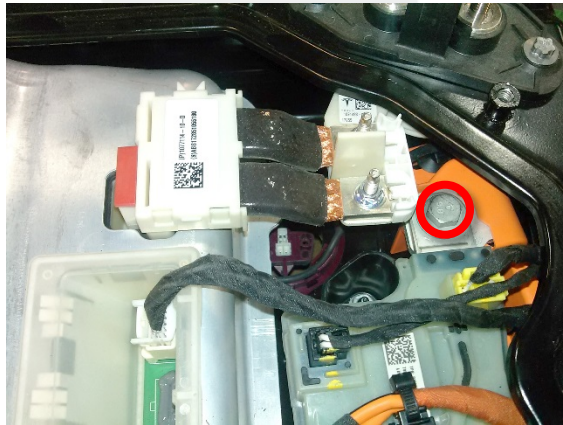
Figure 7

13. Remove and discard the bolt that attaches the HV battery positive contactor to the positive busbar (Figure 7).

14. Install a new bolt to attach the HV battery positive contactor onto the positive busbar, and then mark the bolt with a paint pen after it is torqued (torque 5 Nm +60°) (Figure 7).

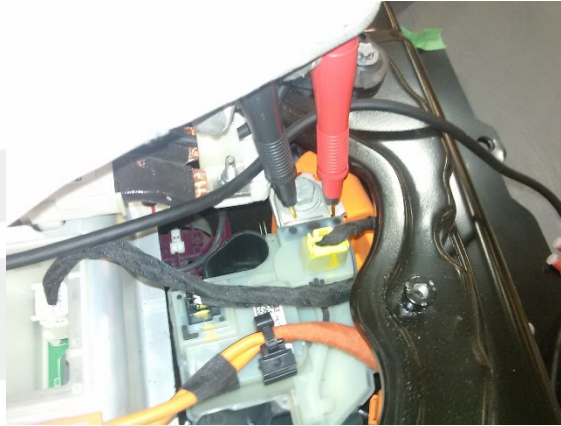
Figure 8

15. Use the Hioki resistance meter to measure the resistance at the HV joint between the HV battery positive contactor and the positive busbar (Figure 8).

NOTE: The maximum acceptable resistance is 0.060 mΩ (60 μΩ). If the resistance is above this value, escalate a Toolbox session, as appropriate.

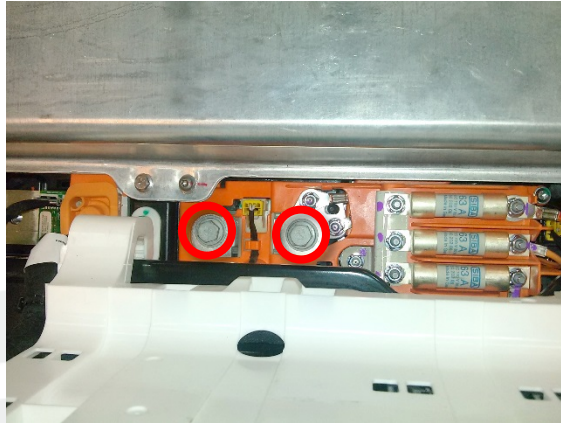
Figure 10

18. Remove and discard the bolts that attach the positive and negative busbars to the rear drive unit HV header (Figure 10).

19. Install new bolts to attach the positive and negative busbars to the rear drive unit HV header, and then mark the bolts with a paint pen after they are torqued (torque 5 Nm +60°) (Figure 10).
20. Use the Hioki resistance meter to measure the resistance at the HV joint between the rear drive unit HV header and the busbar at each bolt (Figure 11).
