Tesla, Inc. Service Bulletin		<i>Replace Bolts in the Steering Rack Housing</i>	
SB-18-32-002 June 4, 2021		R6			
Classification		Section/Group		Mobile Service	
Recall Bulletin		32 - Steering		Cannot Perform	
Model Year	Model	Country/Region		Version	
2012 - 2016	Model S	All		All	
The model(s) and model year(s) listed are a general approximation of the affected VIN list. Refer to the VIN/Bulletin Tracker or Customer/Vehicle profile to determine applicability of this bulletin for a particular vehicle.

Condition

Long-term exposure to high-corrosion environments might weaken the bolts that attach the power steering motor to the steering rack housing.

Replace the bolts (x5) that attach the steering rack housing to the power steering motor and apply wax sealant.

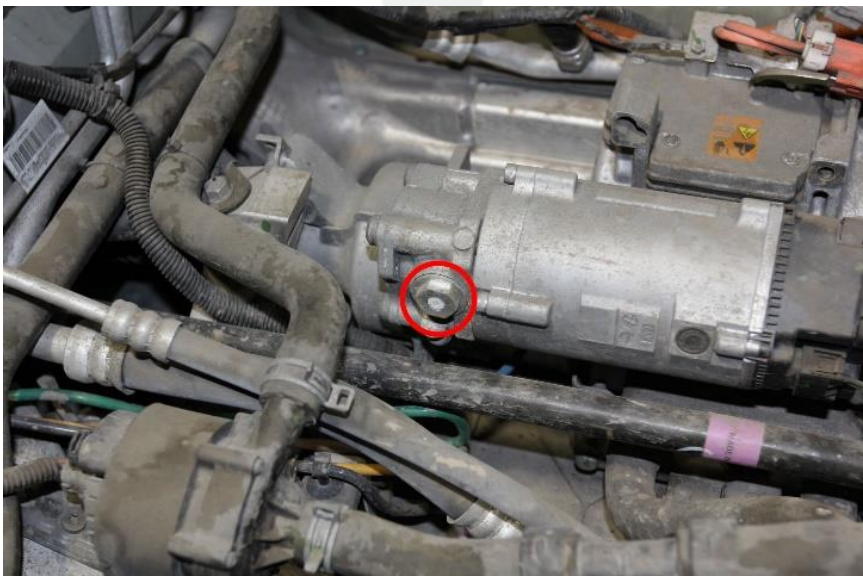
Figure 3

3. Visually inspect the valve body on the steering rack housing, if equipped (Figure 3).

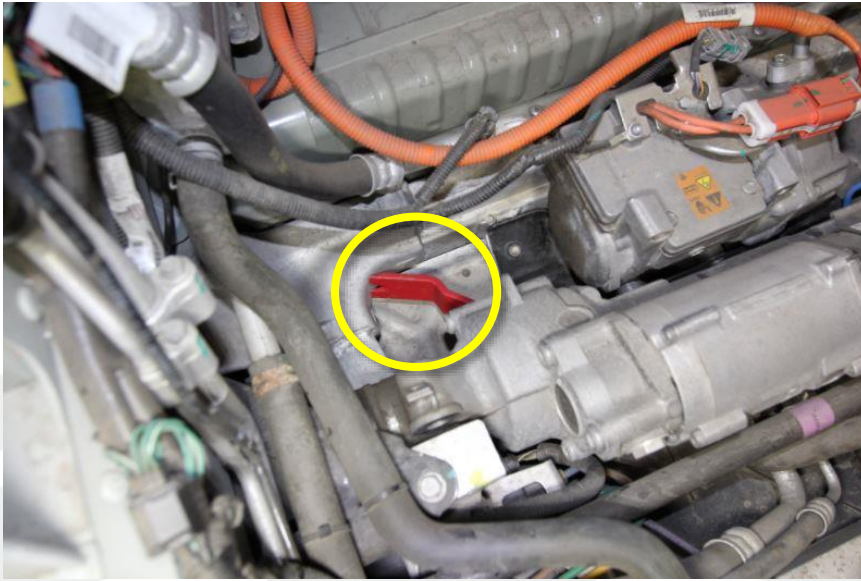
Figure 3

- To access the steering rack without damaging components, use a plastic trim tool, block, or similar spacer as needed between the steering rack and the front subframe to raise and support the RH side of the steering rack (Figure 3).

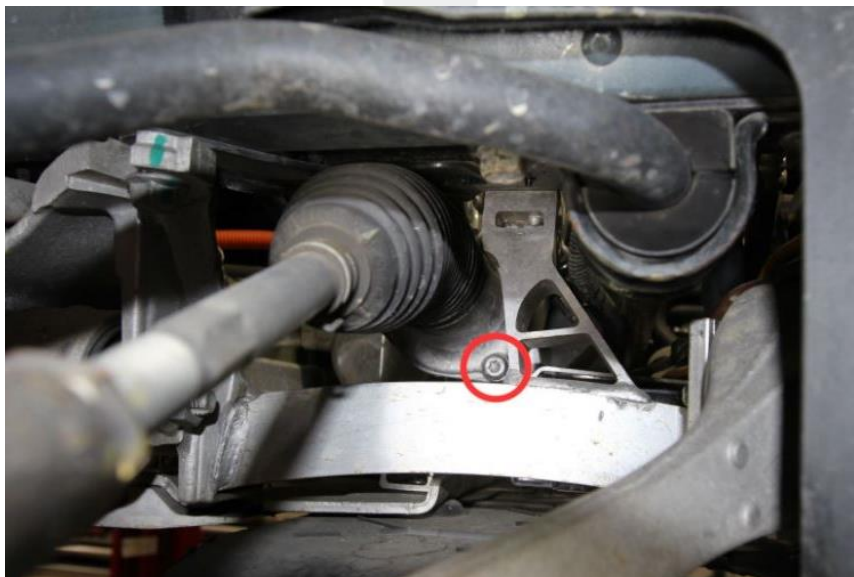
Figure 7

- Clean the area around steering rack housing bolt 4 with a shop towel, and then clean debris away with compressed air (Figure 7).

12. Inspect steering rack housing bolt 4 (Figure 7).

13. Remove steering rack housing bolt 4 (Figure 7).

15. Install a new steering rack housing bolt in location 4 (Figure 7).

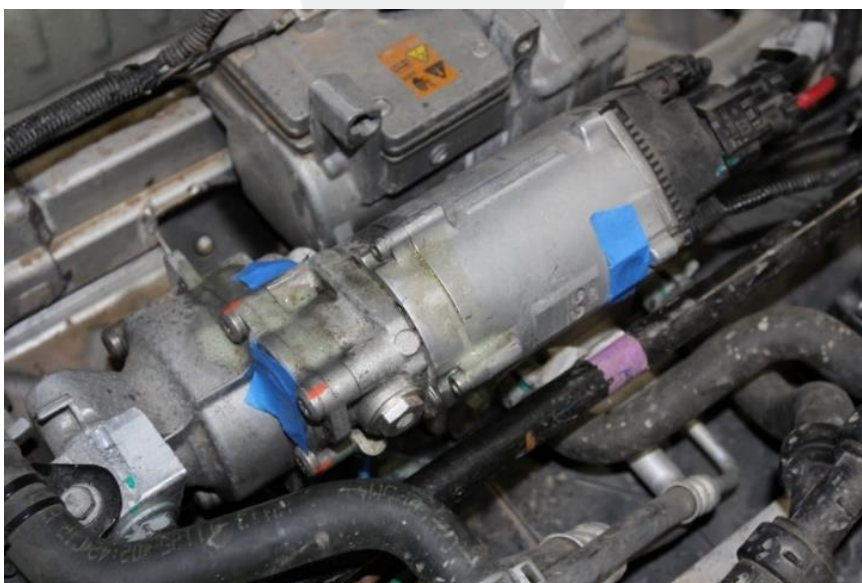
Figure 14

36. Apply masking tape to cover the sealing plugs (x3) on the steering rack (Figure 14).

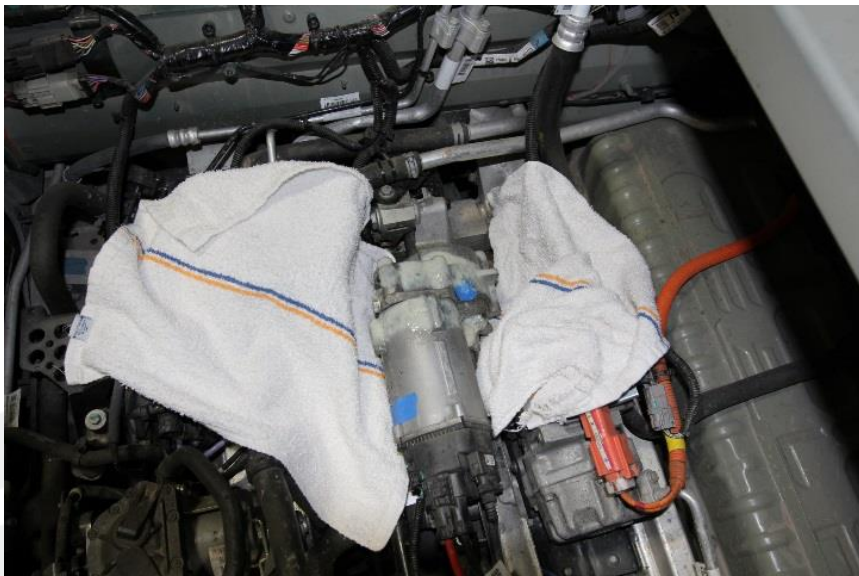
Figure 15

37. Cover the components near the steering rack with shop towels to protect from drips during wax sealant application (Figure 15).

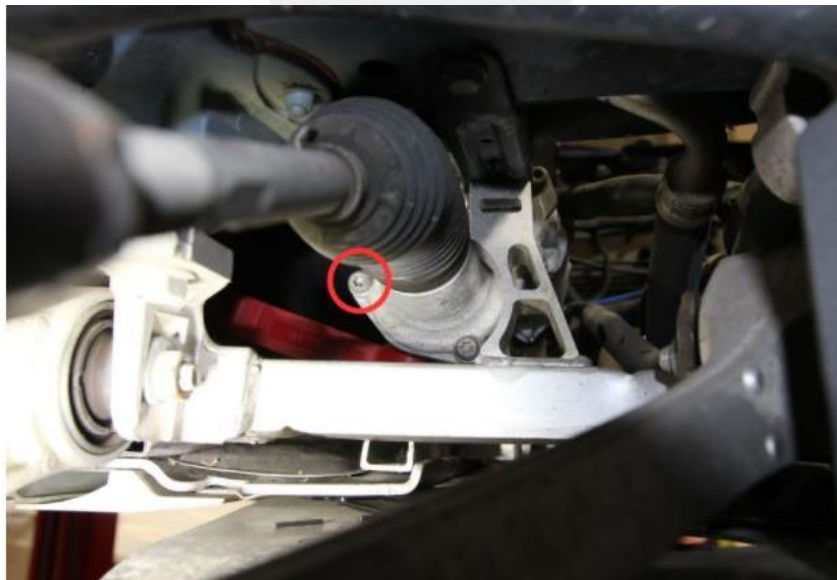
Figure 17

- Access steering rack housing bolt 5 from the RH wheel well (Figure 17).

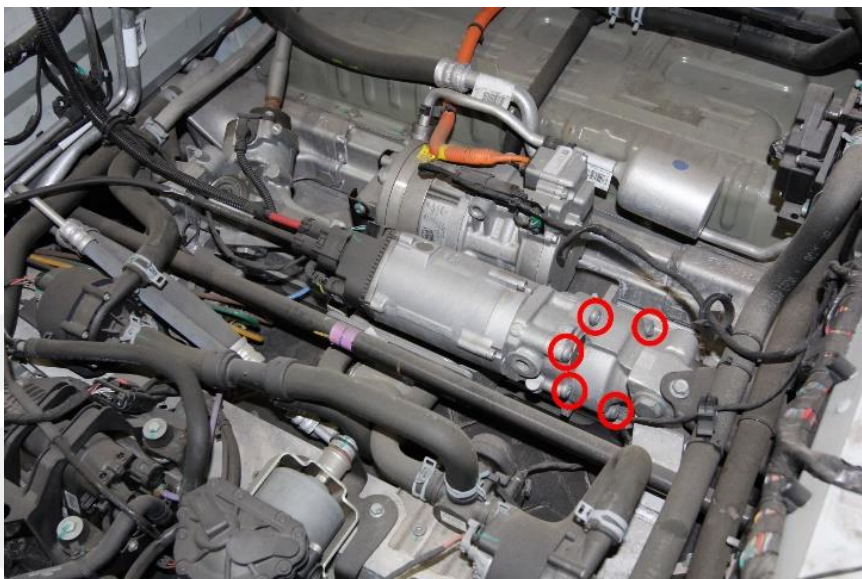
Figure 18

2. Visually inspect all 5 steering rack housing bolts (steering gear to steering gear motor) (Figure 18):
 - If any bolts are damaged or broken, discontinue this procedure and replace the steering rack (refer to Service Manual procedure [32012602](#)).
 - If all 5 bolts appear to be present and undamaged, continue to the next step.

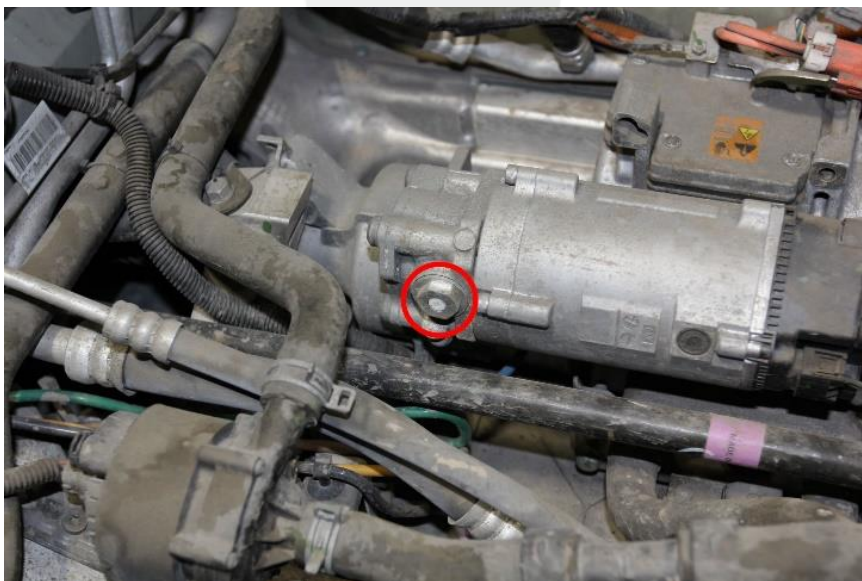
Figure 19

3. Visually inspect the valve body on the steering rack housing, if equipped (Figure 19).

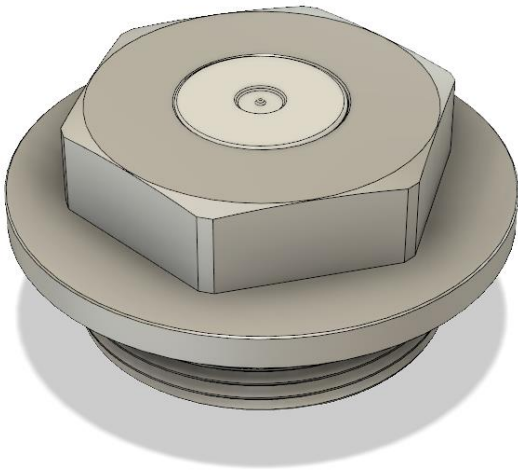
✓ Figure 19

⚠ CAUTION: The center valve plunger should be flush to the valve body (Figure 19). If the center valve plunger is not flush with the valve body (Figure 20), it has been in contact with water and the steering gear must be replaced (refer to Service Manual procedure [32012602](#)).

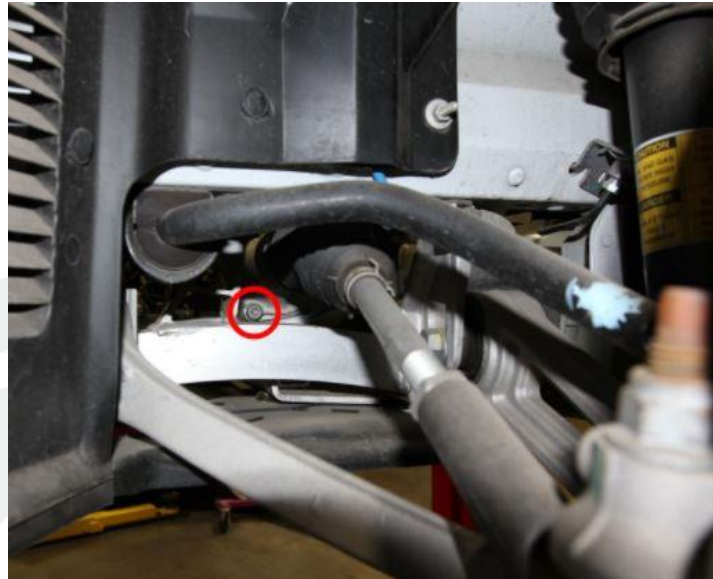
Figure 23

12. Clean the area around steering rack housing bolt 4 with a shop towel, and then clean debris away with compressed air (Figure 23).

13. Inspect steering rack housing bolt 4 (Figure 23).

14. Remove steering rack housing bolt 4 (Figure 23).

16. Install a new steering rack housing bolt in location 4 (Figure 23).

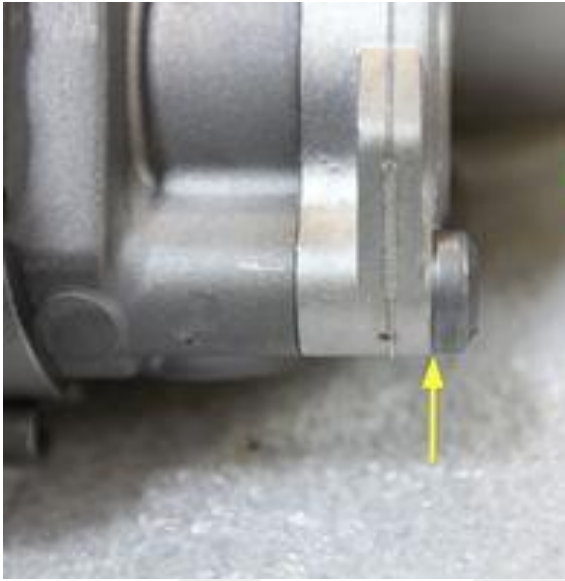
✓ Figure 24

17. Tighten the bolt to 5 Nm (+/- 0.5 Nm). Inspect the bolt to make sure it is fully seated against the steering rack housing (Figure 24) before applying a 90-degree angle torque. If the bolt does not seat properly (Figure 25), remove the bolt, inspect the hole on the steering gear to make sure there is no debris or damage causing the bolt not to fully seat, then reinstall the bolt and torque to 5 Nm (+/- 0.5 Nm).

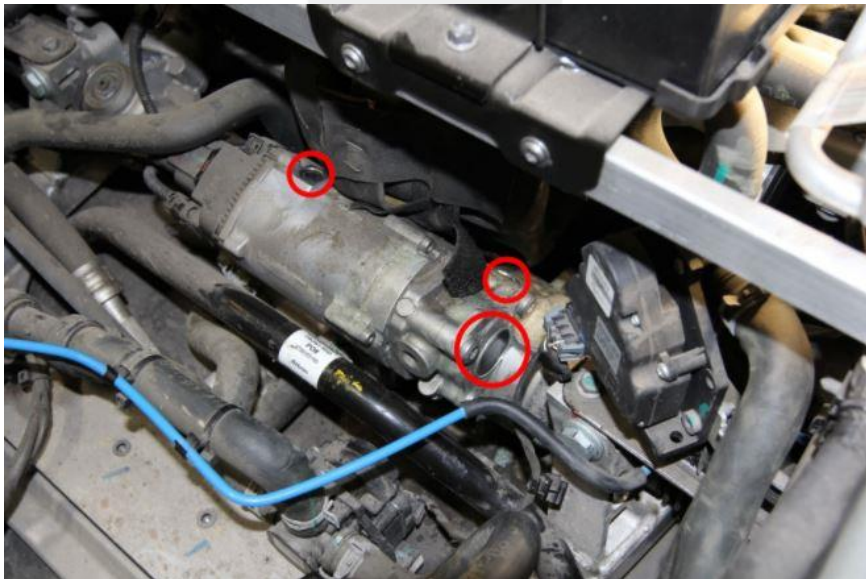
Figure 29

37. Using isopropyl alcohol (IPA) wipes, clean the sealing plugs (x3) on the steering gear (Figure 29). Allow the area to dry for at least 1 minute.

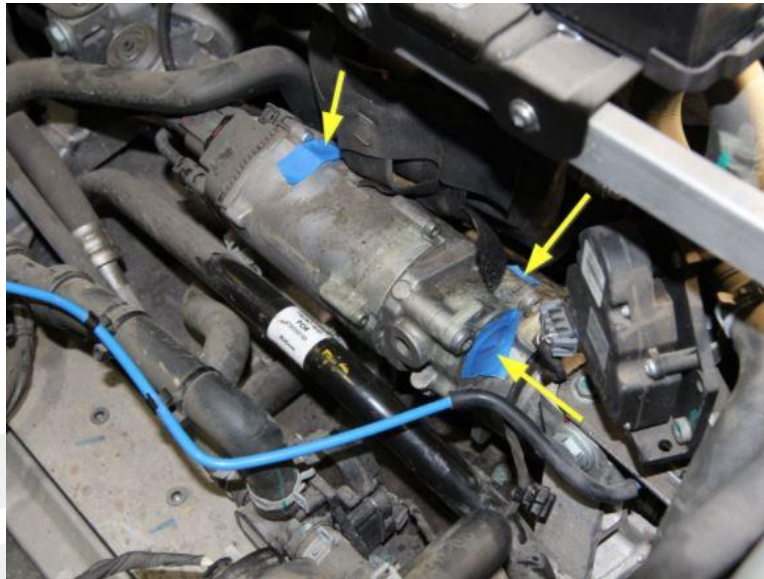
Figure 30

38. Apply masking tape to cover the sealing plugs (x3) on the steering rack (Figure 30).

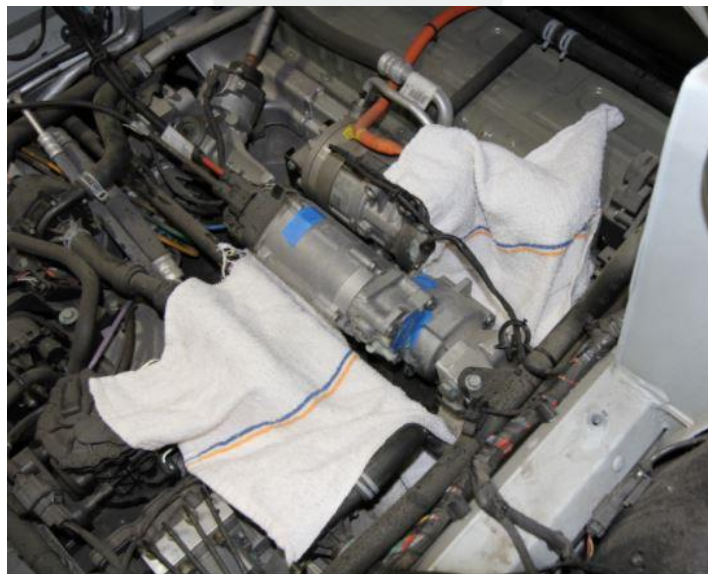
Figure 31

39. Cover the components near the steering rack with shop towels to protect from drips during wax sealant application (Figure 31).

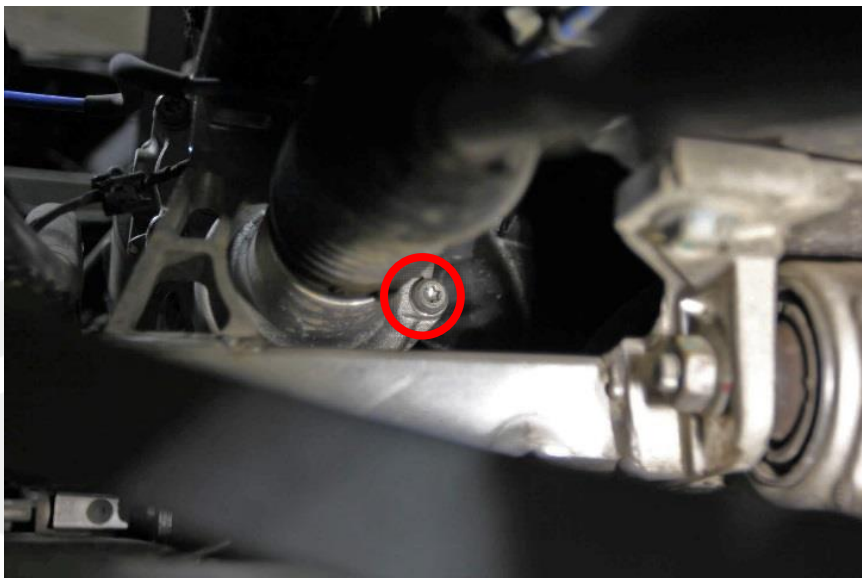
Figure 33

- Access steering rack housing bolt 5 from the LH wheel well (Figure 33).
