Replace Charge Port Pin Deadfronts

Classification	Campaign Bulletin	Section/Group	44 - High Voltage System	Country/Region	United States, Canada
Year	All	Model	Model 3	Version	All

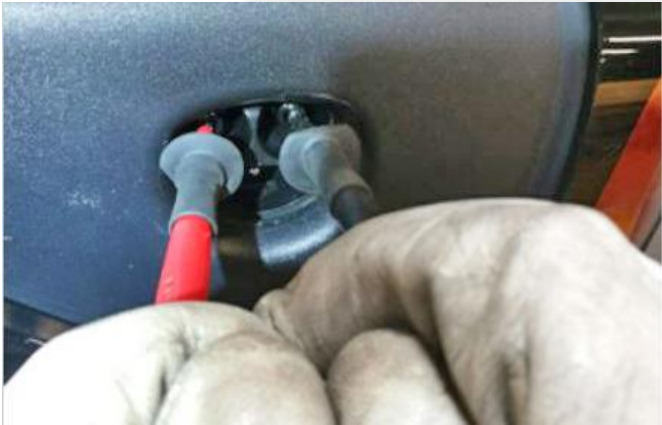
Figure 1

- Charge port terminals B+ and B- (Figure 1)
- Charge port terminal B+ and ground (Figure 2)
- Charge port terminal B- and ground (Figure 3)

6. Measure the voltages at the charge port terminals:

⚠ WARNING: If the voltage measured is greater than 10V, at least one of the HV battery fast charge contactors are closed or welded. Stop this procedure and escalate a Toolbox session, as appropriate.

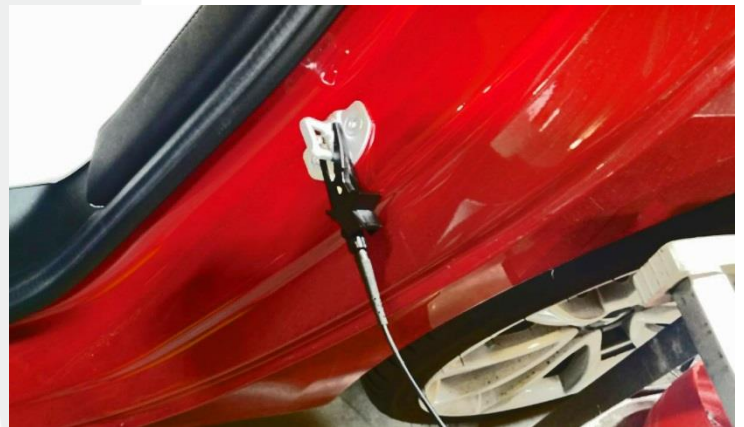
Figure 4

NOTE: Clip the multimeter ground connector to the LH rear door latch striker when measuring the voltage between the charge port terminals and ground (Figure 4).

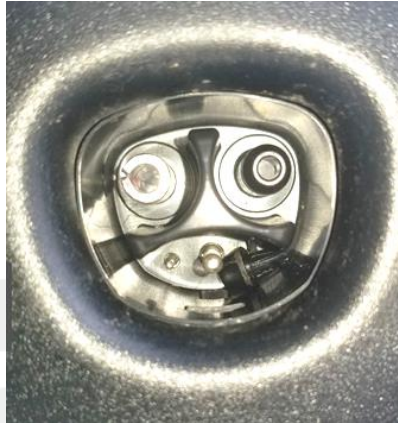
On certain Model 3 vehicles, the charge port power terminals have pin deadfronts that might become dislodged from the terminals, causing the charge handle to not fully connect to the vehicle and therefore preventing the High Voltage (HV) battery from charging.

Figure 5 (Dislodged pin deadfront at lower right)

7. Inspect the charge port for any broken or dislodged pin deadfronts and remove them with needle nose pliers (Figure 5).
