Tesla, Inc. Service Bulletin		<h2>Reroute Front Passenger Buckle Electrical Harness</h2>	
SB-20-17-003 February 26, 2020			
Classification		Section/Group	Mobile Service
Campaign Bulletin		17 - Electrical	Can Perform (where permitted)
Model Year	Model	Country/Region	Version
2019 - 2020	Model 3	China	Giga Shanghai
<small>The model(s) and model year(s) listed are a general approximation of the affected VIN list. Refer to the VIN/Bulletin Tracker or Customer/Vehicle profile to determine applicability of this bulletin for a particular vehicle.</small>

On certain Model 3 vehicles built at Giga Shanghai, the front passenger buckle electrical harness might be damaged due to improper routing.

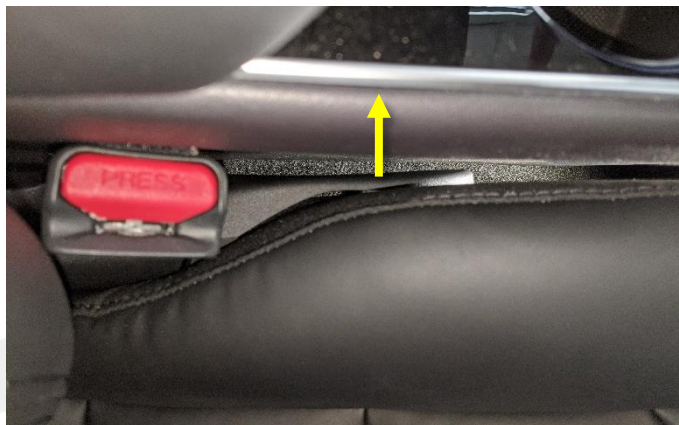
Figure 1

- a. Release the front clip that attaches the inboard side shield to the front passenger seat inner seat rail (Figure 1).

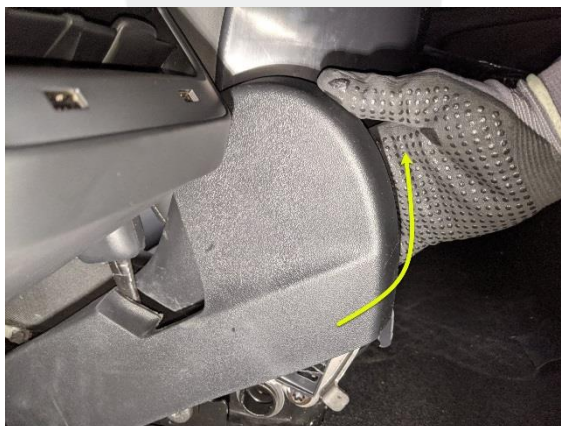
Figure 2

- b. Release the rear portion of the inboard side shield from the inner seat rail, and then rotate the shield upwards (Figure 2).

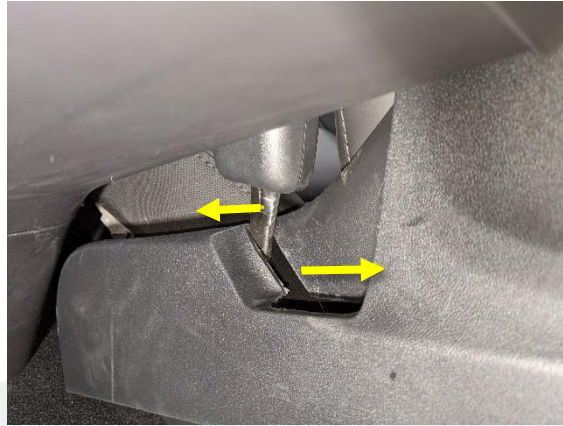
Figure 3

- c. Pass the buckle out through the slot of the inboard side shield, and then remove the inboard side shield from the vehicle (Figure 3).

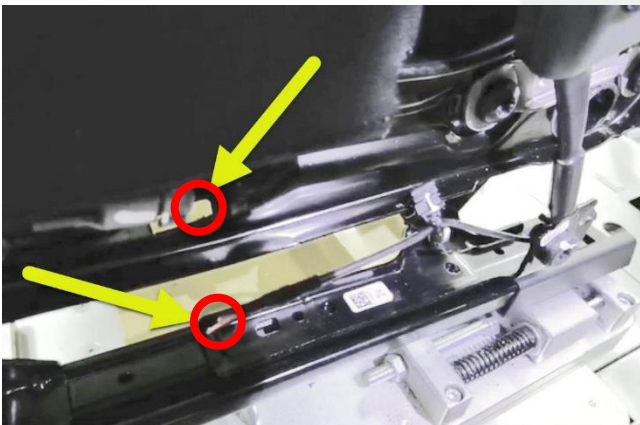
✗ Figure 4 – Buckle electrical harness separated from connector

- If the electrical harness is damaged (Figure 4), replace the buckle (refer to Service Manual procedure 20054702), and then continue to step 6b.
- If the electrical harness is undamaged (Figure 5), continue to the next step.

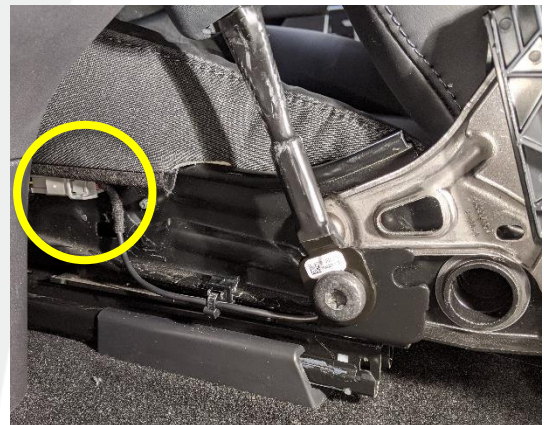
✓ Figure 5 – Buckle electrical harness attached to connector

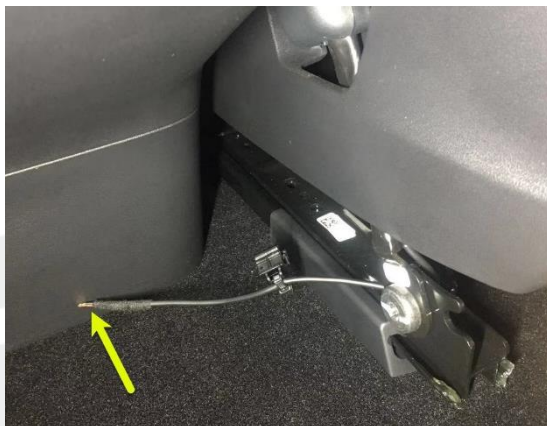
Figure 6

5. Inspect the front passenger buckle electrical harness for damage while raising the front passenger seat to the highest position:
 - If the electrical harness is damaged (Figure 6), replace the buckle (refer to Service Manual procedure 20054702), and then continue to step 6b.
 - If the electrical harness is undamaged, continue to the next step.

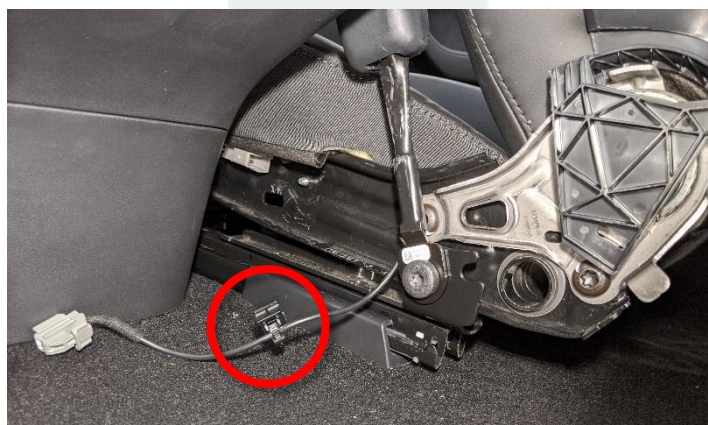
Figure 7

6. Reroute the front passenger buckle electrical harness:
 - a. Release the clip that attaches the front passenger buckle electrical harness to the inner seat rail (Figure 7).

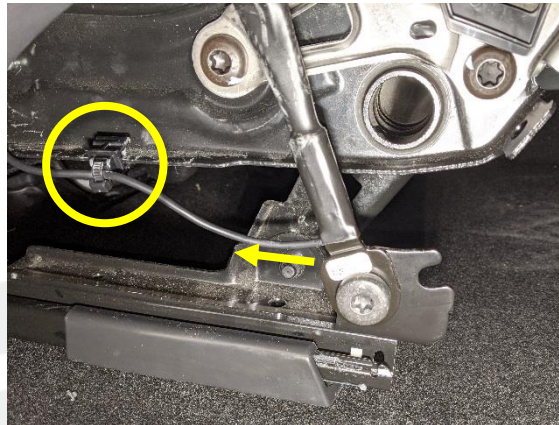
Figure 8

- b. If the harness is secured to the seat with tape, remove and discard the tape.
- c. Remove the excess slack within the harness, and then reattach the clip so that there is a small amount of slack with the harness as shown in Figure 8.

NOTE: Reattach the clip as far toward of the seat as possible without causing strain on the harness.

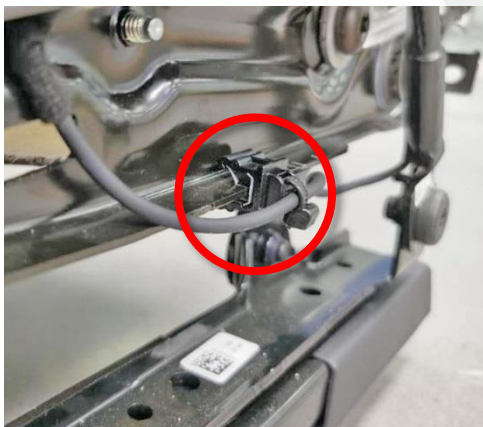
✓ **Figure 9**

NOTE: Make sure that the clip is fully attached to the inner seat rail (Figure 9) and not at an angle (Figure 10).

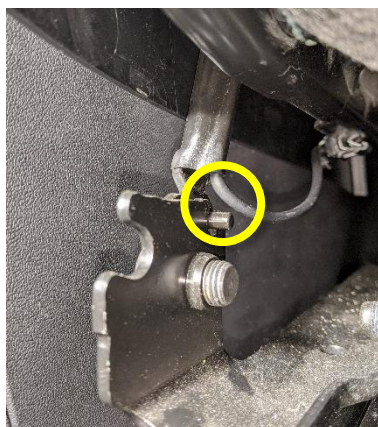
- d. Make sure that the harness is routed in front of the seat recliner bolt and the alignment pin (Figure 11), and not around it (Figure 12).

✓ **Figure 11 – Harness in front of the seat recliner bolt and alignment pin**

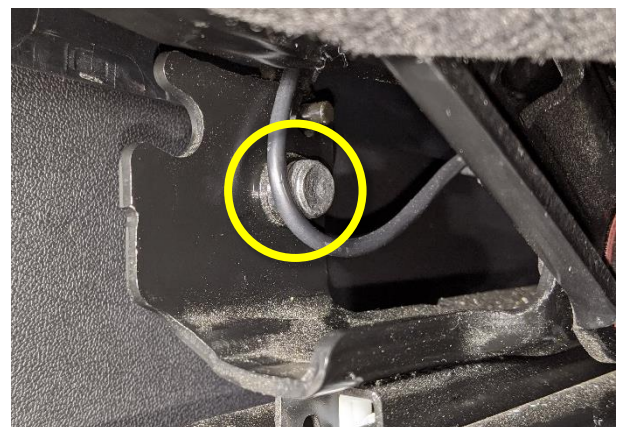
✗ **Figure 12 – Harness around the seat recliner bolt**

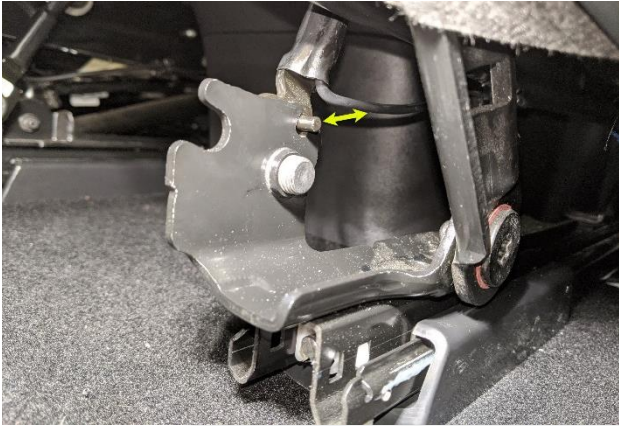
Figure 13

- e. Verify that the harness does not catch on anything while cycling the seat from the lowest position to the highest position (Figure 13), and readjust the harness clip as needed (Figure 14).

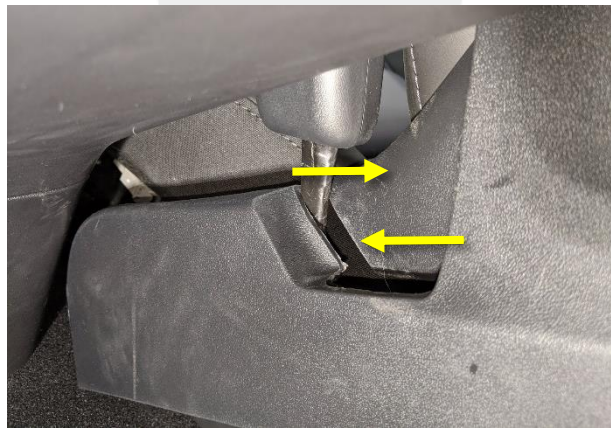
Figure 15

- 7. Move the front passenger seat to the lowest and rearmost position.
- 8. Install inboard side shield onto front passenger seat:
 - a. Pass the seat belt buckle in through the inboard side shield (Figure 15).

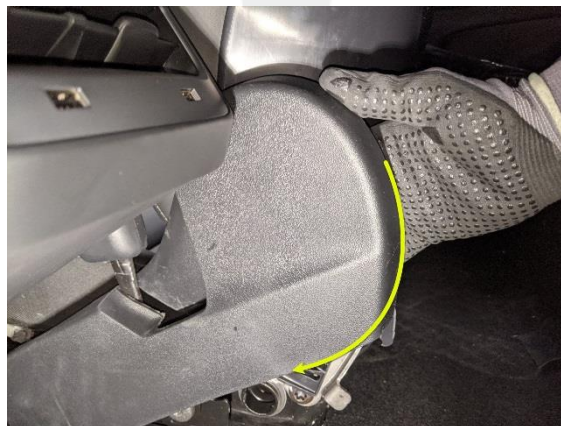
Figure 16

- b. Rotate the inboard side shield down into position, and then fasten the rear portion to the inner seat rail (Figure 16).

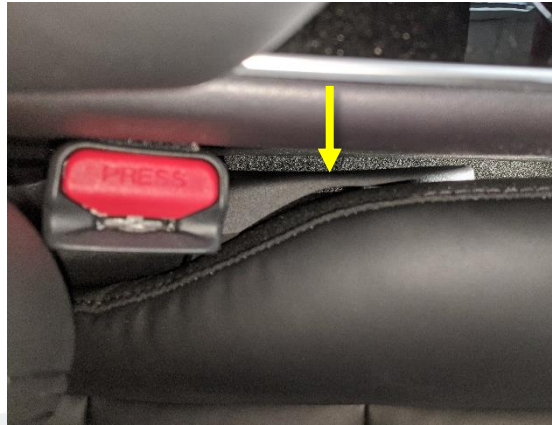
Figure 17

- c. Fasten the front clip that attaches the inboard side shield to the front passenger inner seat rail (Figure 17).
