<b>Tesla, Inc.</b> Service Bulletin		<h2>Replace Steering Rack Housing Bolts, Model X</h2>	
<b>SB-20-32-002</b> October 26, 2021		<b>R2</b>	
<b>Classification</b> Recall Bulletin		<b>Section/Group</b> 32 - Steering	<b>Mobile Service</b> Cannot Perform
<b>Model Year</b> 2015 - 2016	<b>Model</b> Model X	<b>Country/Region</b> All	<b>Version</b> Left Hand Drive (LHD)
<small>The model(s) and model year(s) listed are a general approximation of the affected VIN list. Refer to the VIN/Bulletin Tracker or Customer/Vehicle profile to determine applicability of this bulletin for a particular vehicle.</small>

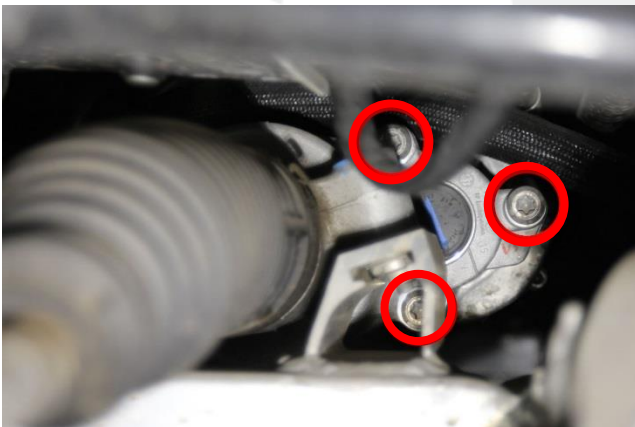
Figure 1 – Steering rack housing bolts 1, 2, and 3

1. Raise and support the vehicle on a 2-post lift (refer to Service Manual procedure [10000205](#)).
2. Remove the RH front wheel (refer to Service Manual procedure [34015001](#)).
3. Inspect all 5 steering rack housing bolts (steering gear to steering gear motor) (Figures 1 – 4):
  - If any bolts are damaged or broken, discontinue this procedure and replace the steering rack (refer to Service Manual procedure [32010102](#)).
  - If all 5 bolts are present and undamaged, continue to the next step.

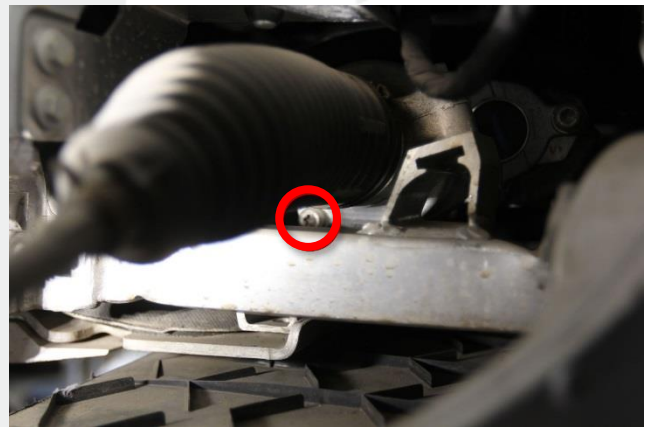
Figure 2 – Steering rack housing bolt 4

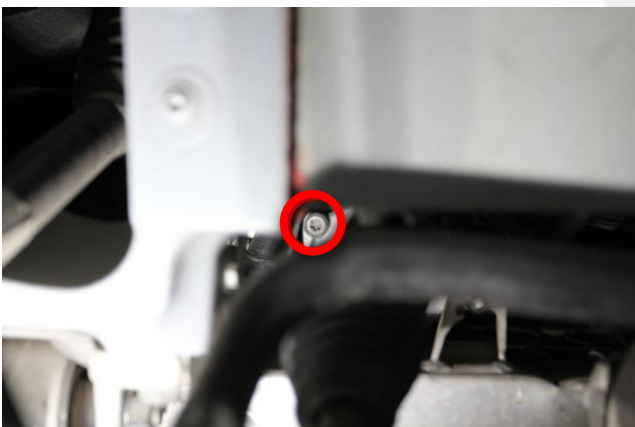
Figure 3 – Steering rack housing bolt 5

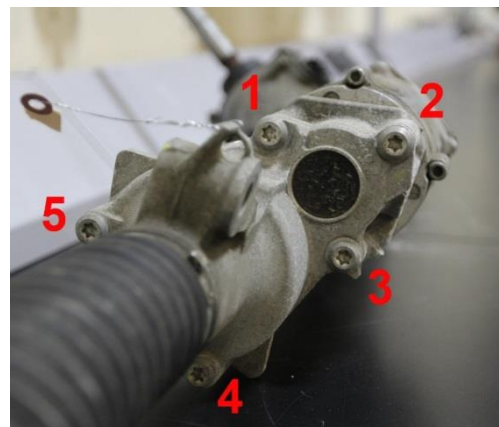
Figure 4 – Identification of all steering rack housing bolts (steering rack removed from vehicle)

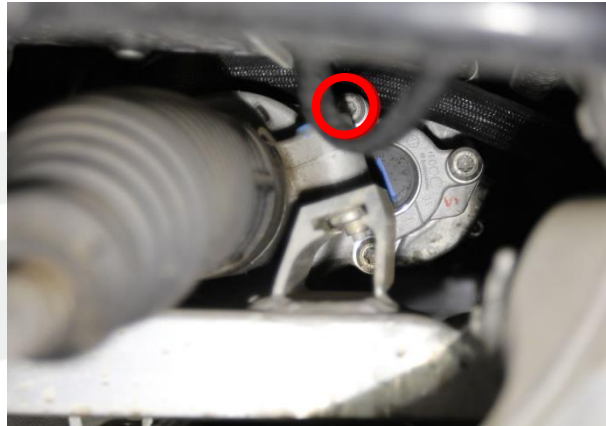
**Figure 8 – Steering rack housing bolt 1**

6. Remove and discard steering rack housing bolt 1 (Figure 8).

8. Install a new steering rack housing bolt 1 (torque 5 Nm) (Figure 8).
9. Inspect the bolt to make sure it is fully seated against the steering rack housing (Figure 9) before applying a 90-degree angle torque. If the bolt does not seat properly (Figure 10), remove the bolt and inspect the hole on the steering rack to make sure there is no debris or damage preventing the bolt from fully seating.

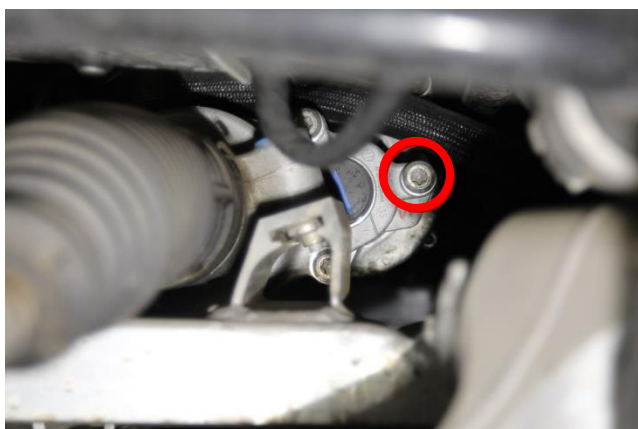
Figure 11 – Steering rack housing bolt 2

11. Repeat steps 6 – 10 for each of the remaining steering rack housing bolts 2, 3, 4, and 5 (Figures 11 - 14).

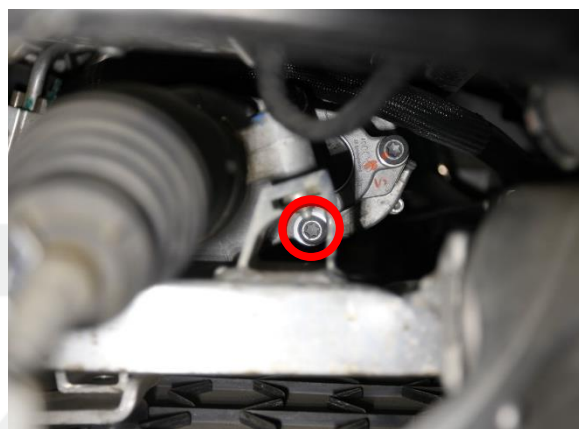
Figure 12 – Steering rack housing bolt 3

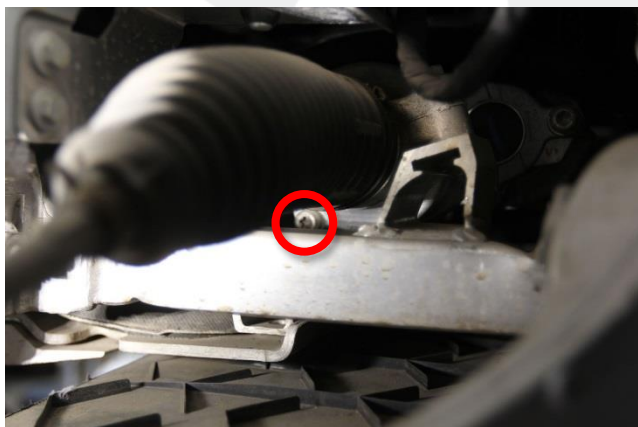
Figure 13 – Steering rack housing bolt 4

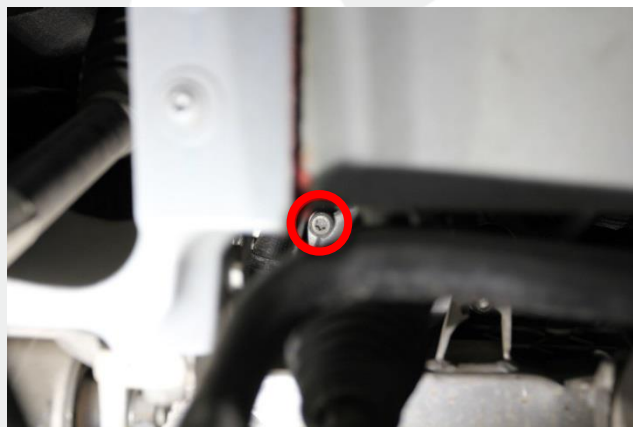
Figure 14 – Steering rack housing bolt 5

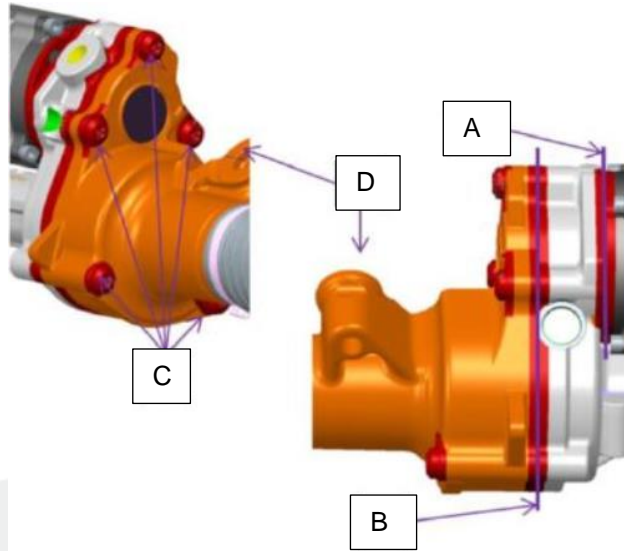
**Figure 22**

- A. The entire seam at the interface of the steering rack housing and the motor
- B. The entire seam at the interface of the steering rack housing and the gear cover
- C. All 5 bolt heads
- D. The open screw thread bore

20. Apply the wax sealant to the steering rack housing bolts and steering rack housing seams (Figures 20 and 21). Make sure to apply wax sealant to the underside of the steering rack, as well as the motor housing. Completely cover the following areas with the wax sealant (Figure 22):
