Tesla, Inc. Service Bulletin	<i>Inspect HV Battery Positive Thermal Coefficient Heater and A/C Compressor Connector</i>	
SB-20-44-003 October 19, 2020				
Classification		Section/Group	Mobile Service	
Campaign Bulletin		44 - High Voltage System	Cannot Perform	
Model Year	Model	Country/Region	Version	
2019 - 2020	Model 3	China	Giga Shanghai	
The model(s) and model year(s) listed are a general approximation of the affected VIN list. Refer to the VIN/Bulletin Tracker or Customer/Vehicle profile to determine applicability of this bulletin for a particular vehicle.

On certain Giga Shanghai-built Model 3 vehicles, the HV battery positive thermal coefficient (PTC) heater and A/C compressor connector may not be fully latched.

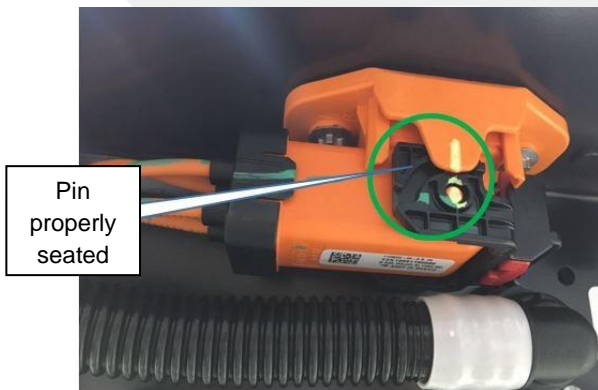
✓ Figure 1

1. Support and slightly raise the vehicle (refer to Service Manual procedure [10000205](#)).
2. Disconnect 12V power (refer to Service Manual procedure [17010200](#)).
3. Perform vehicle electrical isolation procedure (refer to Service Manual procedure [17010000](#)).
4. Remove the mid aero shield panel (refer to Service Manual procedure [12030502](#)).
5. Remove the rear HV battery skid plate (refer to Service Manual procedure [16102202](#)).
6. Visually inspect the HV battery PTC heater and A/C compressor connector to confirm the retention pin is properly seated in the handle on both sides of the connector (Figures 1 and 2).

- If the pin is not properly seated in the handle on either side of the connector, skip to step 8.
- If the pin is properly seated in the handle on both sides of the connector, continue to the next step.

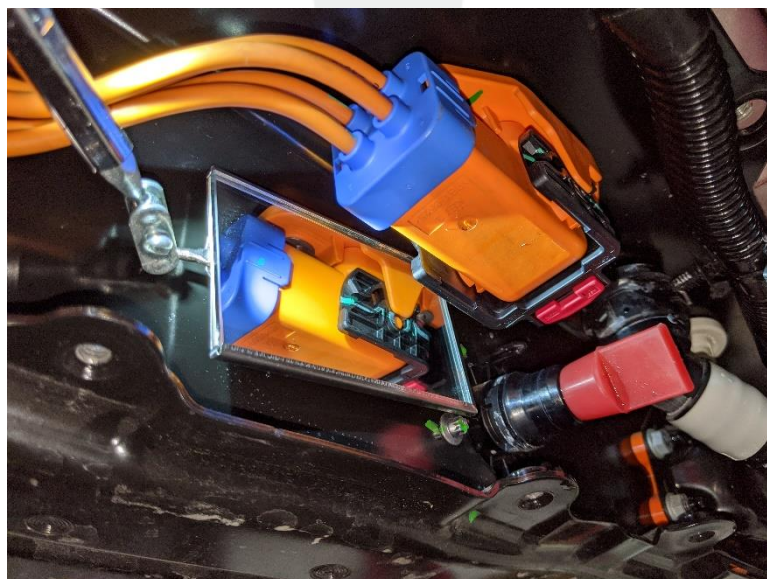
Figure 3

**NOTE:** Use a rectangular inspection mirror and a flashlight to confirm the inside retention pin is properly seated in the handle (Figure 3).

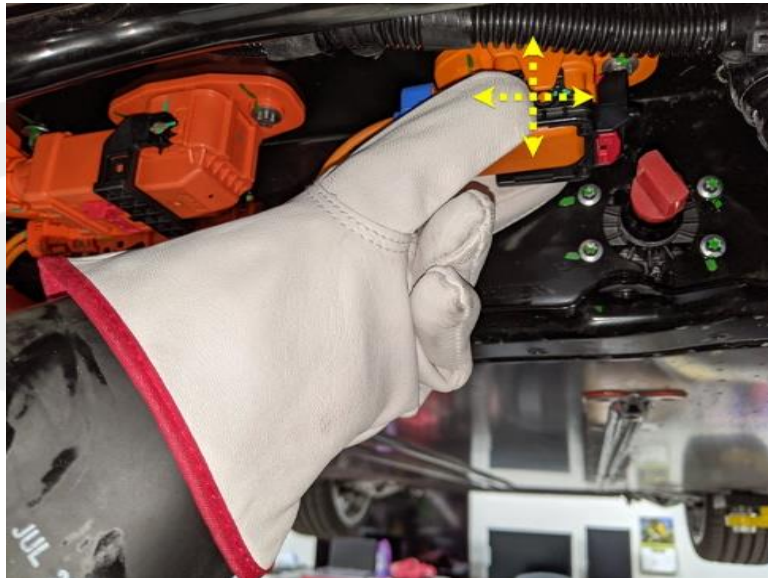
Figure 4

7. Physically inspect the HV battery PTC heater and A/C compressor connector to verify a secure connection (Figure 4).

📄 NOTE: Gently wiggle the connector in all directions to check for looseness.

- If the connector is secure, no repairs are needed. Install all parts that were removed for access, and then discontinue this procedure.
- If the connector is loose, continue to the next step.

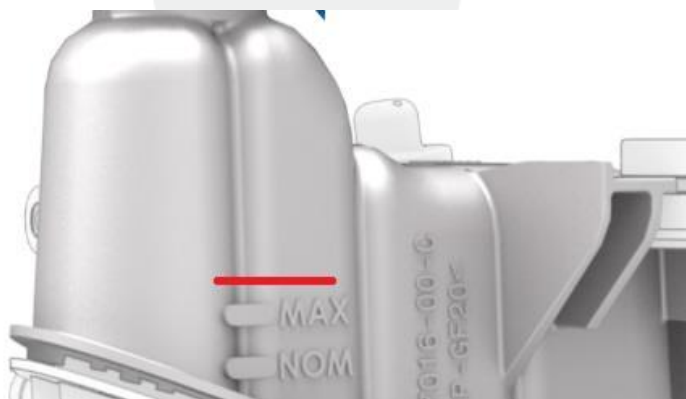
Figure 16 – Fill coolant to 5 mm above “Max” line

25. Fill with coolant so that the fluid level is 5mm above the “Max” line (Figure 16).
