Tesla, Inc. Service Bulletin		<h2><i>Inspect Curtain Airbags</i></h2>	
SB-21-20-006 October 26, 2021			
Classification		Section/Group	Mobile Service
Recall Bulletin		20 - Safety and Restraint	Can Perform (where permitted)
Model Year	Model	Country/Region	Version
2020 - 2021	Model 3	Denmark, Germany, Norway, South Korea, United Kingdom, United States	All
<small>The model(s) and model year(s) listed are a general approximation of the affected VIN list. Refer to the VIN/Bulletin Tracker or Customer/Vehicle profile to determine applicability of this bulletin for a particular vehicle.</small>

On certain Model 3 vehicles, the LH and/or RH curtain side airbag(s) may have been improperly secured to the interior rail roof during installation.

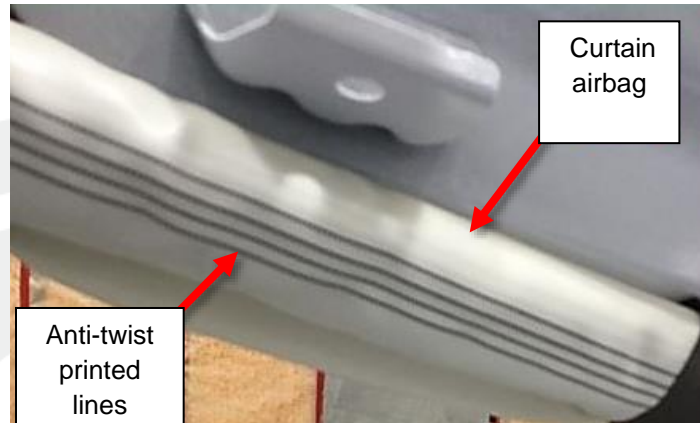
1. Remove the headliner (refer to Service Manual procedure [15203101](#) or [15203111](#)).
2. Inspect the anti-twist printed lines (Figure 1) along the entire LH curtain airbag, from the bottom of the A-pillar (Figure 2) to the end of the C-pillar (Figure 3). Make sure that the printed lines are parallel and facing the interior cabin.
 - If the printed lines are parallel and facing the interior cabin (Figures 1, 2, and 3), skip to step 5.
 - If the printed lines are twisted (not parallel) (Figures 4 and 5), continue to step 3.

Figure 1 – LH curtain airbag; RH similar

5. Inspect the anti-twist printed lines (Figure 1) along the entire RH curtain airbag, from the bottom of the A-pillar (Figure 2) to the end of the C-pillar (Figure 3). Make sure that the printed lines are parallel and facing the interior cabin.
 - If the printed lines are parallel and facing the interior cabin (Figures 1, 2, and 3), no further action is necessary. Continue to step 6.
 - If the printed lines are twisted (not parallel) (Figures 4 and 5), perform steps 3 and 4 for the RH curtain airbag, and then continue to step 6.
6. Install the LH and/or RH curtain airbag(s), if removed (refer to Service Manual procedure [20012002](#)).
7. Install the headliner (refer to Service Manual procedure [15203101](#) or [15203111](#)).

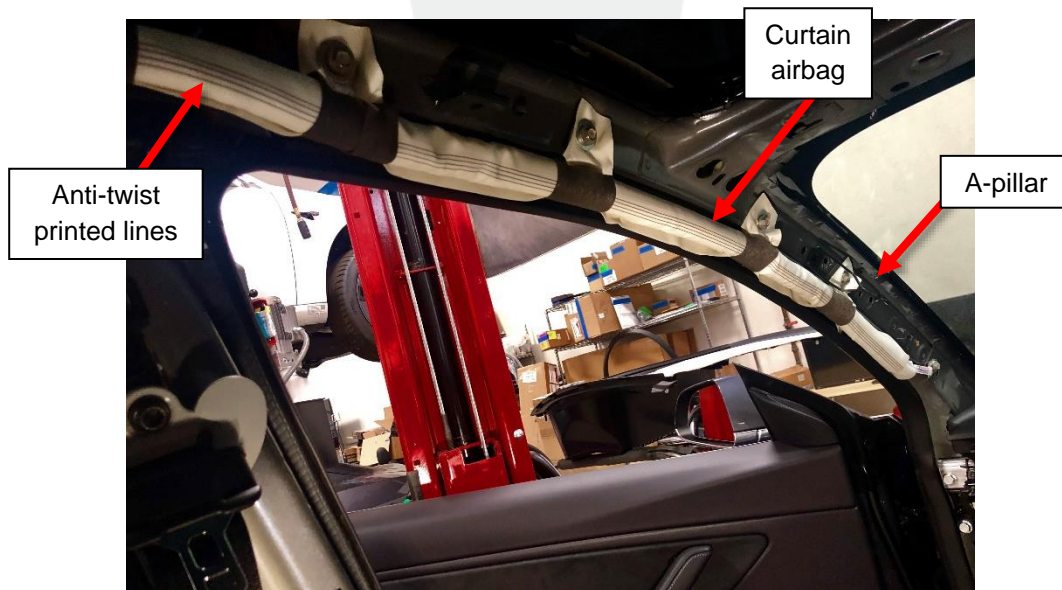
✓ Figure 2 – LH curtain airbag, front view; RH similar

3. Remove the LH curtain airbag (refer to Service Manual procedure [20012002](#)).
4. Adjust the curtain airbag so that the anti-twist printed lines are parallel (Figures 2 and 3), and then continue to step 5

NOTE: Make sure the anti-twist printed lines are lined up correctly as shown (Figures 2 and 3).

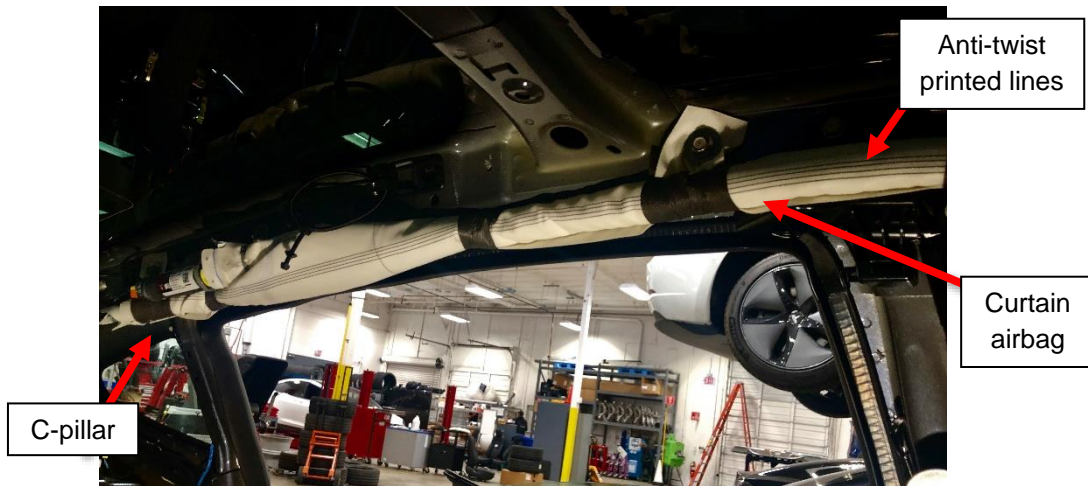
✓ **Figure 3 – LH curtain airbag, rear view; RH similar**

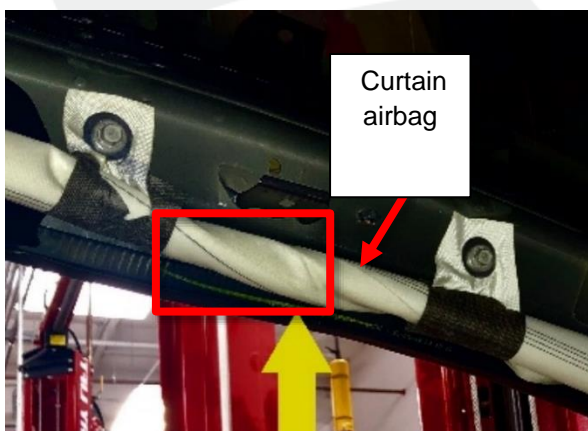
✗ **Figure 4 – Twisted curtain airbag; LH shown, RH similar**

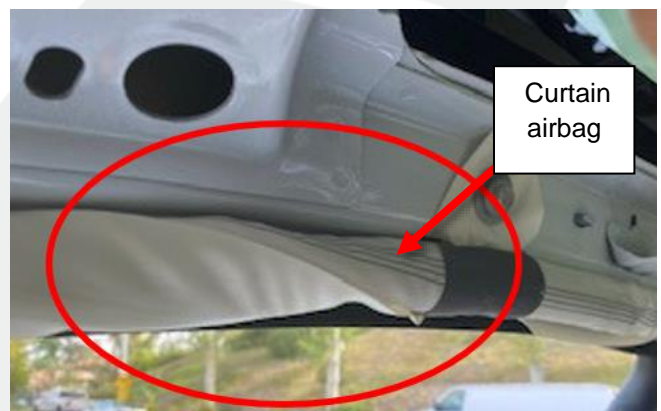
✗ **Figure 5 – Twisted curtain airbag; LH shown, RH similar**
