Tesla, Inc. Service Bulletin		<h2>Retrofit EPB Wires with Corrugated Tubing</h2>	
SB-22-17-003 March 18, 2022			
Classification		Section/Group	Mobile Service
Campaign Bulletin		17 - Electrical	Can Perform (where permitted)
Model Year	Model	Country/Region	Build Location
2021 - 2022	Model S, Model X	North America	Fremont
<small>The model(s) and model year(s) listed are a general approximation of the affected VIN list. Refer to the VIN/Bulletin Tracker or Customer/Vehicle profile to determine applicability of this bulletin for a particular vehicle.</small>

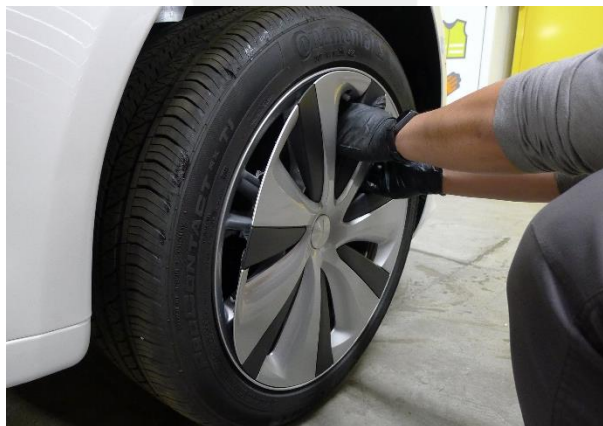
Figure 1

NOTE: Lift every other wheel cap spoke (Figure 1) until the wheel cap is removed from the wheel.

1. Remove the LH and RH rear wheel caps, if equipped.

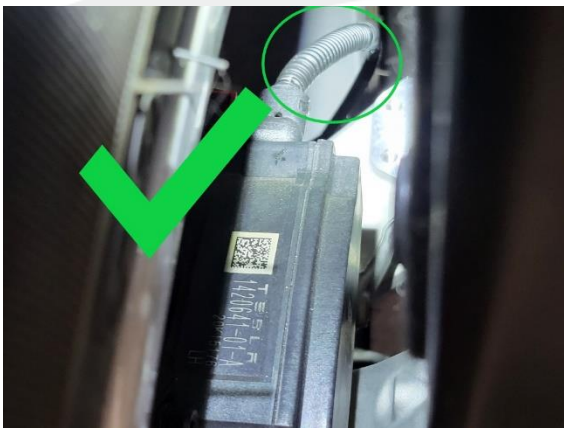
2. Carefully inspect the LH EPB wires at the rear brake caliper. Repeat this inspection for the RH side.
 - If the EPB wires are covered with corrugated tubing (Figure 2), no further rework is needed. Reinstall the wheel caps, if equipped, and discontinue this procedure.

Figure 2 – Corrugated tubing installed

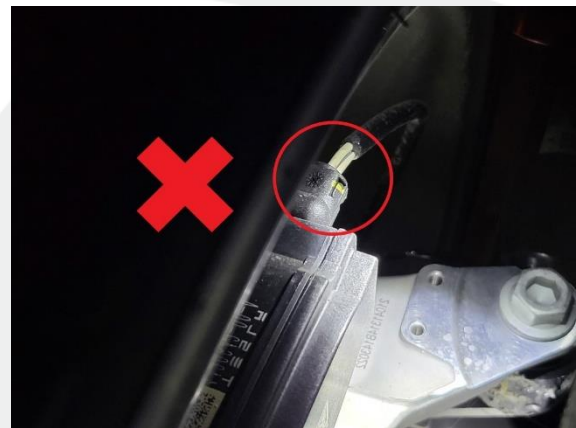
- If the EPB wires are NOT covered with corrugated tubing but no wire damage is evident (Figure 3), continue to the next step.
 - If the insulation of the EPB wires is damaged (Figure 4), replace the rear chassis harness (refer to Service Manual procedure 17107302; [Model S](#), [Model X](#)):

Figure 3 – Corrugated tubing not installed

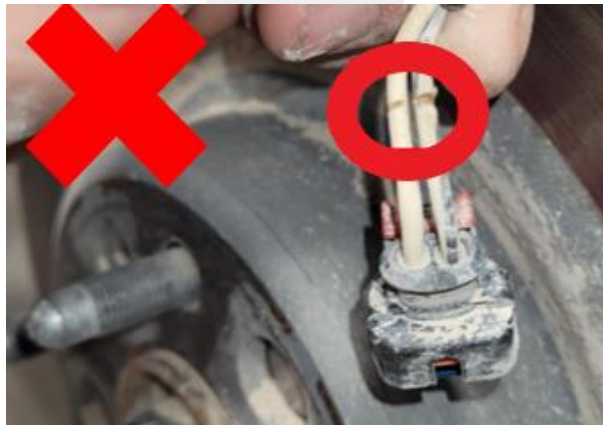
On certain Model S and Model X vehicles, the electrical wires for the Electronic Parking Brake (EPB) may be subject to abrasion caused by long term vibration cycling. Abrasion between the EPB wires and the backshell may strip the EPB wire insulation, resulting in water ingress or an electrical short.

Figure 4 – EPB wire insulation damaged

- If the new rear chassis harness is revision C, it does not have the corrugated tubing and must be retrofitted with the corrugated tubing. Install the new rear chassis harness, and then skip to step 5.

- If the new rear chassis harness is revision D, it has the corrugated tubing. Install the new rear chassis harness, and then skip to step 9.

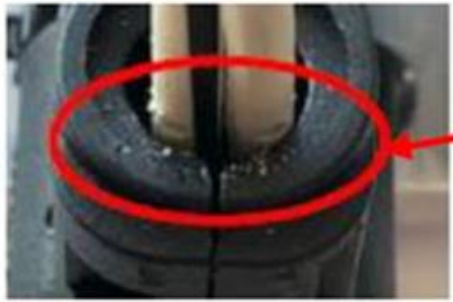
Figure 8

⚠ CAUTION: If the backshell has worn through the outer jacket or the EPB wires are damaged (Figure 8), the rear chassis harness must be replaced (refer to Service Manual procedure 17107302; [Model S](#), [Model X](#)):

- If the new rear chassis harness is revision C, it does not have the corrugated tubing and must be retrofitted with the corrugated tubing. Install the new rear chassis harness, repeat step 5, and then continue to the next step.
- If the new rear chassis harness is revision D, it has the corrugated tubing. Install the new rear chassis harness, and then skip to step 9.

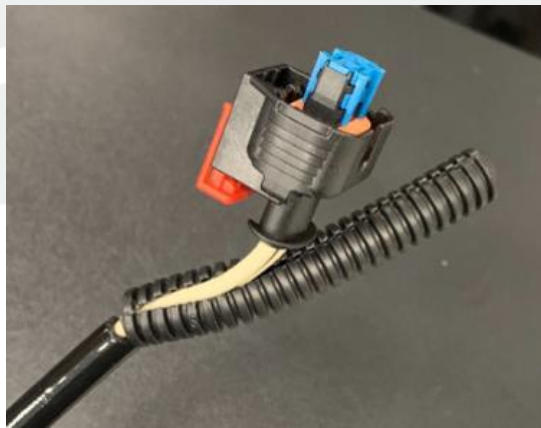
Figure 9 – EPB electrical connector disconnected for clarity

6. Install the corrugated tube into the EPB electrical harness (Figure 9).

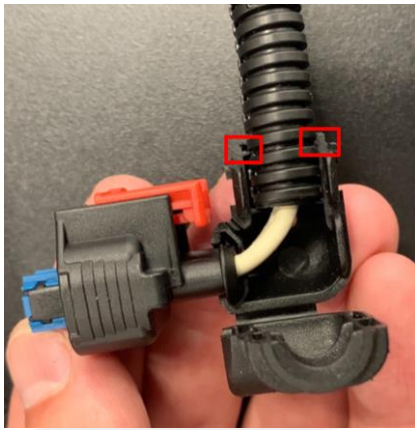
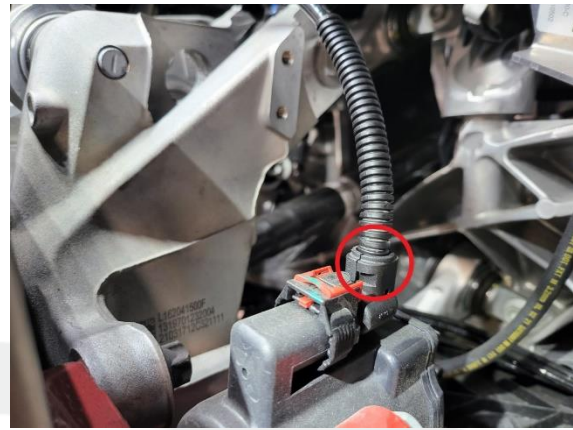
Figure 11 – EPB electrical connector disconnected for clarity

- b. Align the third groove on the corrugated tube with the ridge and snap the backshell shut (Figures 11 and 12). Listen for an audible click when closing the backshell.
