Tesla, Inc.
Service Bulletin

Retrofit Hydraulic Control Unit Wake-Up Wire, Model 3 (Lead-Acid Battery)

SB-22-33-002
April 30, 2022

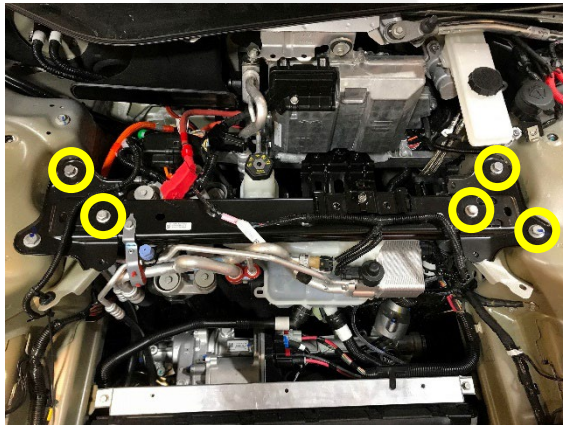
Figure 2

4. Remove the remaining shock tower brace bolts (x5) (Figure 2), and shift the shock tower brace forward on the LH side.

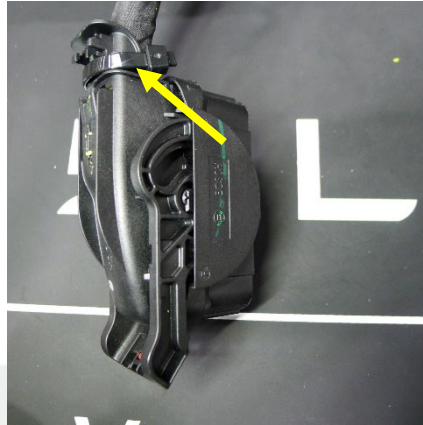
Figure 5

7. Remove the cable tie from the rear of connector X151 (Figure 5).

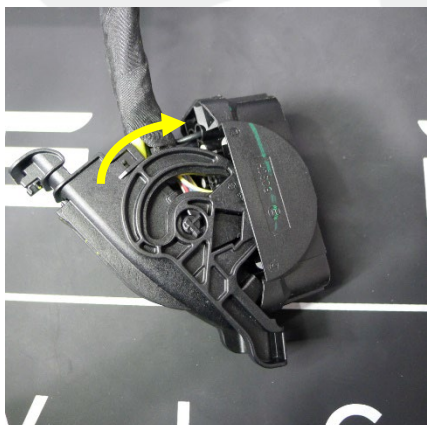
Figure 24

20. Attach the rear cover to connector X151, and then swing the rear cover close (Figure 24), engaging the tabs (x2) (Figure 25).

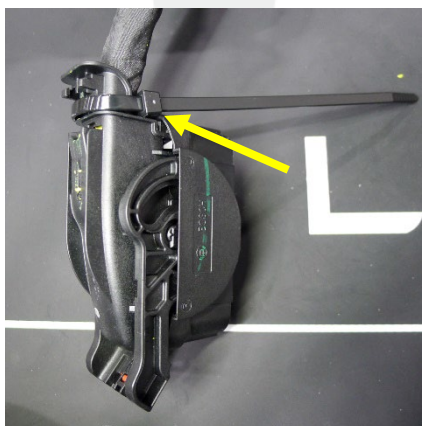
Figure 26

21. Fasten a small cable tie to the rear of connector X151 to secure the rear cover (Figure 26), and then trim the tie.

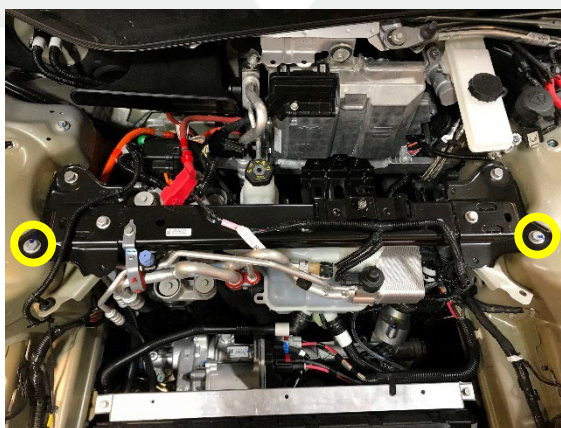
Figure 29

23. Return the shock tower brace back to position, install all bolts, and then tighten the forward bolts (x2) as shown (Figure 29) (torque 62 Nm).
