Model: Model 3

Vehicle System: 11 - Closures

Tech Note: Primary Side Body Seals Installation Guidelines

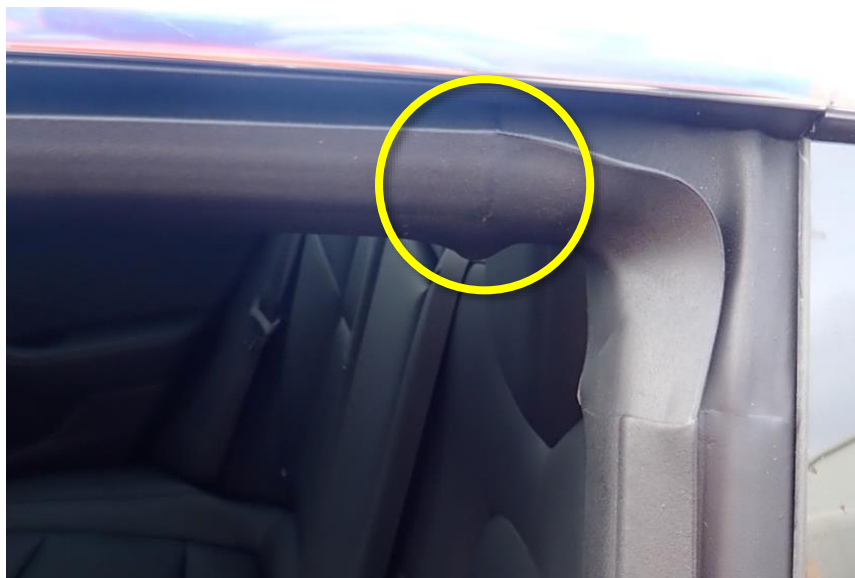
Figure 5

1. Open the LH rear door.
2. Inspect the top edge of the rear primary side body seal (Figure 5):
 - If puckering is present, continue to the next step.
 - If puckering is not present, skip to the “Puckering at the Rear Edge of the Rear Primary Side Body Seal” section of this document.

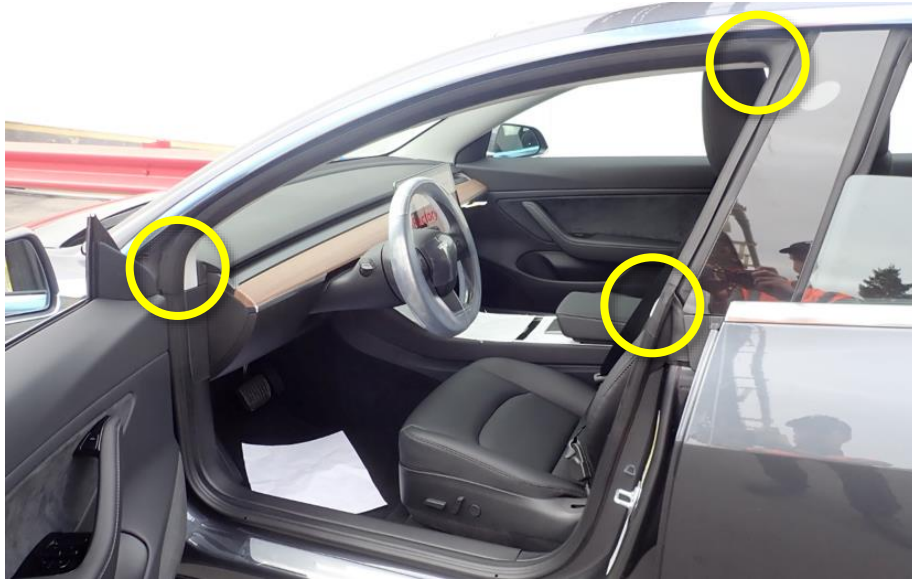
Figure 14

1. Open the LH front door.
2. Inspect the entire LH front primary side body seal for any puckering related issues (Figure 14).

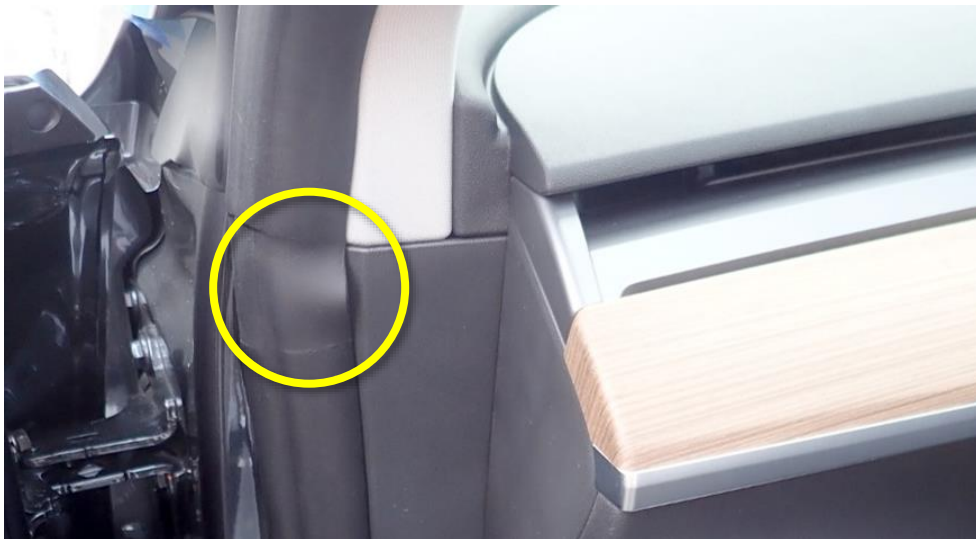
Figure 15

Inspect the front edge of the front primary side body seal near the A-pillar (Figure 15):

- If puckering is present, continue to the next step.
- If puckering is not present, skip to the “Puckering at the B-Pillar of the Front Primary Side Body Seal” section of this document.

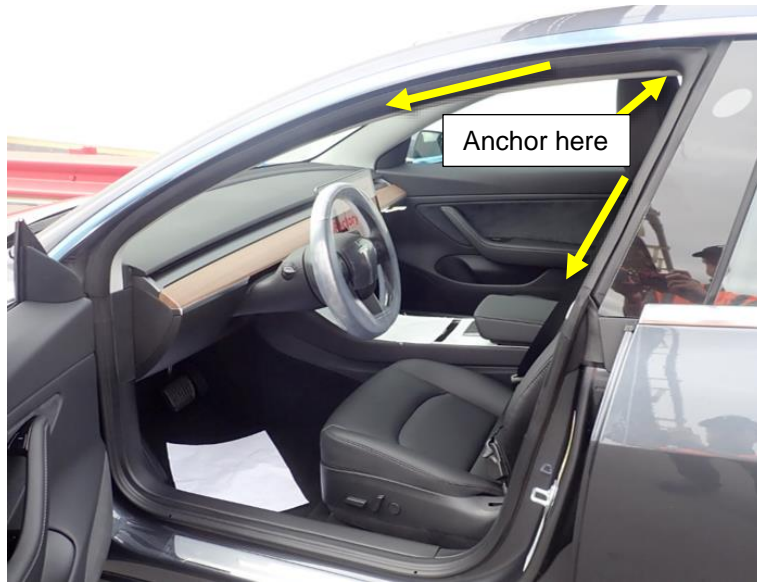
Figure 18

Inspect the top or rear edge of the front primary side body seal at the B-pillar:

1. Pull the portion of the front seal where the puckering is present, away from the door frame.

- Anchor the front seal in the top corner with one hand, and then reinstall the front seal with the other hand, working away from the corner (Figure 18).

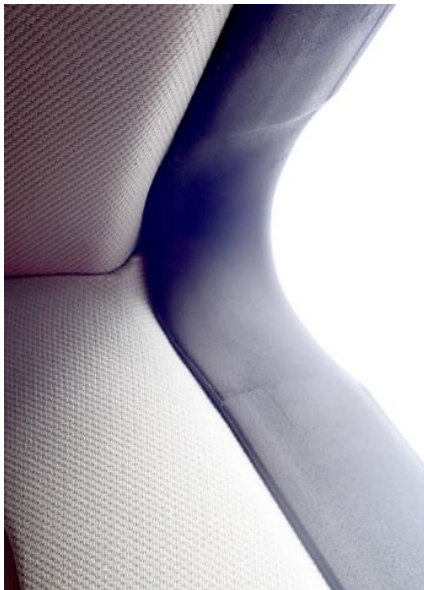
✓ Figure 19

Inspect the corner between the top edge and the B-pillar edge of the door frame (Figures 19 and 20):

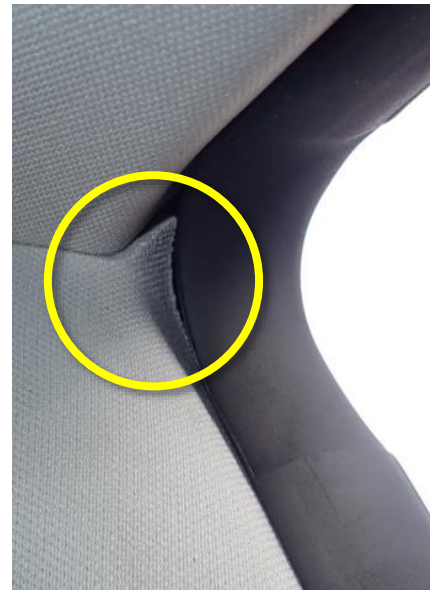
✗ Figure 20

- If the front primary side body seal has a void present, continue to the next step.
- If a void is not present, skip to the "Void at the C-Pillar of the Rear Primary Side Body Seal" section of this document.

1. Partially remove the front seal from the top and B-pillar sides of the door frame.
2. Press the corner of the front seal into place.
3. Anchor the front seal in the top corner with one hand and reinstall the front seal with the other hand, working away from the corner.

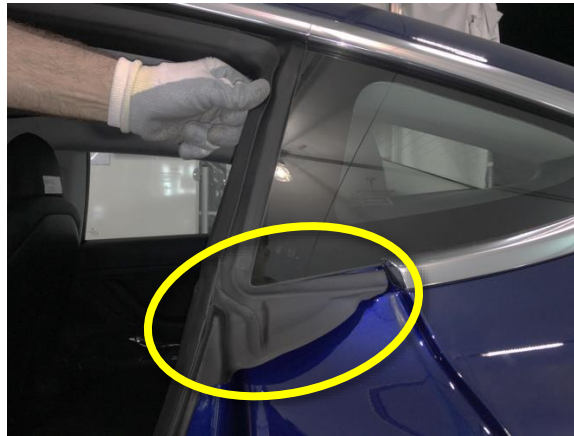
Figure 21

1. Open the LH rear door.
2. Inspect the entire rear section of the rear primary side body seal for voids near the C-pillar.

NOTE: Pay particular attention to the area circled in Figure 21.

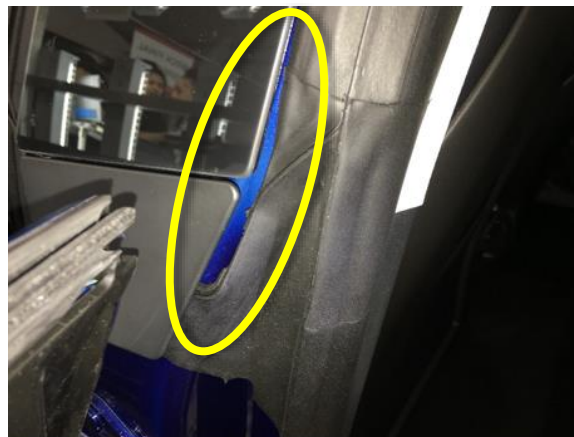
~~Figure 27~~

1. Open the LH rear door.
2. Inspect the entire front section of the rear primary side body seal at the B-pillar for voids.

NOTE: Pay particular attention to the area circled in Figure 27.

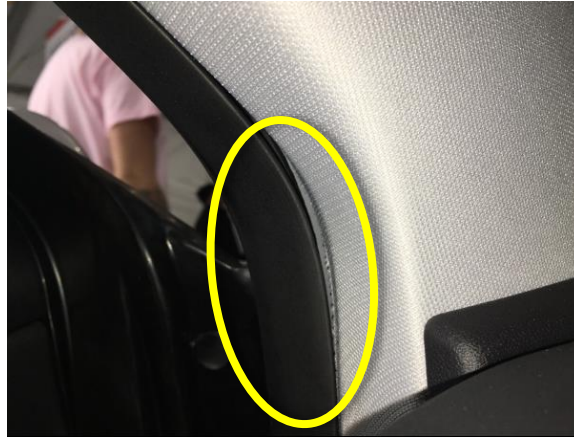
**Figure 31**

1. Open the LH front door.
2. Inspect the entire front section of the front seal for voids.

NOTE: Pay particular attention to the area circled in Figure 31.

3. Partially remove the front seal at the lower A-pillar, and then slightly push the front seal up into the A-pillar corner.

**CAUTION:** Pushing the front seal too hard might cause puckering at the A-pillar.
